SAFETY ALERT

SAND FACE COLLAPSES ON LOADER

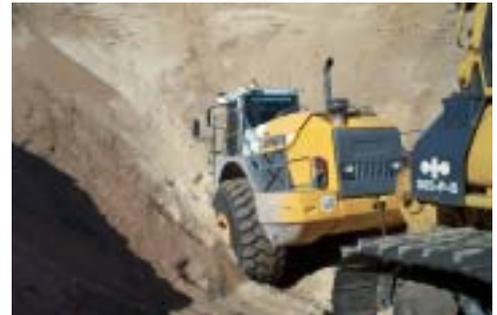
A front end loader was being used at a dune sand mine to remove sand from a face about 15 metres high by 50 metres wide. The sand collapsed around the loader burying it up to the front wind screen and slightly pushing the wind screen in. The operator was not hurt and was able to escape through the door. It took a few hours to dig the loader out.

- All sand faces should be worked back and forth along the total length of the face in as straight a line as possible. Loaders should load straight into the face. A cavity should not be made into a face.
- Knock down the face at the end of the day.
- When the height of the face exceeds the reach of excavating equipment consider benching the face.
- Erect a fence or other barrier at the top of the face to stop people from falling over a dangerous face.

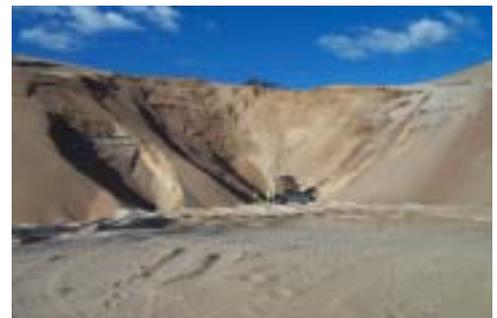
Because of problems with the quality of sand across the face workers chased a pocket of better sand and formed a large hole in the face about 10 metres wide and 10 metres deep. This created an arc around the top of the face which caved-in around the loader.
