# INVESTIGATION INFORMATION RELEASE

## Worker hit by shotcrete delivery line

**Event:** Serious injury in underground metal mine

**Location:** Woodlawn Mine, Tarago NSW

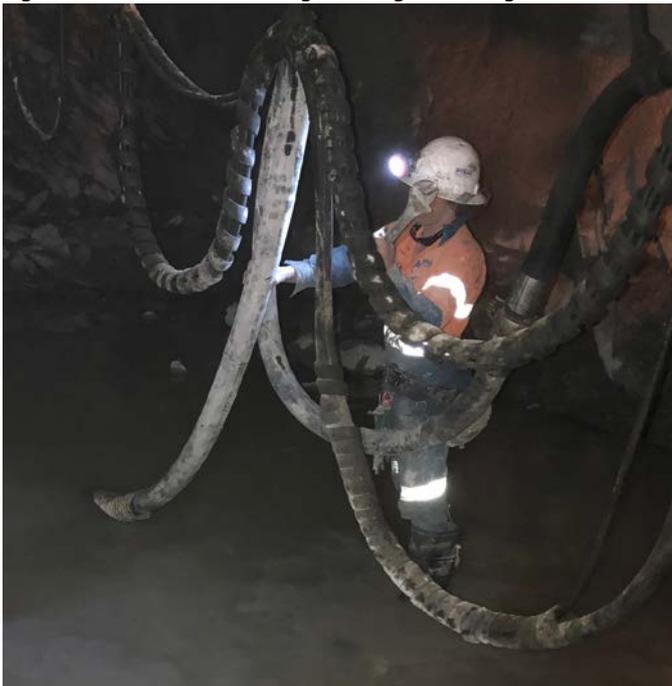
*Figure 1 A worker simulating clearing a blockage in a shotcrete delivery line*

A trainee mine worker was carrying out shotcreting work in an underground area of the mine while accompanied by an experienced worker. The two workers had applied about five cubic metres of shotcrete when they experienced a blockage in the delivery line of the spray rig. The blockage was believed to have been caused by an oversized rock, or rocks, entering the system during batching.

The workers tried unsuccessfully to flush the blocked line with compressed air. The workers then disconnected the delivery line from the spray nozzle end and again unsuccessfully tried to flush the line using compressed air. The workers informed inspectors they believed that residual air pressure had bled from the system, and one of the workers tried to clear the blockage by hitting the delivery line with a large shifting spanner. The blockage cleared, causing stored air under pressure in the line to suddenly release. The unsecured delivery line jerked, hitting the trainee worker in the lower leg.

Clearing blockages in the delivery lines of shotcrete spray rigs is a hazardous activity due to the potential for stored energy contained within the system to be released. The sudden release of stored energy in delivery lines can cause them to move unpredictably, causing injury or death.

- identify risks associated with pressurised delivery systems
- implement reasonably practicable control measures to ensure the health and safety of workers conducting inspections, maintenance or cleaning pressurised delivery systems
- ensure plant is isolated and residual system pressure is relieved before starting maintenance or cleaning tasks
