WEEKLY INCIDENT SUMMARY

Week ending Friday 08 October 2021

INCIDENT TYPE	SUMMARY	COMMENTS TO INDUSTRY
Dangerous incident IncNot0040846 Underground coal mine

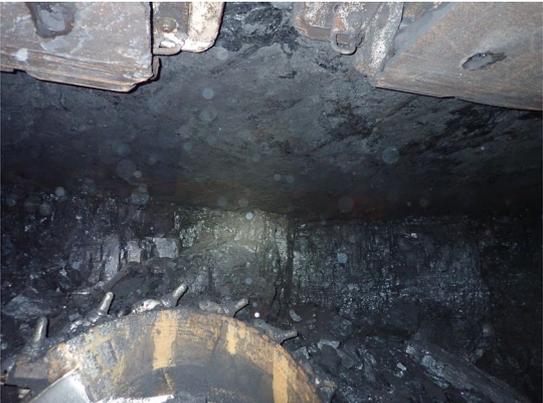
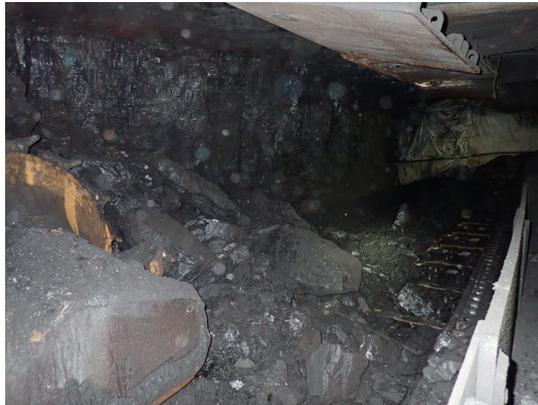
Ground or strata	A coal burst occurred while a longwall was in full remote operation. The workers were operating from the maingate as per their coal burst TARP.

Identification of increased coal burst potential and properly implemented TARPs reduces the likelihood of a coal burst exposing workers to risk. TARPs should be continually reviewed to ensure that the triggers and controls remain appropriate as mining conditions evolve. Refer to: IIR16-05 Austar coal burst Report into double fatality at Austar Coal Mine on 15 April 2014
