WEEKLY INCIDENT SUMMARY

Week ending Friday 11 December 2020

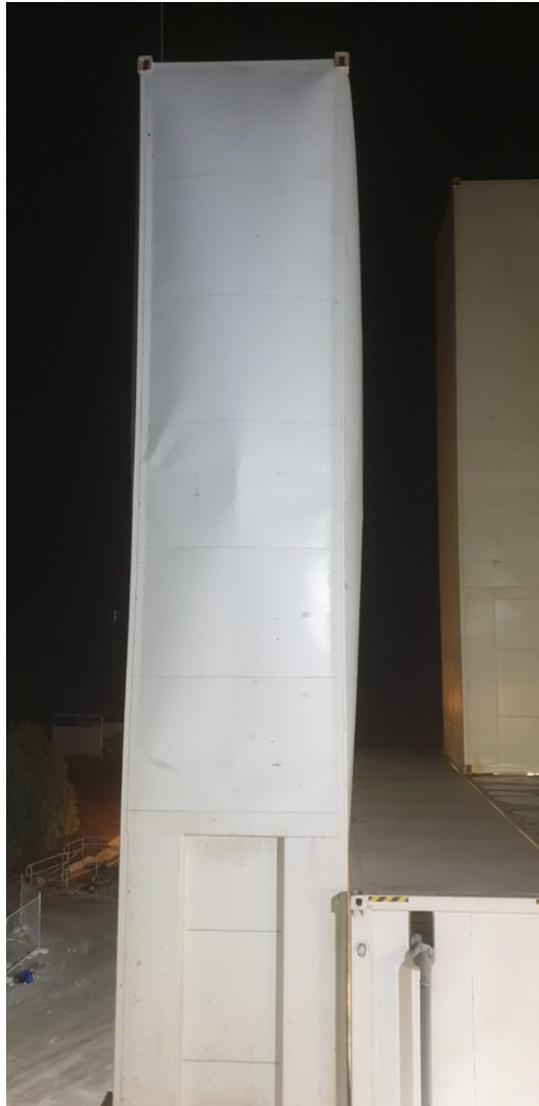
INCIDENT TYPE	SUMMARY	COMMENTS TO INDUSTRY
Dangerous incident IncNot0038802 Underground metals mine	<p>During the filling of a cement silo an over-pressurisation resulted in deformation of the silo. As a result, bridge clamps connected to another silo snapped and one fell to the ground landing approximately three metres from a person. The two pieces of the bridge clamp that fell weighed 1.6 kilograms and 1.5 kilograms. No one was injured.</p> <p>Preliminary investigation suggests that a blockage in the dust extraction hose prevented the pressure relief valve from working.</p>	<p>This incident is under investigation and further information may be published later.</p> <p>Mine operators should review their maintenance programs for silos and ensure that their dust extraction hose system allows for easy removal to check for blockages.</p> <p>Consider fitting individual relief valves to each silo tank and installing overhead protection for operators filling the silos.</p>

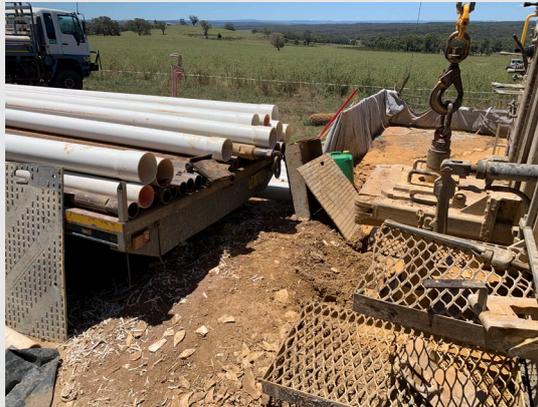
A driller's offsider had the tip of his finger amputated when it was crushed between a drill bit and hammer shroud. The driller was lowering the hammer bit onto a trolley on the rod trailer when the offsider slipped on the wet surface causing his left hand to slip between the bit and hammer shroud. The weight transferred to the trolley, causing the gap between the bit and hammer shroud to close, resulting in the crush injury.

Mine operators and contract companies should ensure their training includes identifying potential pinch points and their associated hazards.

- eliminating, or where this is not possible, controlling the hazards that could result in hand injuries. This may require operators to install effective guarding.

- alternative methods to remotely move drill rods and drill bits onto the trolley on the rod trailer
- separating the stabiliser from the hammer bit to reduce the weight of the drill bit assembly
- Improving work area floor surface to reduce soft/wet areas.
