WEEKLY INCIDENT SUMMARY

Week ending Friday 7 May 2021

This incident summary provides information on reportable incidents and safety advice for the NSW mining industry. To report an incident to the NSW Resources Regulator: phone 1300 814 609 24 hours a day, 7 days a week.

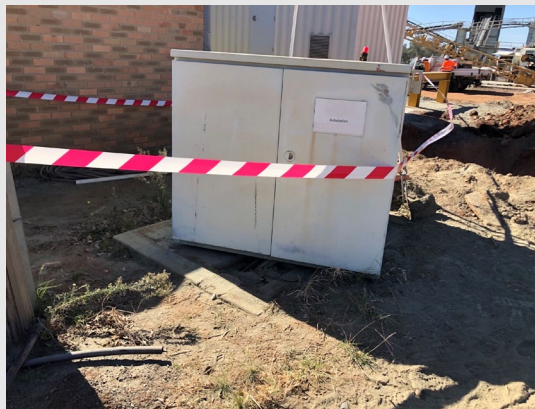
Dangerous incident
IncNot0039789
Open cut
construction
materials

An excavator has unintentionally contacted an energised pad mounted transformer (main transformer substation) forcing it from its normal position and causing a high voltage electrical fault which caused the electrical protection to activate. The excavator was digging a trench close to the transformer when the machine slewed around, and the counterweight hit the transformer dislodging it from its mounts.

When working in proximity to live high voltage equipment, mines should consider the associated hazards and apply the hierarchy of controls. De-energising the HV equipment prior to work or minimising the risk by using alternative plant, the erection of barriers, the application of safe operating distances and using observers should all be considered.
