# SAFETY ALERT

## Electrician receives arc flash burns

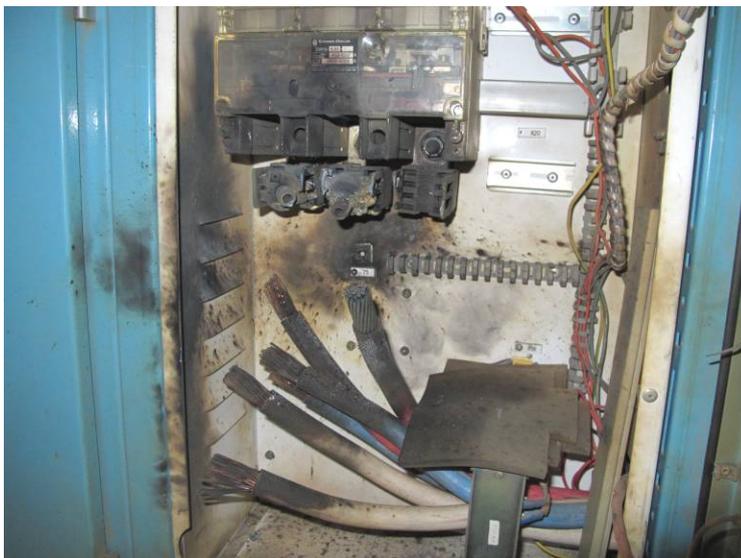
The investigation found that the cubicle door had been open prior to the 415V circuit breaker being closed. The electrician had placed himself to the side of the cubicle, before he rotated the switching shaft using a shifting spanner. It appears that the loose terminal cable clamps on the load side of the circuit breaker have come in contact with each other and an arc flash has resulted. The electrician did not receive an electric shock.

- Clause 208 of the *NSW Occupational Health and Safety Regulations 2001* requires that an employer develop and implement safe work procedures for live testing.
- When determining work practices, test equipment and PPE for live testing, reference should be made to relevant standards, including **AS/NZS 4836 - Safe working on or near low-voltage electrical installations and equipment**, for guidance.
- Live testing should only be conducted when there is no effective testing technique that can be undertaken while the equipment is de-energised.
- Any testing method shall minimise the need for worker interaction with exposed, energised conductors.
- Creepage and clearance distances for electrical cabling systems should be verified as being suitable for the rated voltage of the installation.
- Mining operations should review safety alert [SA05-06 'Serious Electrical Shock Incident'](#)
