SAFETY ALERT

Worker falls through guardrail

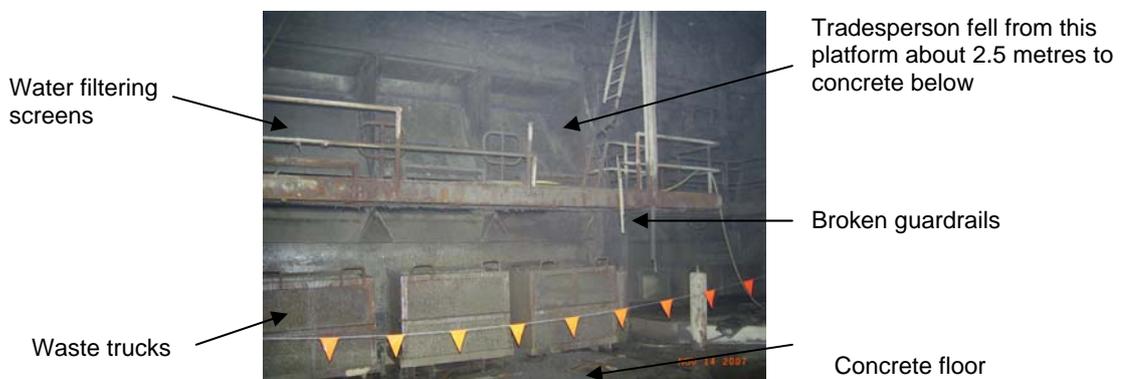
After cleaning around the floor level and waste trucks it appears the tradesperson took the hose up onto the platform above the floor level and began hosing the screens. During hosing the tradesperson either tripped or stumbled back onto the platform guardrails. The guardrail collapsed and broke, allowing the tradesperson to fall about 2.5 metres to the concrete floor below.

Photograph of fixed underground plant

- Fixed guardrails corroded and in poor condition
- Inadequate inspection and testing of the structural condition of the fixed plant, in particular the fixed platform, guardrails and ladders
- Inadequate procedures for working alone.

1. Testing is conducted regularly to determine the condition of guardrails and guardrail posts. Refer to Australian Standard AS 1657-1992 *Fixed platforms, walkways, stairways and ladders – Design, construction and installation*.
2. Preventative maintenance is conducted to ensure the effects of corrosion are minimised.
3. Appropriate procedures are developed and implemented for persons working alone. These procedures should include adequate communication and monitoring systems.
