COMPLIANCE AUDIT REPORT

HUNTER VALLEY OPERATIONS SOUTH – TOPSOIL MANAGEMENT

Hunter Valley Operations Pty Ltd

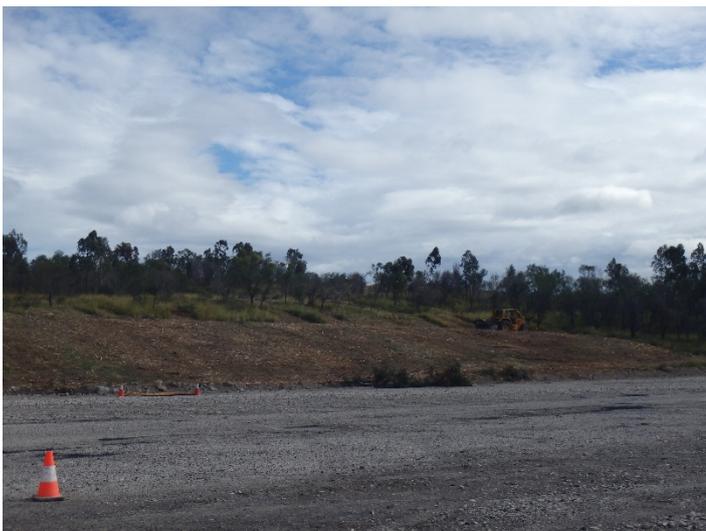
It was observed that grubbing of the area had been completed to remove large trees and shrubs from the site (Figure 1). A mulcher was in operation on the groundcover along the strip for incorporation into the topsoil when stripped. This process was observed to be consistent with the process described in section 2.4.2.3 of the MOP.

Figure 1 Mulcher on Cheshunt strip 24 before topsoil removal

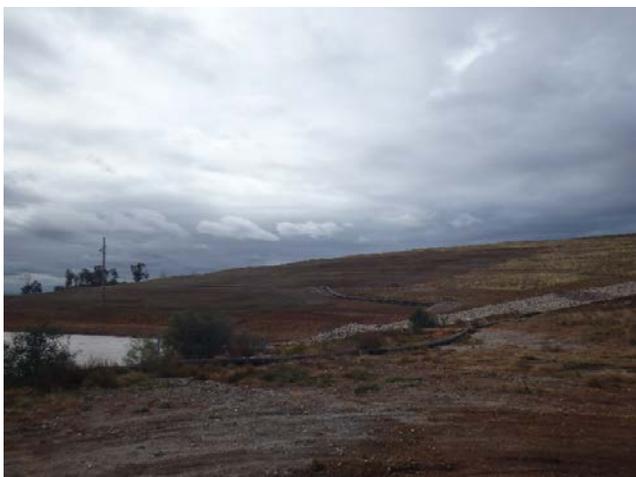
HVO has identified that direct placement of topsoil was the preferred option when undertaking topsoil stripping operations and the site inspection identified several areas of rehabilitation have had direct placement of topsoil, for example, topsoil stripped from Riverview South was direct placed on Riverview North (Figure 2).

Figure 2 An area of Riverview North where topsoil was direct placed

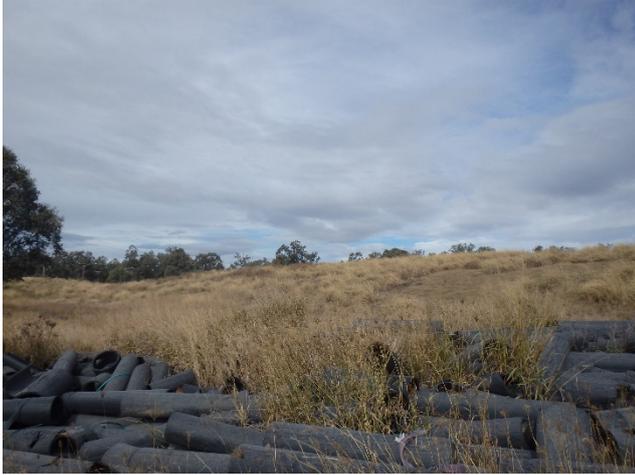
However, one older stockpile (possibly 15+ years old) was observed next to a laydown area for high density polyethylene pipe (HDPE pipe) (Figure 3). Although the stockpile was well vegetated and signposted, there was a risk that vehicles could inadvertently impact the stockpile during placement or retrieval of the pipe sections. The location of the laydown area for the HDPE pipe would not appear to be consistent with the location principles for topsoil stockpiles specified in the MOP. It is acknowledged that this stockpile was established before the existing guidelines for topsoil management, however, the placement of HDPE pipe has occurred after stockpile establishment and the pipes could be moved to a more suitable location. This is raised as **observation of concern no. 2**.

Figure 3 An older topsoil stockpile immediately adjacent to a pipe laydown area

OBSERVATION OF CONCERN NO.	DESCRIPTION OF ISSUE	RECOMMENDATION
1	Generally, the descriptions in the MOP relating to topsoil management are very brief and quite generic using language such as ‘where possible’ or ‘if required’. Using a risk-based approach to topsoil management, it would be expected that some form of trigger action response plan (TARP) would be available to provide the triggers for ‘when’ a particular control might be required.	This should be addressed during the development of the topsoil management plan being prepared in response to the Section 240 direction issued in October 2018.
2	One older stockpile (possibly 15+ years old) was observed to be located next to a laydown area for high density polyethylene pipe (HDPE pipe). Although the stockpile was well vegetated and signposted, there was a risk that vehicles could inadvertently impact the stockpile during placement or retrieval of the pipe sections. The location of the laydown area for the HDPE pipe would not appear to be consistent with the location principles for topsoil stockpiles specified in the MOP.	HVO should review the risks associated with the pipe laydown area adjacent to the topsoil stockpile and implement controls as required.

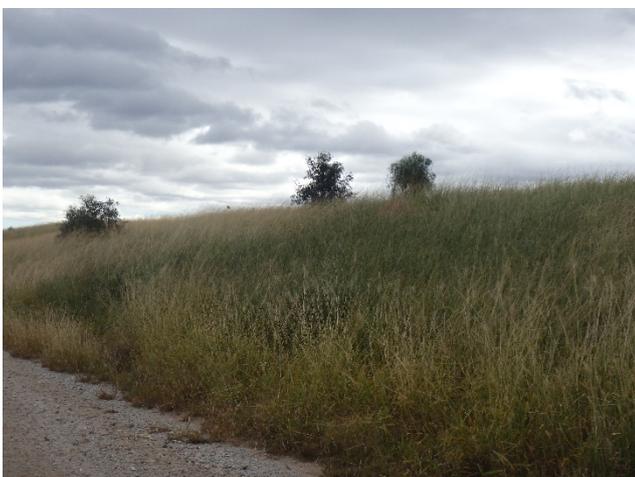
The MOP states that stockpiles will generally be sown with a multi-species cover crop, and generally the stockpiles inspected had been sown similar to stockpile 53 (Figure 4). However, the procedure for sowing of stockpiles does not appear to be consistently implemented as stockpile 47 did not appear to have a cover crop sown (Figure 5).

Figure 4 Topsoil stockpile 53, sown and well vegetated

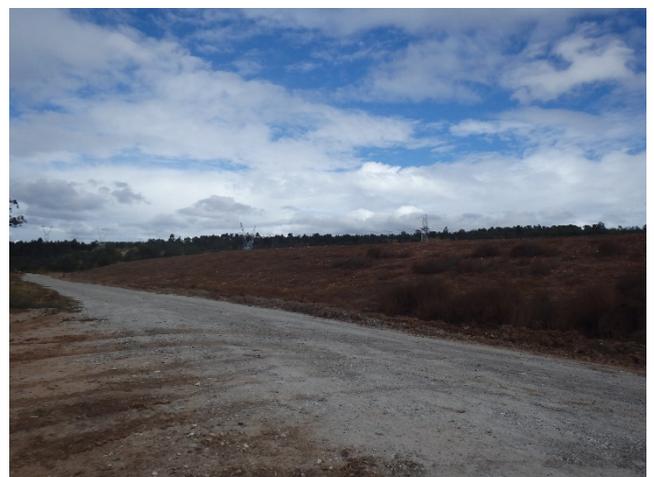
Figure 5 Topsoil stockpile 47, not sown, little vegetation
