# WEEKLY INCIDENT SUMMARY

Week ending Friday 13 November 2020

## Summarised incidents

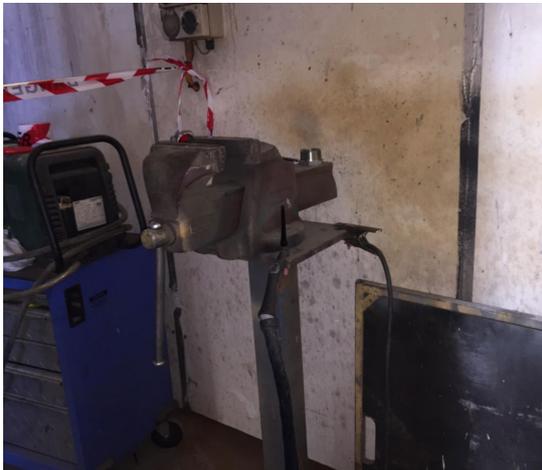
INCIDENT TYPE	SUMMARY	COMMENTS TO INDUSTRY
Dangerous incident IncNot0038618 Underground metals mine	An apprentice received an electric shock when his abdomen touched the vice that was holding the item he was welding.

Workers undertaking welding activities should remain insulated from the welding job. Mine operators should verify that workers carrying out welding activities have identified appropriate earthing points, their personal protection equipment (PPE) is dry and they are appropriately trained. Refer to: <a href="#">Safety Bulletin SB19-03 Welding-related electric shocks increase</a> <a href="#">NSW Resources Regulator Information Sheet No.2: Basic welding practices</a>

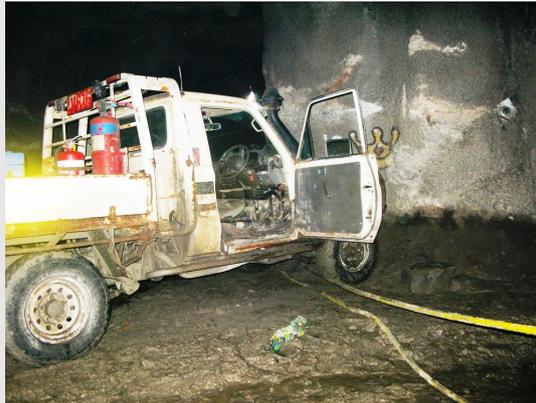
While travelling down an incline a light vehicle’s brakes failed. The operator steered the vehicle into the wall to bring it to a stop. The operator was not injured.

Roads or other  
vehicle operating  
areas

Mine operators should ensure defect reporting and pre-start inspections are being used effectively to maintain safe operating vehicles.

Operators should review their maintenance procedures, to ensure commissioning checks are carried out by competent people, before plant is returned to service as fit-for-purpose.

Safety critical systems, such as braking and steering systems, should be inspected, maintained and tested in accordance with the manufacturer's recommendations.

All vehicle drivers should be trained in what to do in the case of brake failure.
