# WEEKLY INCIDENT SUMMARY

Week ending Friday 20 November 2020

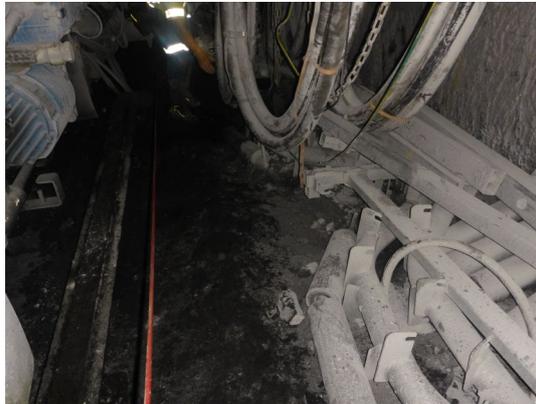
INCIDENT TYPE	SUMMARY	COMMENTS TO INDUSTRY
Dangerous incident IncNot0038655 Underground coal mine	<p>A worker sustained a head injury during a conveyor belt extension in an underground coal mine. Slack cable was being moved inbye on the primary monorail system (from transformer to DMU), outbye of the DMU monorail tow arm.</p> <p>The worker was found by other workers in a hunched over position and semi-conscious. It is suspected that he was hit in the back of the head, as he could not recall what had happened.</p> <p>An inspection of the site showed interaction between the monorail cables, hoses and a structure stored on the ground. The cables were tangled around</p>	<p>Mine operators should develop a risk mitigation strategy for the task of conveyor belt extensions. Consider engineering controls such as ensuring monorail loops are raised in the area between the DMU pull arm and the boot end. Ensure exclusion zones are in place.</p> <p>Mine operators should also have a standard procedure for managing workers with head injuries affecting their level of consciousness.</p>

the structure and the structure had moved from where it had been stored.

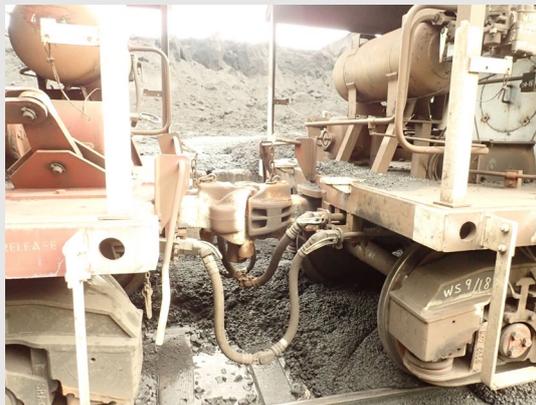
Dangerous incident  
IncNot0038658  
Coal processing

A major slump occurred on a coal stockpile. The slump migrated to three coal train wagons that were being loaded by manned front-end loaders. Coal slurry also flowed through to the rail tracks of several other wagons.

A manned front-end loader was close to the failed stockpile. No workers were on foot in the area at the time.

Mine operators should review their stockpile management documents and procedures and include:

- design of the stockpiles
- surface profile of the stockpiles to manage water at various stages of the formation of the stockpile
- controls to prevent water accumulation on the surfaces
- measurement of stockpile water levels at various stages of stockpile formation
- TARPs for stockpile management to include references to water content in the stockpiles and rainfall events
