## SERIOUS INJURY

# Fall from elevated work platform

**Incident date:** 29 July 2018

**Location:** Cowal Gold Mine, West Wyalong

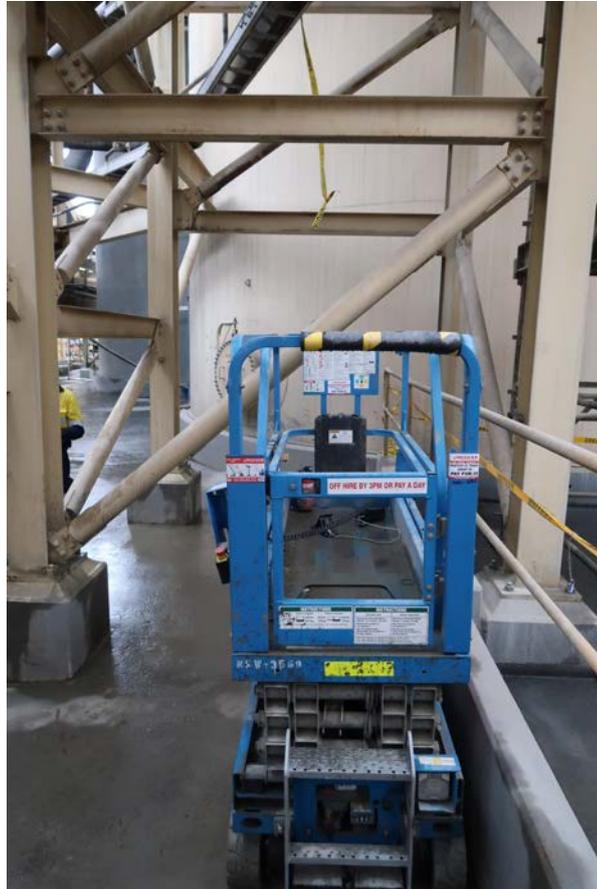
**Photograph 1: The scissor lift adjacent to the work location taken following the incident, with guardrails refitted.**  
Photograph by Resources Regulator.

About 11.30 am on 29 July 2018, a contract worker, 58, suffered spinal injuries when he fell from the platform of a scissor lift. The scissor lift's front and left side guard rails had been removed to move it under a steel structure.

A person falling from height from mobile plant is a foreseeable risk and adequate control measures should be put in place to manage the risk. The provision of guard rails on mobile plant is a critical control measure to reduce the risk of falling.

Mine operators and contractors must have effective safety management systems in place and identify risks associated with the operation of mobile plant. In managing these risks, mine operators and contractors must ensure that workers do not modify safety features or attempt to use equipment that they have not been verified competent to use.

Mine operators must ensure that workers are adequately trained and competent in the safe use of mobile plant, and that effective supervision and clear instructions are provided to workers. Only equipment which is fit for purpose of the task being undertaken should be used. Effective controls should be used to prevent falls from height occurring, which may include guard rails, barriers and fall restraint or fall arrest systems.

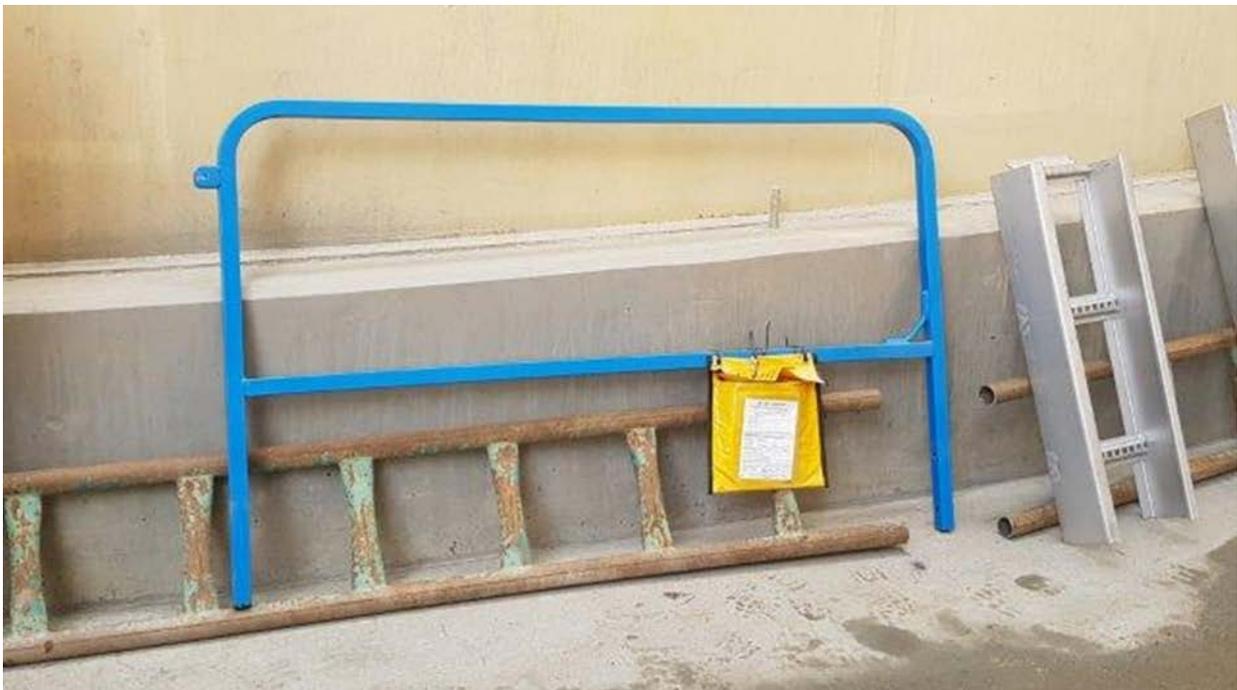
While standing on the scissor lift platform using its control unit, the worker lost balance and fell off the platform from a height of about one metre. The worker's injuries required surgery.

**Photograph 2: The removed side guard rail. Photograph courtesy of the mine.**
