WEEKLY INCIDENT SUMMARY

Week ending Friday 01 October 2021

This incident summary provides information on reportable incidents and safety advice for the NSW mining industry. To report an incident to the NSW Resources Regulator: phone 1300 814 609 24 hours a day, 7 days a week.

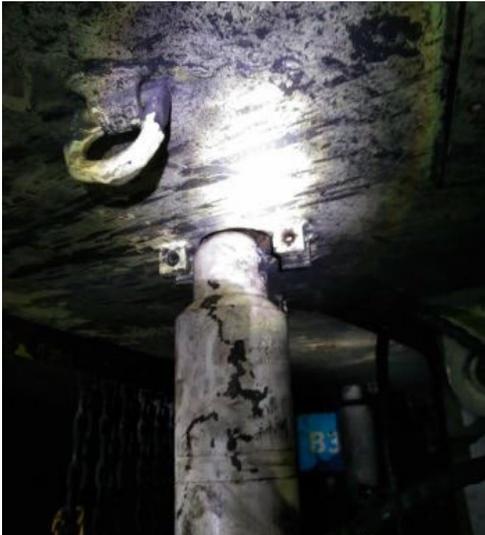
INCIDENT TYPE	SUMMARY	COMMENTS TO INDUSTRY
Dangerous incident IncNot0040801 Underground coal mine

A worker was replacing a leg cylinder on a breaker line support. While positioning to install the top pin, the yield valve

sprayed oil onto the worker. The investigation identified that the powered lower circuit entrapped fluid. When the leg was raised, the pressure intensified and caused the yield valve to dissipate the pressure from the leg’s top stage. The worker was uninjured.

<p>Effective isolation and energy dissipation practices are critical risk controls when working with high pressure fluid systems. Mine risk assessment on hydraulic systems must identify and provide effective controls for areas where trapped fluid poses a hazard. Refer to the following publications:</p> <p>SB13-01 Fluid injections result in surgery</p> <p>MDG41-Fluid-power-systems</p>

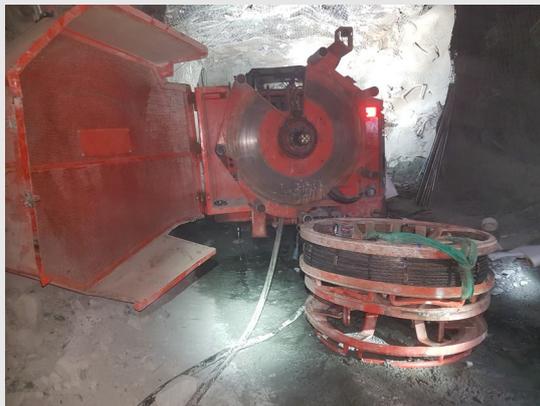
Dangerous incident
IncNot0040788
Underground
metals mine

A cable cassette was being changed out with an integrated tool carrier, when it dislodged. As it fell to the ground, it glanced the operator, who received some scratches to their hand and knee.

Workers need to identify safe standing zones and ensure they remain outside of the line of fire when replacing cassettes and attachments on mobile plant. When lifting loads, workers must:

- use the correct lifting equipment and machine for the task
- clean the work area of equipment not required for the task.
