SAFETY ALERT

UNSTABLE STRUCTURE CRUSHES WORKMAN

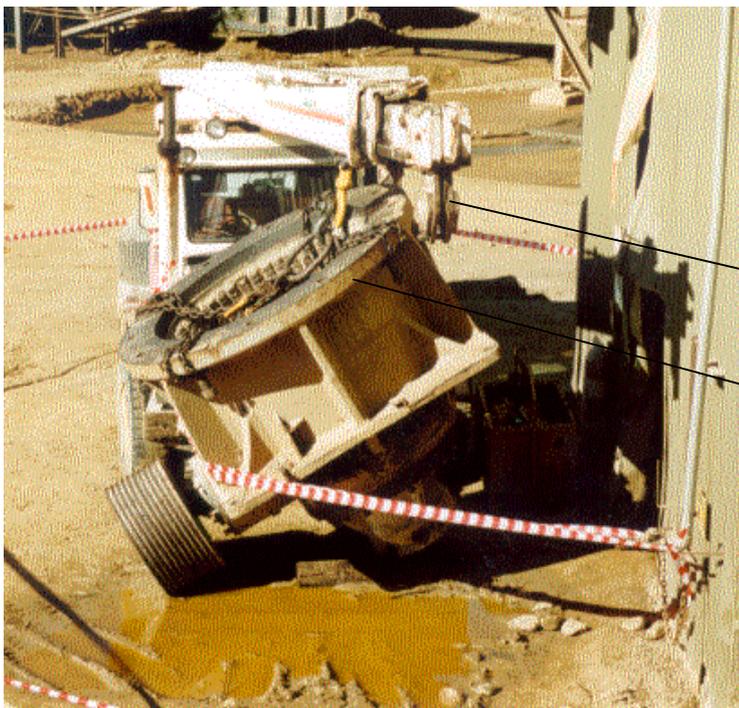
THE ROLLED-OVER CRUSHER MAIN FRAME

The main-frame was placed on two pieces of wood.

The rigger climbed inside the top of the main-frame to relocate the chain assembly. The edge of the pieces of wood gave way and the main-frame rolled.

- Its base is much smaller than its height and upper surface area.
- The ground was wet and muddy, and the ground and the two wooden supports were not level.
- Not all the threaded studs at the base of the main-frame were in contact with the wooden supports.

The workman was trapped and injured between the crane boom/hook and the inside of the main-frame upper flange.

Crane boom/hook

Upper flange of main-frame.

- Identify, assess and control risks before and during work which involves handling heavy objects.
- Use a support frame when you handle unstable things which need to be moved regularly, so that you make them more stable.

- Ensure temporary supports are strong enough, level and on a firm base.
- If there is any doubt about how stable an object is, use extra means of support, and do not let personnel enter a position of danger.

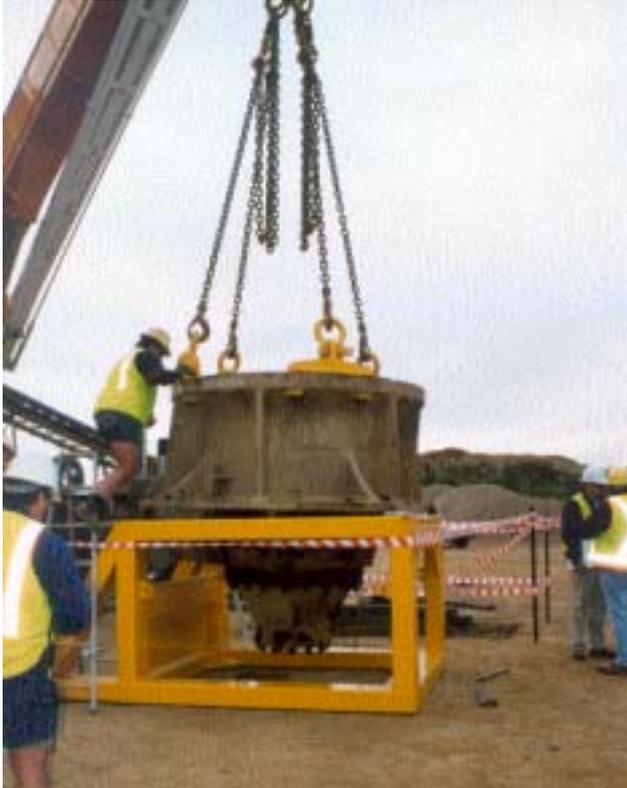
SAFE HANDLING

The crusher main-frame being placed on a new transport/support frame.
