WEEKLY INCIDENT SUMMARY

Week ending Friday 16 July 2021

CM9 reference	DOC21/607667
Mine safety reference	ISR21-28
Date published	23 July 2021
Approved by	Deputy Chief Inspector Office of the Chief Inspector

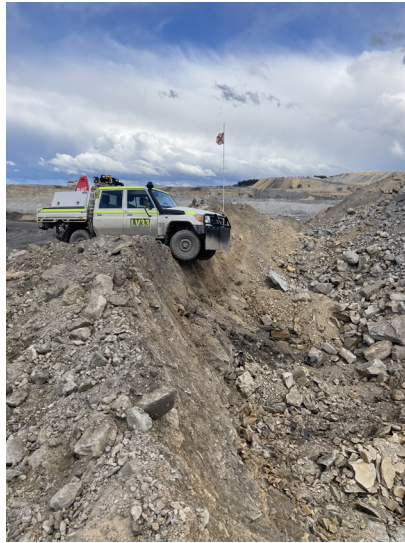
INCIDENT TYPE	SUMMARY	COMMENTS TO INDUSTRY
Dangerous incident IncNot0040312 Open cut coal mine

Roads or other vehicle operating areas	A light vehicle travelling up a ramp narrowly avoided driving over a 3.5 metre face. The ramp had been constructed in the morning to link two work areas but was partially excavated during the day. Due to the incline of the ramp, the light vehicle driver couldn't see that the ramp had been partially removed. The front wheels went over the edge and the vehicle bellied out on the open edge. The occupants were able to exit the vehicle safely and did not suffer any injuries. The ramp had been excavated without any delineation markers, windrow or positive communication to the light vehicle operators.	Mine operators should ensure that appropriate barricading standards are applied in instances where ramps or roads are excavated, or edges are exposed. Changes to roads and other vehicle operating areas should be communicated to affected workers. The Resources Regulator is currently investigating a similar incident in which a light vehicle drove over an open edge and fell 12 metres following the excavation of a ramp. Refer to: IIR20-03 Light vehicle drives over open edge

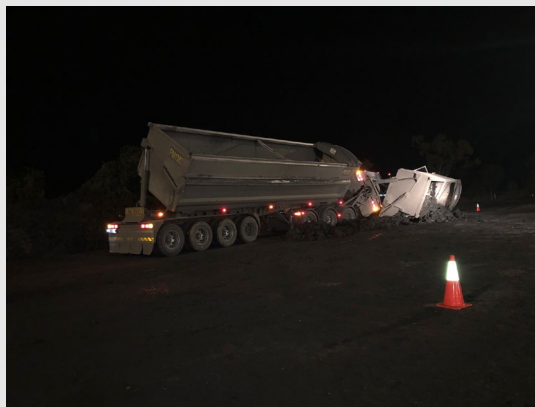
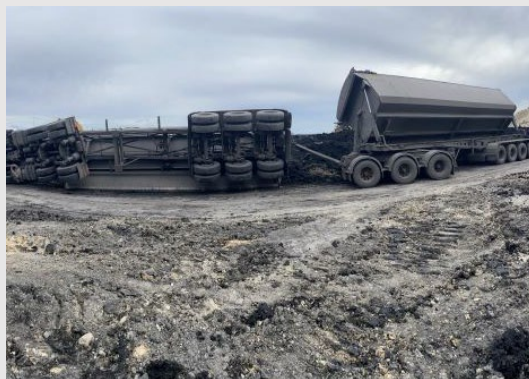
Dangerous incidents
IncNot0040301 &
IncNot0040298
Open cut coal mines

In two separate incidents, road registered prime movers have overturned. The trucks were each towing two side-tipping trailers. While tipping, the front trailer has rolled and pulled the prime mover onto its side. One truck was transporting coal preparation plant reject material and the other, material from a settlement pond. One worker had identified material hang up in the body, however, the truck rolled before the material released. Neither operator was injured.

Mine operators should consider the most appropriate truck type for the material being transported. Workers should monitor for material hang up and should report unsafe conditions to their supervisor.
