WEEKLY INCIDENT SUMMARY

Week ending Friday 26 March 2021

Mine safety reference ISR21-12

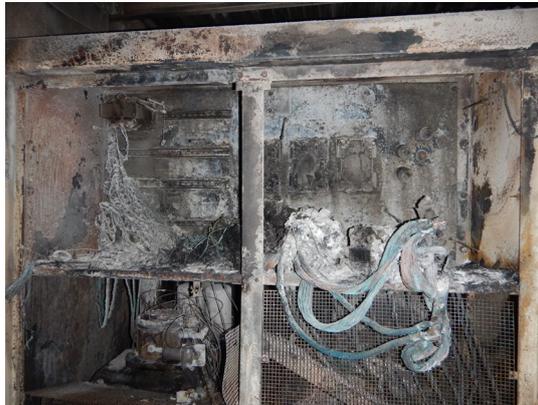
Two workers suffered nausea and headaches after taking about 30 minutes to extinguish a fire on a compressor. The compressor was on the mine surface, however, the workforce was withdrawn from underground as a precaution. Repairs had recently been completed to the compressor and it was deemed fit to continue in operation.	The cause of the fire is unknown. Further information may be published at a later date, following examination of the compressor.
