Investigation Report

Into the death of Jason Symonds at
PERILYA MINE on 09 January 2007

Investigation report for the Director General of NSW Department
of Primary Industries.

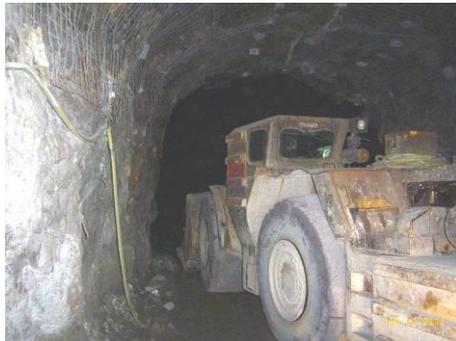
Photo 1

Remote controlled loader at the accident scene.

Photo shows width of loader in relation to the side wall of the drive..

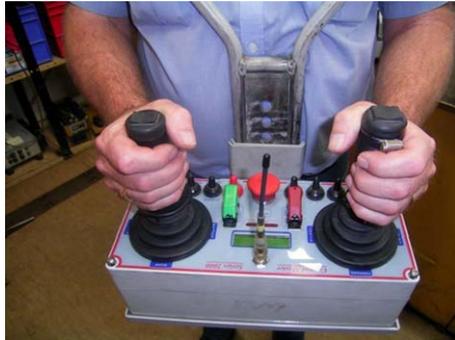
Photo 2

Remote control transmitter with harness as worn by operator.

The radio remote control system consists of a remote control transmitter, carried by the operator using a shoulder harness, and a radio receiver installed on the loader. The system was designed to AS/NZS 4240 - Remote Controls for Mining Equipment.

The system incorporated a number of safety features designed to shut the loader down or inhibit movements in the event of a malfunction of the radio system or an unsafe condition.

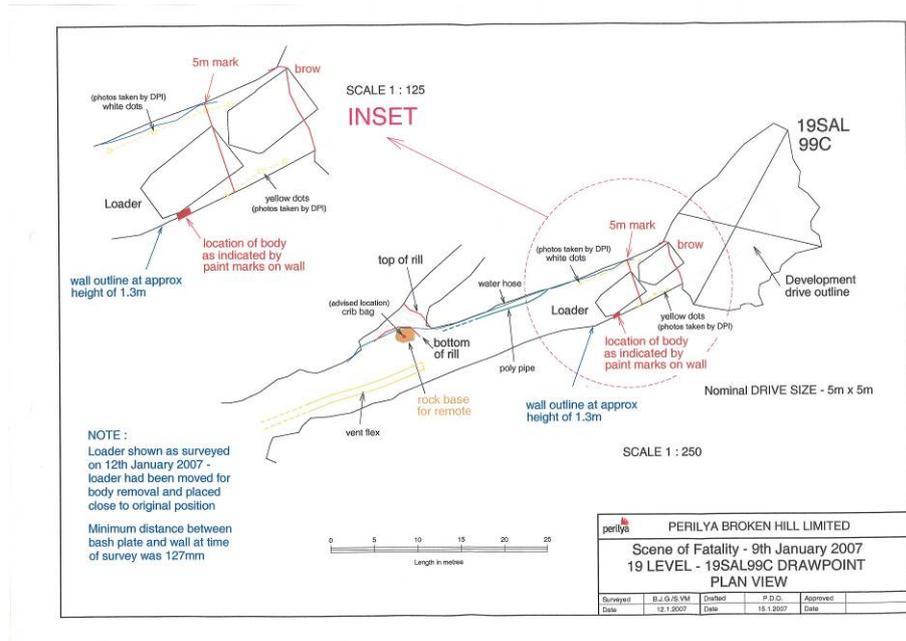
Photo 3 - Plan of incident site showing location of loader.

The plan also shows the operators cuddy

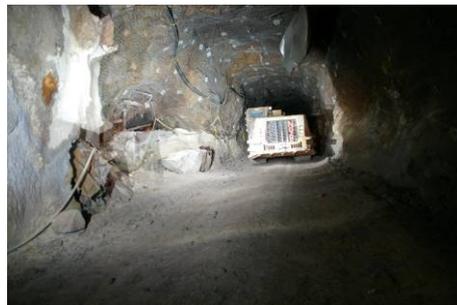
Photo 4

View of cuddy and access drive showing loader after it had been moved.

On arrival at the entry barricade sign they tried calling Symonds and received no answer. They drove through the "No Access" sign into the work area and found Symonds pinned against the right hand wall by the rear of the loader.

The loader engine was not running, which can be explained by the tilt switch in the remote control shutting the loader down if it is tilted by around 45°.
