**NSW
Resources
Regulator**

COMPLIANCE AUDIT PROGRAM – SUBSIDENCE MANAGEMENT

METROPOLITAN COLLIERY

Metropolitan Collieries Pty Ltd

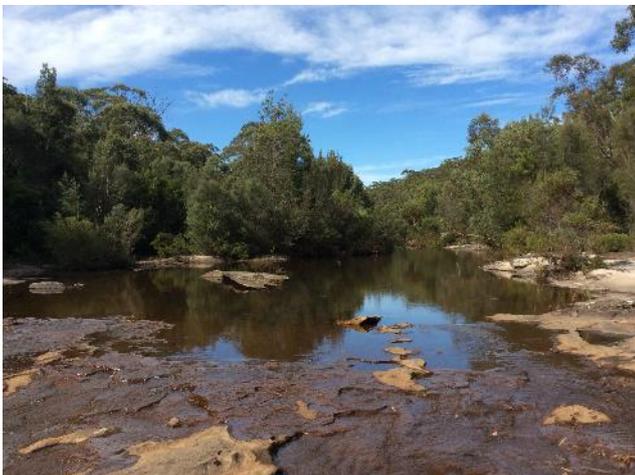
Figure 1 Waratah Rivulet Pool F

- Remediation of the rock bar at Pool F had been completed and appeared to be effective in holding water within the pool, with water flowing over the rock bar at the time of inspection. (refer to Figure 1 and Figure 2). A completion report for the rock bar remediation works was prepared and available for review during the audit.

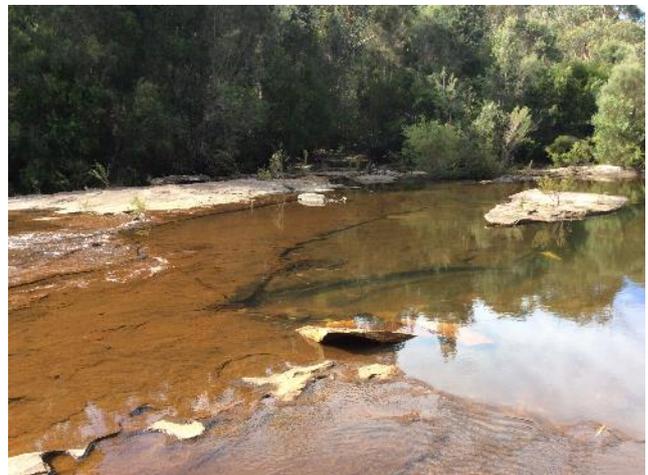
Figure 2 Water flowing over Pool F rock bar

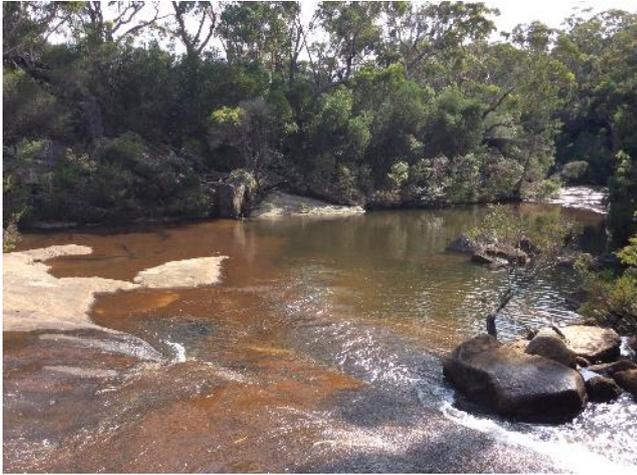
- Pool I was observed to have some surface cracking, but water was flowing freely with no remediation having been required (refer to Figure 3 and Figure 4).

Figure 3 Waratah Rivulet Pool I

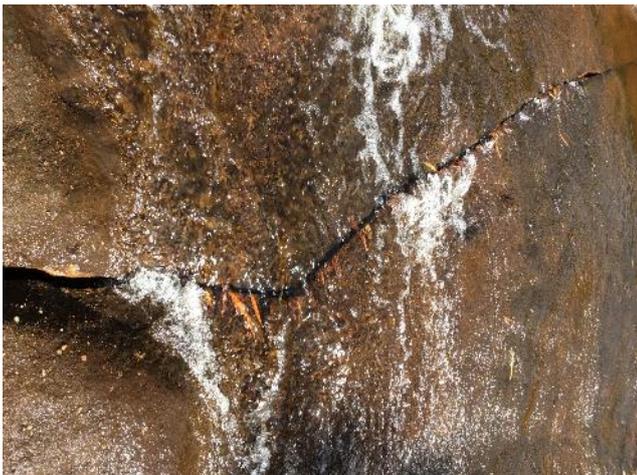
Figure 4 Example of surface cracking in Pool I rock bar

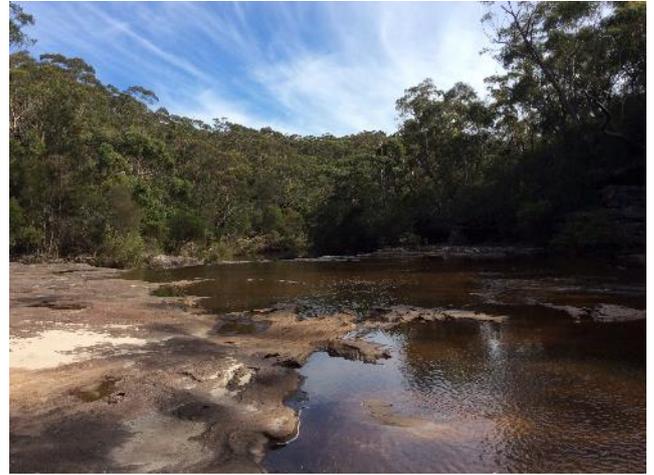
- Water was observed to be flowing through Pool J (refer to Figure 5). Rock ledges adjacent to Pool J appeared stable with limited signs of rock fall (refer to Figure 6).

Figure 5 Waratah Rivulet Pool J

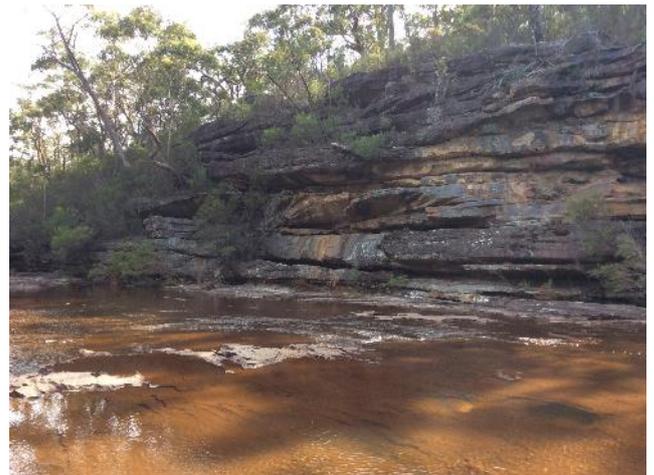
Figure 6 Rock ledges adjacent to Pool J

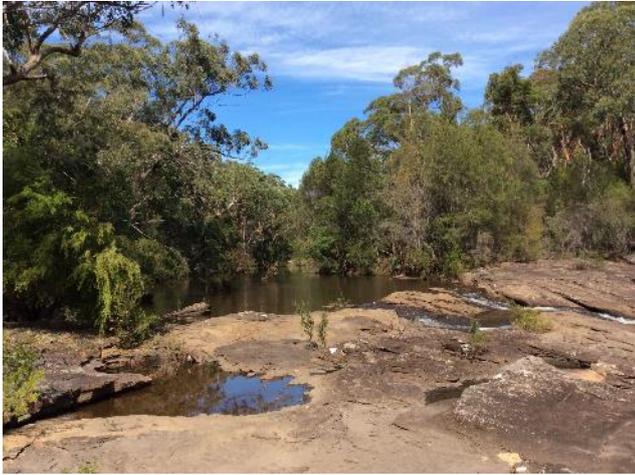
- Monitoring data and interviews with Metropolitan staff showed that Pool N had drained during extraction of longwalls but has since recharged following a significant rainfall event some years ago and has held water since (refer to Figure 7). This may indicate that the pool had settled into its new regime following subsidence, however, further monitoring would be required to determine whether remediation work was required. Water was flowing freely over the small waterfall between Pool N and Pool O (refer to Figure 8).

Figure 7 Waratah Rivulet Pool N

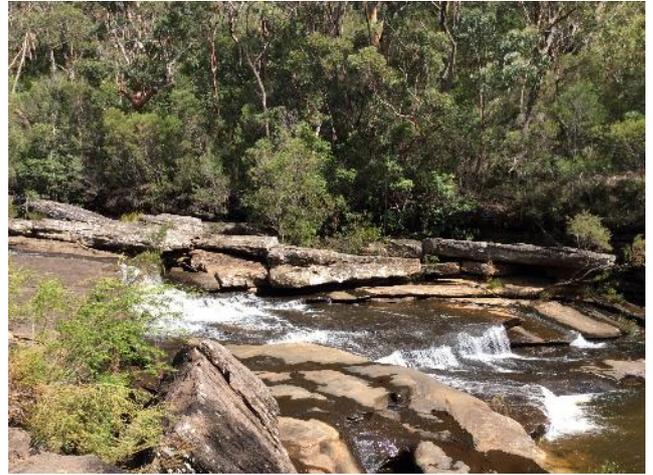
Figure 8 Small waterfall between Pool N and Pool O

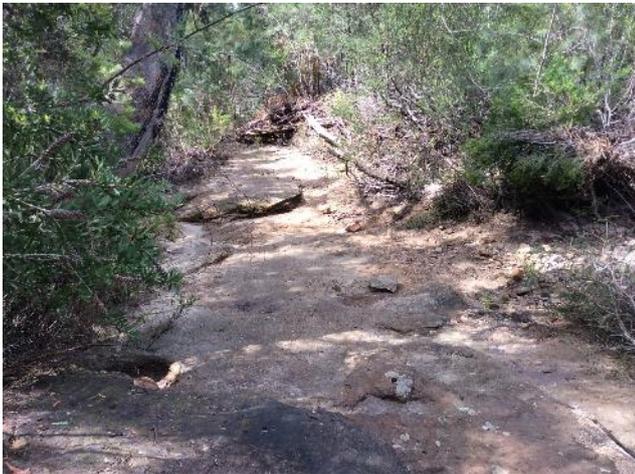
Tributary B was dry at the time of the audit (refer to Figure 9 and Figure 10), but Metropolitan staff advised that this stream was intermittent and generally only flowed after a significant rainfall event. No specific remediation was proposed for site RTP2.

Figure 9 Tributary B Pool RTP2 looking downstream

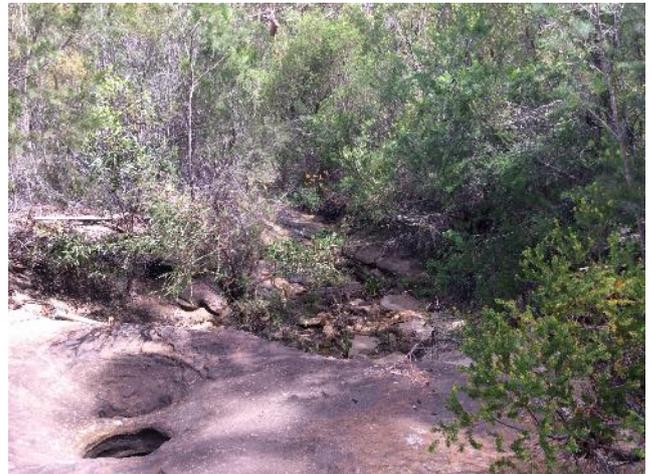
Figure 10 Tributary B Pool RTP2 looking upstream
