# SAFETY BULLETIN

DATE: 14 MARCH 2022

# Impacts of severe weather on slope stability

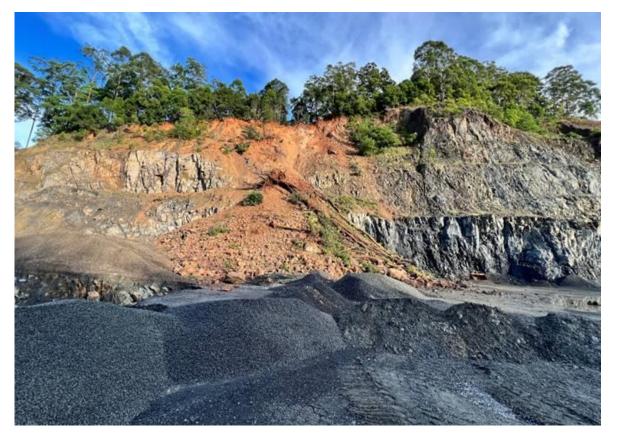
Figure 1: Failure of overburden bench.

Mine operators should monitor conditions and identify areas where the potential exists for slopes to fail. Areas which have potential to fail must be managed to ensure that workers are not impacted if a slope failure occurs. Monitor highwalls and benches for cracking, fretting and any other signs of movement. Ensure that drains are functioning correctly so that flood water cannot pool on the surface of highwalls, benches and dumps. Keep workers and equipment away from areas where stability has been compromised by recent rainfall.
