Safety Bulletin

Hose ball valves injure mine workers

Safety Bulletin SB23-04

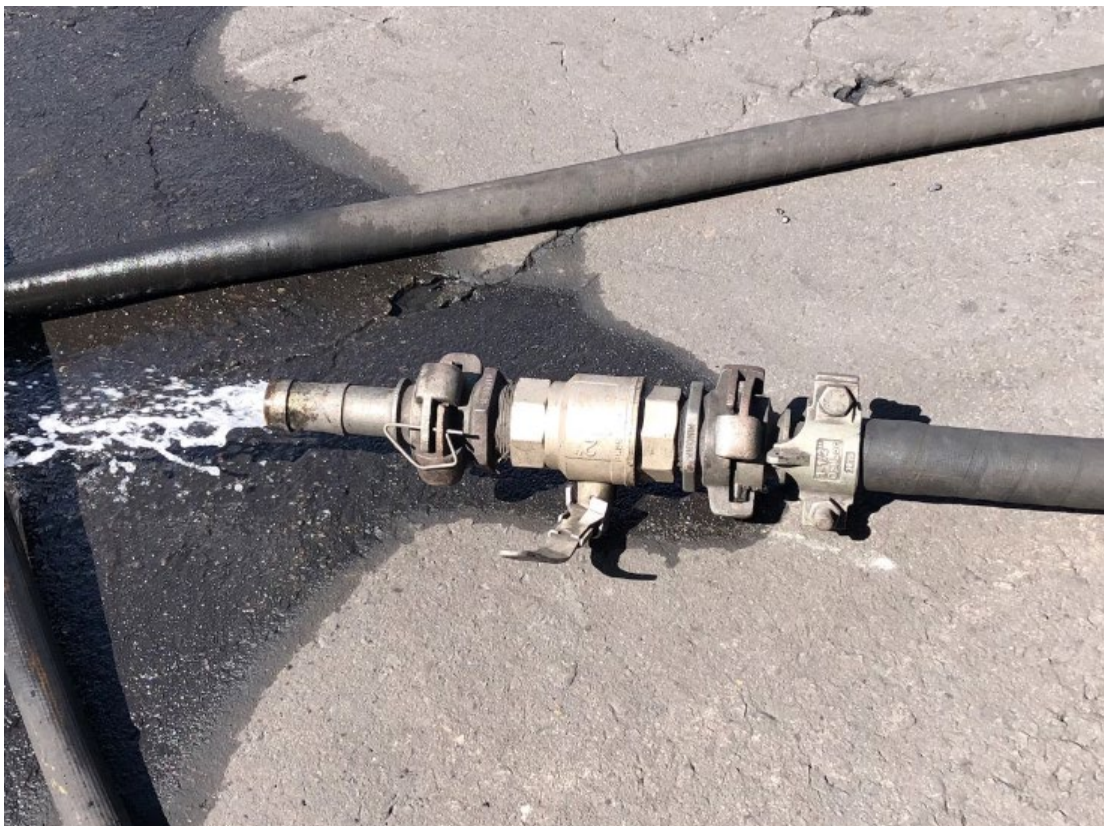
There have been many injuries resulting from energised hoses fitted with lever handle ball valves on the discharge end. A common cause of injuries have been a worker moving a hose while not in direct control of the ball valve. The handle lever catches on something and the hose is inadvertently activated, with the resulting jet of pressurised fluid (water, air, etc) whipping the hose around and the valve and/or hose hitting a worker.

Figure 1: Ball valve with lever handle fitted to the free end of a hose at a mine

- risk assess the use of ball valves attached to the free end of hoses as a known hazard that may result in injury
- review alternatives to the use of ball valves attached to the free end of hoses that are fit for purpose
- retrain supervisors and workers in hazards associated with hose whip from inadvertent activation of a hose
- ensure workers check the operating condition and function of the hose valves before use
- depressurise hoses when not in use.

If this is not practicable, as a minimum, hoses should be fitted with nozzles that will not activate without direct involvement by a worker such as:

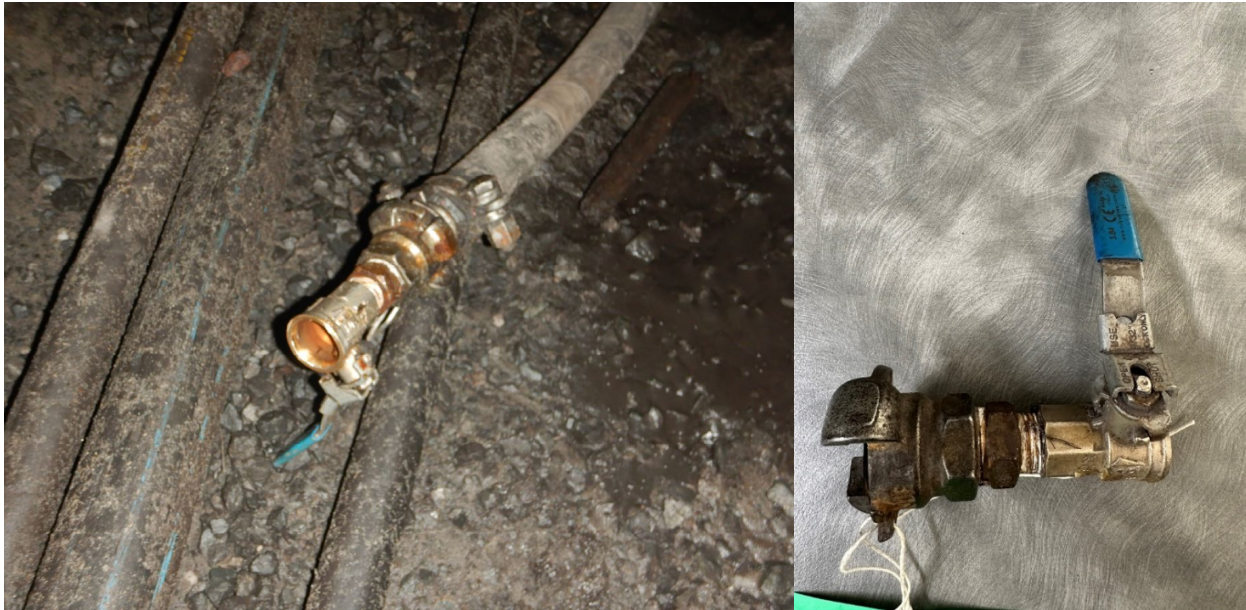
Recent injury 2: A worker was washing out a concrete kibble using a hose fitted with a ball valve on the free end on 27 April 2023. The worker turned the hose off at the ball valve, placed it on the kibble, and while climbing onto the kibble, the hose moved, activating the ball valve. The hose and valve flung back cutting the person's forearm.

Figure 2 and 3: Ball valve associated with recent injury 2

In both recent incidents, the injured workers moved the hoses, or by their actions caused the hoses to move resulting in the handles becoming caught on a fixed object, rotating and activating the flow of water.

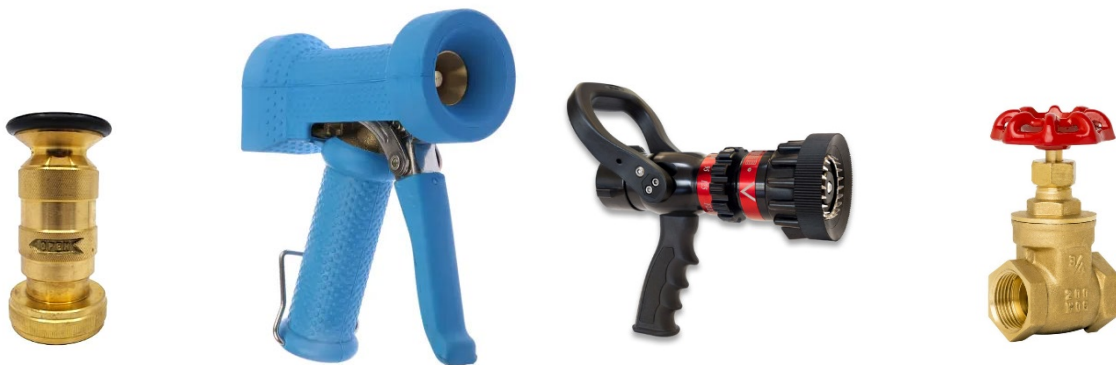
Figure 4: Potential alternatives to ball valves

- two-handed controls such as twisting nozzles similar to fire hoses
- trigger handles
- spring return handles
- handles that positively lock in the off position
- handles that require multiple twists/turns of the valve body/handle to liberate full flow, such as gate valves.
