# MINE SAFETY INVESTIGATION UNIT

Human interaction with backhoes and excavators

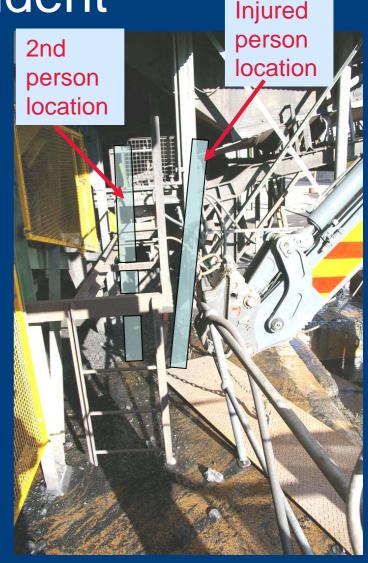
### Person to Vehicle Incident

- What happened
  - Person located in between two steel structures and in front of a backhoe arm lifting a steel plate.
  - Backhoe operator not aware the person had entered into backhoe arm work zone
  - Unplanned slip and forward movement of the backhoe due to slope of ground
- Result Person crushed across the hips by the steel handrail as the backhoe arm pushed against the handrail.
- When 11 August 2008
- Where Coal preparation plant, Southern Districts, NSW.
- Published Safety Alert SA 08 -11

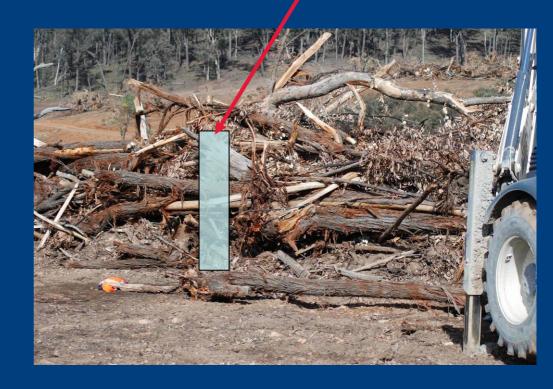
Injured person location

- What happened
  - Person walked into the work zone of a backhoe excavator arm whilst levering out a log from a pile of timber logs.
- Result Person struck in head by the root ball of the timber log as it ejected from the timber pile.
  - 32 skull fractures and brain injury
- When 24 August 2008
- Where Surface waste dump, Western Districts, NSW.
- Published Safety Bulletins
  - SB 08-08
  - SB 09-04

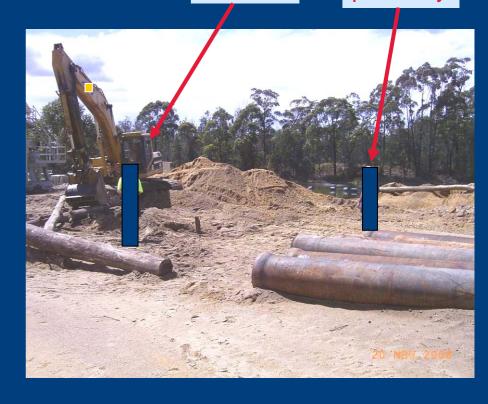
Injured person location

- What happened
  - Person located in the work zone of an excavator moving logs.
- Result

Person struck by the moving timber log. Fractured pelvis and internal injuries

2nd person in proximity

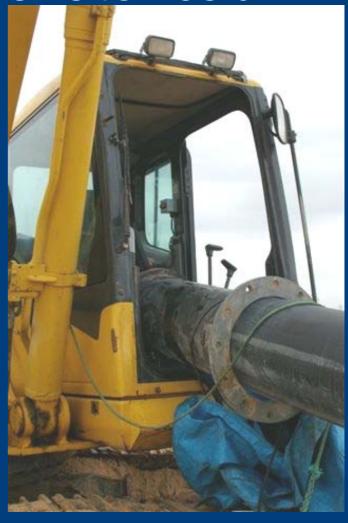
Operator struck in excavator cabin

- What happened
  - Excavator used to lift and drag 12m length of poly pipe weighing 600kg.
     The pipe slipped through the supporting chains and entered the operators cabin.
- Result Poly pipe broke cabin window and struck the operator.
  - Crush injuries
- When 31 March 2009
- Where Extractives, Sydney Region, NSW.
- Published Safety Bulletin
  - SB 09-04
