**Electric shock – high voltage isolation
– 20 June 2005**

Electric shock incident

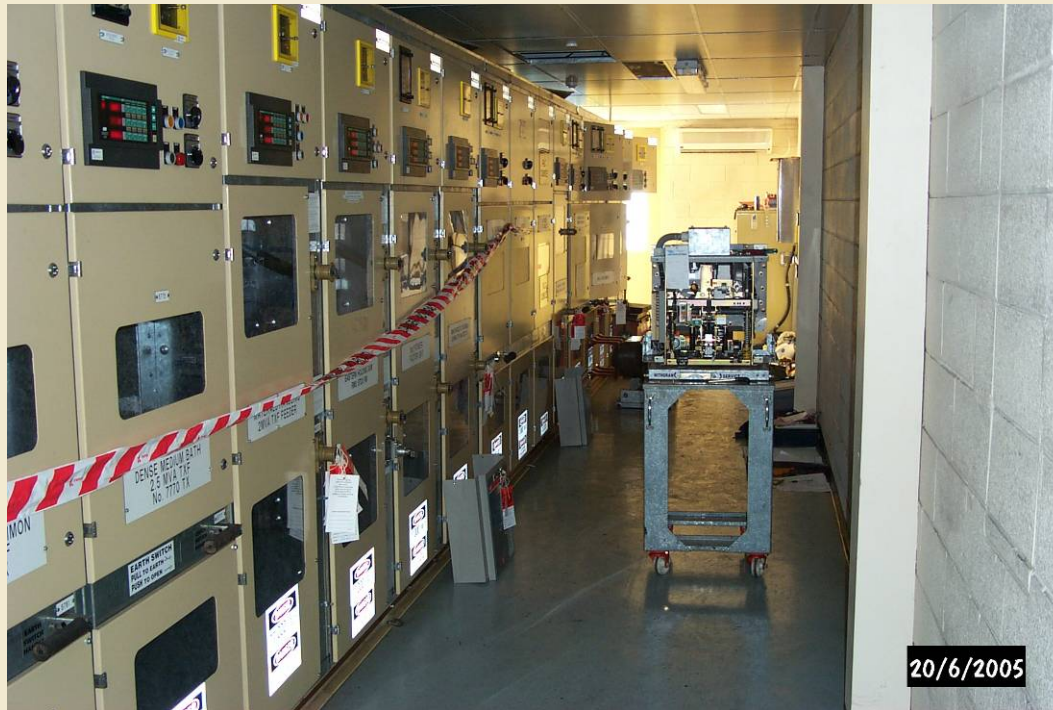
The distribution board.

Originally intended to be fully isolated for the job.

Late decision to only isolate half the board at the bus tie breaker.

- Changes to the job plan were made after the risk assessment
- Isolation did not include locks or hard barriers
- Supervision did not include close monitoring of work
- Safe work procedure did not address risk of access to live areas

- High Voltage work to be regarded as specialised work for trained people
- High Voltage Safety Management Plans based on industry benchmarks
- High Voltage work needs particular job planning and risk assessment
- Changed conditions to cause stop and review of job plan

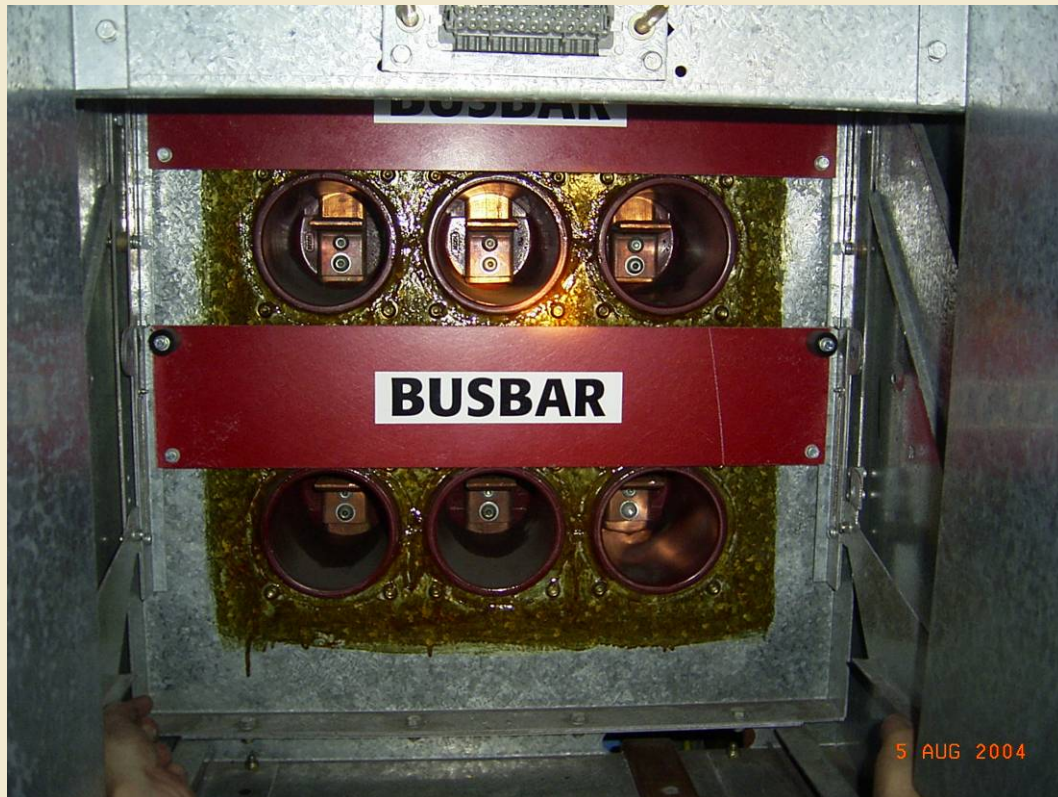
Contract electrician opened bus tie shutters to wipe down the spouts.

The top set was live at 11 kV.
