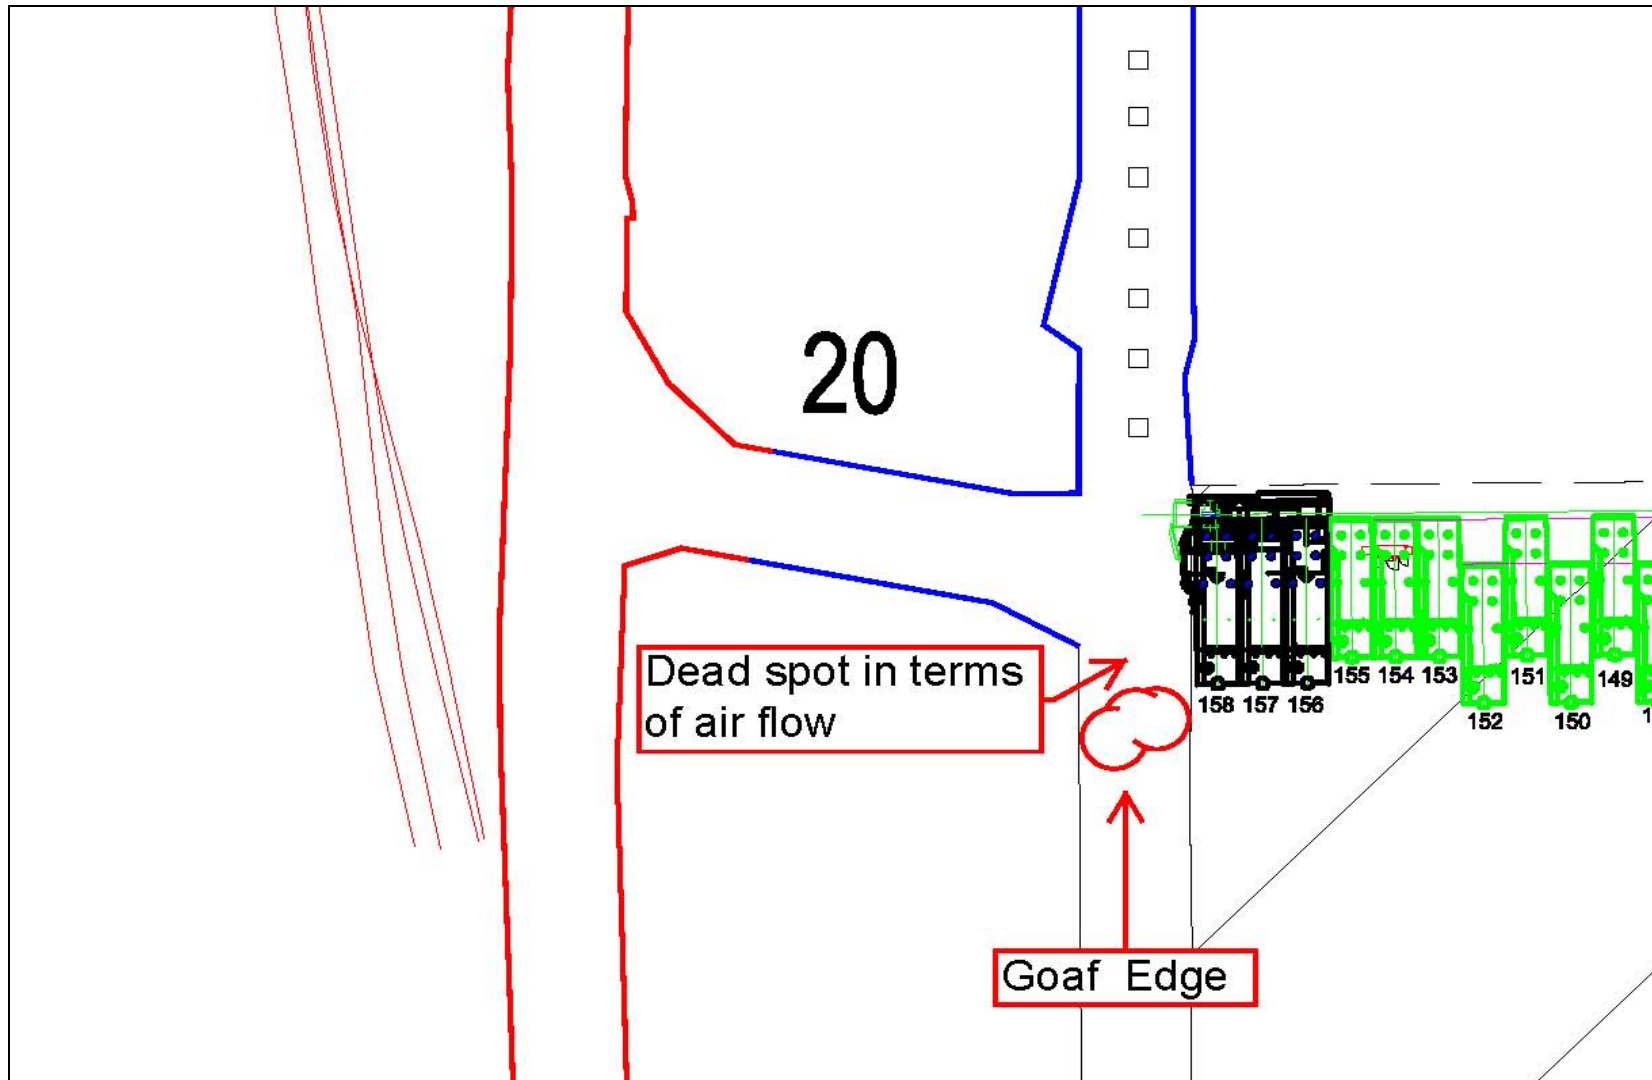
Figure 7: Enlargement of tailgate at 20 C/T highlighting goaf edge and dead spot in the ventilation
