# SAFETY ALERT

## Faulty Sabre CABA units

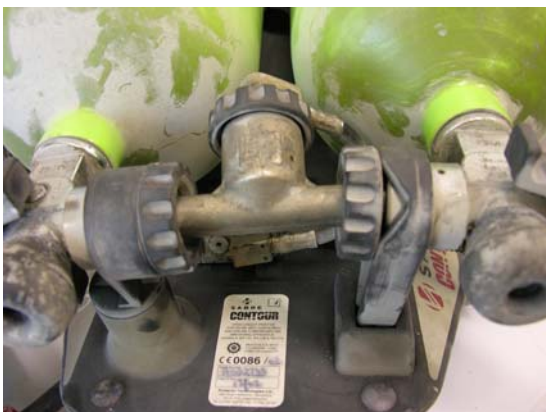
On one unit there was an obvious curve in the T-piece between the two bottles.

CABA unit showing curved connection - should be straight

- All mines should check this type of equipment for faults and contact their suppliers for further information.
- Review handling procedures for CABA units.

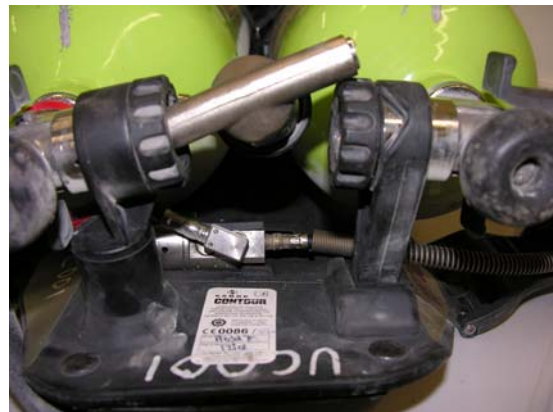
On examination, it was noted that there was flexibility in the T-piece that joins the two compressed air bottles (located near the bottle valves).

CABA unit with T-Piece removed from housing

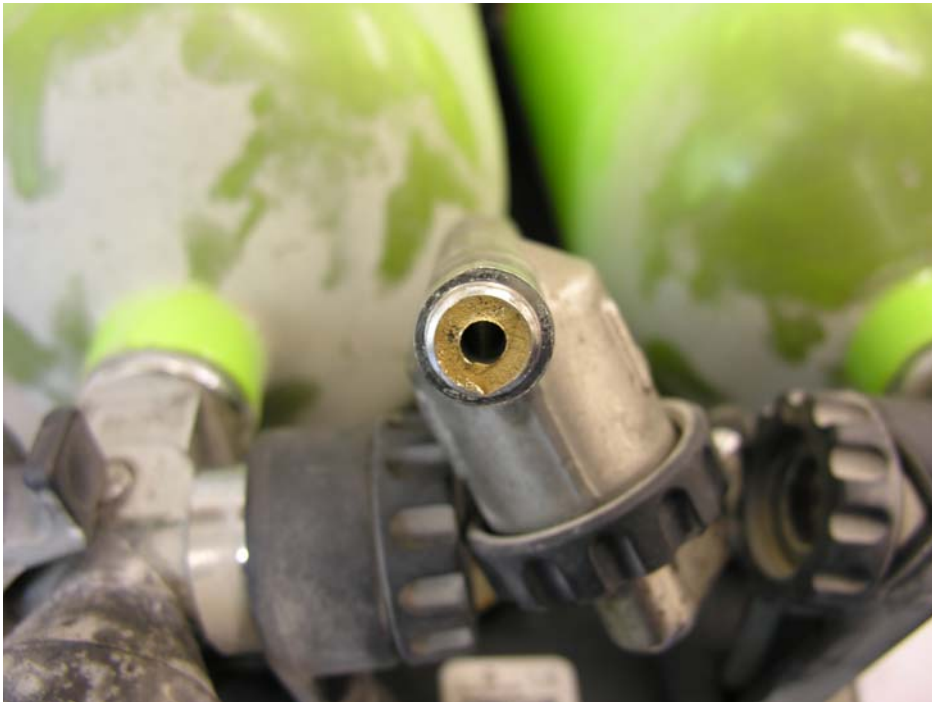
A failed T-piece can be easily detected as there are significant air leaks when the unit is operated.

CABA unit showing broken connection
