SAFETY ALERT

Worker sucked into Auxiliary fan ventilation tube

This safety alert provides safety advice for the NSW mining industry.

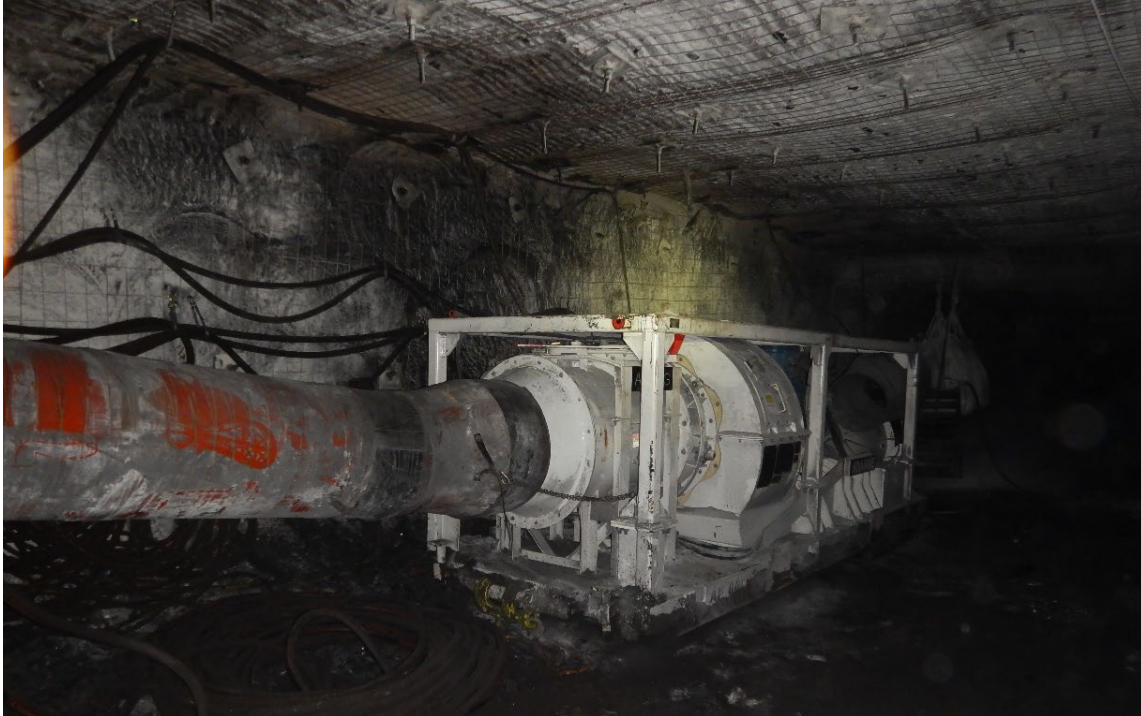
Figure 1 The auxiliary fan

The auxiliary fans specifications were 200KW and 26 m³/s open circuit capacity. The variable inlet vanes (VIVs) were set at 13 m³/s and 618 millimetre diameter tubes were being used.

The photographs in figures 1 and 2 show the auxiliary fan and the ventilation ducting involved with the incident.

- mine operators should review their auxiliary fan operational risk assessments (for each type of auxiliary fan in use at each site) and ensure the risks to health and safety for people working in close proximity to ventilation ducts during installation, operation, maintenance and repair are identified and controlled. The specific hazard identified with this incident (workers being drawn into or against the ventilation ducting) should be considered
- with the review of risk assessments above, mine operators should implement controls in accordance with the hierarchy of control measures as required in clauses 35 and 36 of the Work Health and Safety Regulation 2017
- the operating range of auxiliary fans (i.e. VIV settings) should be determined through modelling and testing, to ensure the ventilation tubes can be added into the circuit without

risk to workers being sucked into or onto the end of a tube while clearing gas, dust, and diesel exhaust pollutants, as well as preventing recirculation

- the location used for monitoring ventilation performance and hence determining any change in fan operational parameters must be formalised in the mine's safety management system (for example – the procedure for auxiliary fan operations)
- safe standing zones and the detailed process steps to safely install ventilation ducting should be formalised and documented in the mine's safety management system
- the relevant sections of the workforce should be trained and refreshed (at a frequency determined by the mine) in the safe operation of auxiliary fans on site – including the installation/extending of ducting.

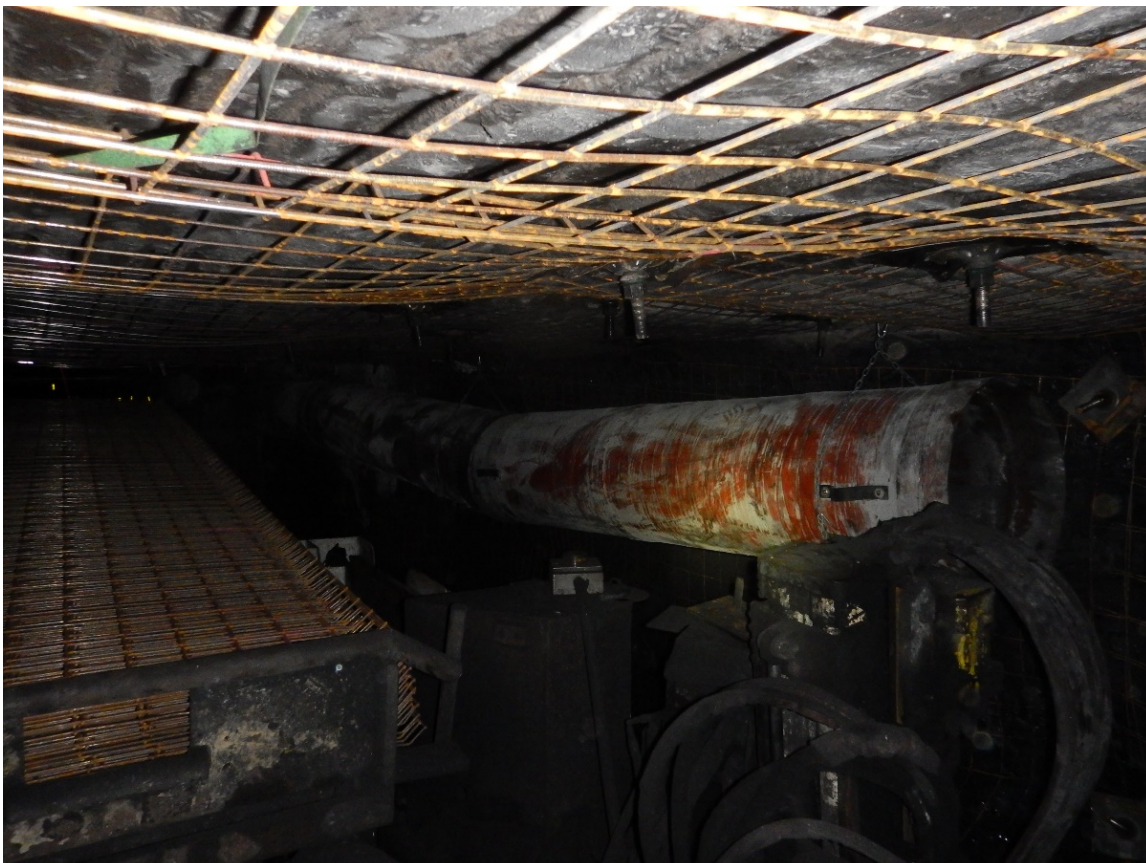
Figure 2 The incident scene at the mine face

A mine worker, who was installing an auxiliary fan ventilation tube, was sucked into the end of the tube. Due to the pressure around his neck, the worker briefly lost consciousness.

The ventilation duct run was about 90 metres to the face. The run included a 90 degree elbow and an inline T-piece with an end cap fitted.
