**MINE SAFETY**

**INVESTIGATION UNIT**

**Fatal Incident – R/C Loader – 09 Jan 2007**

# Fatal Incident – R/C Loader

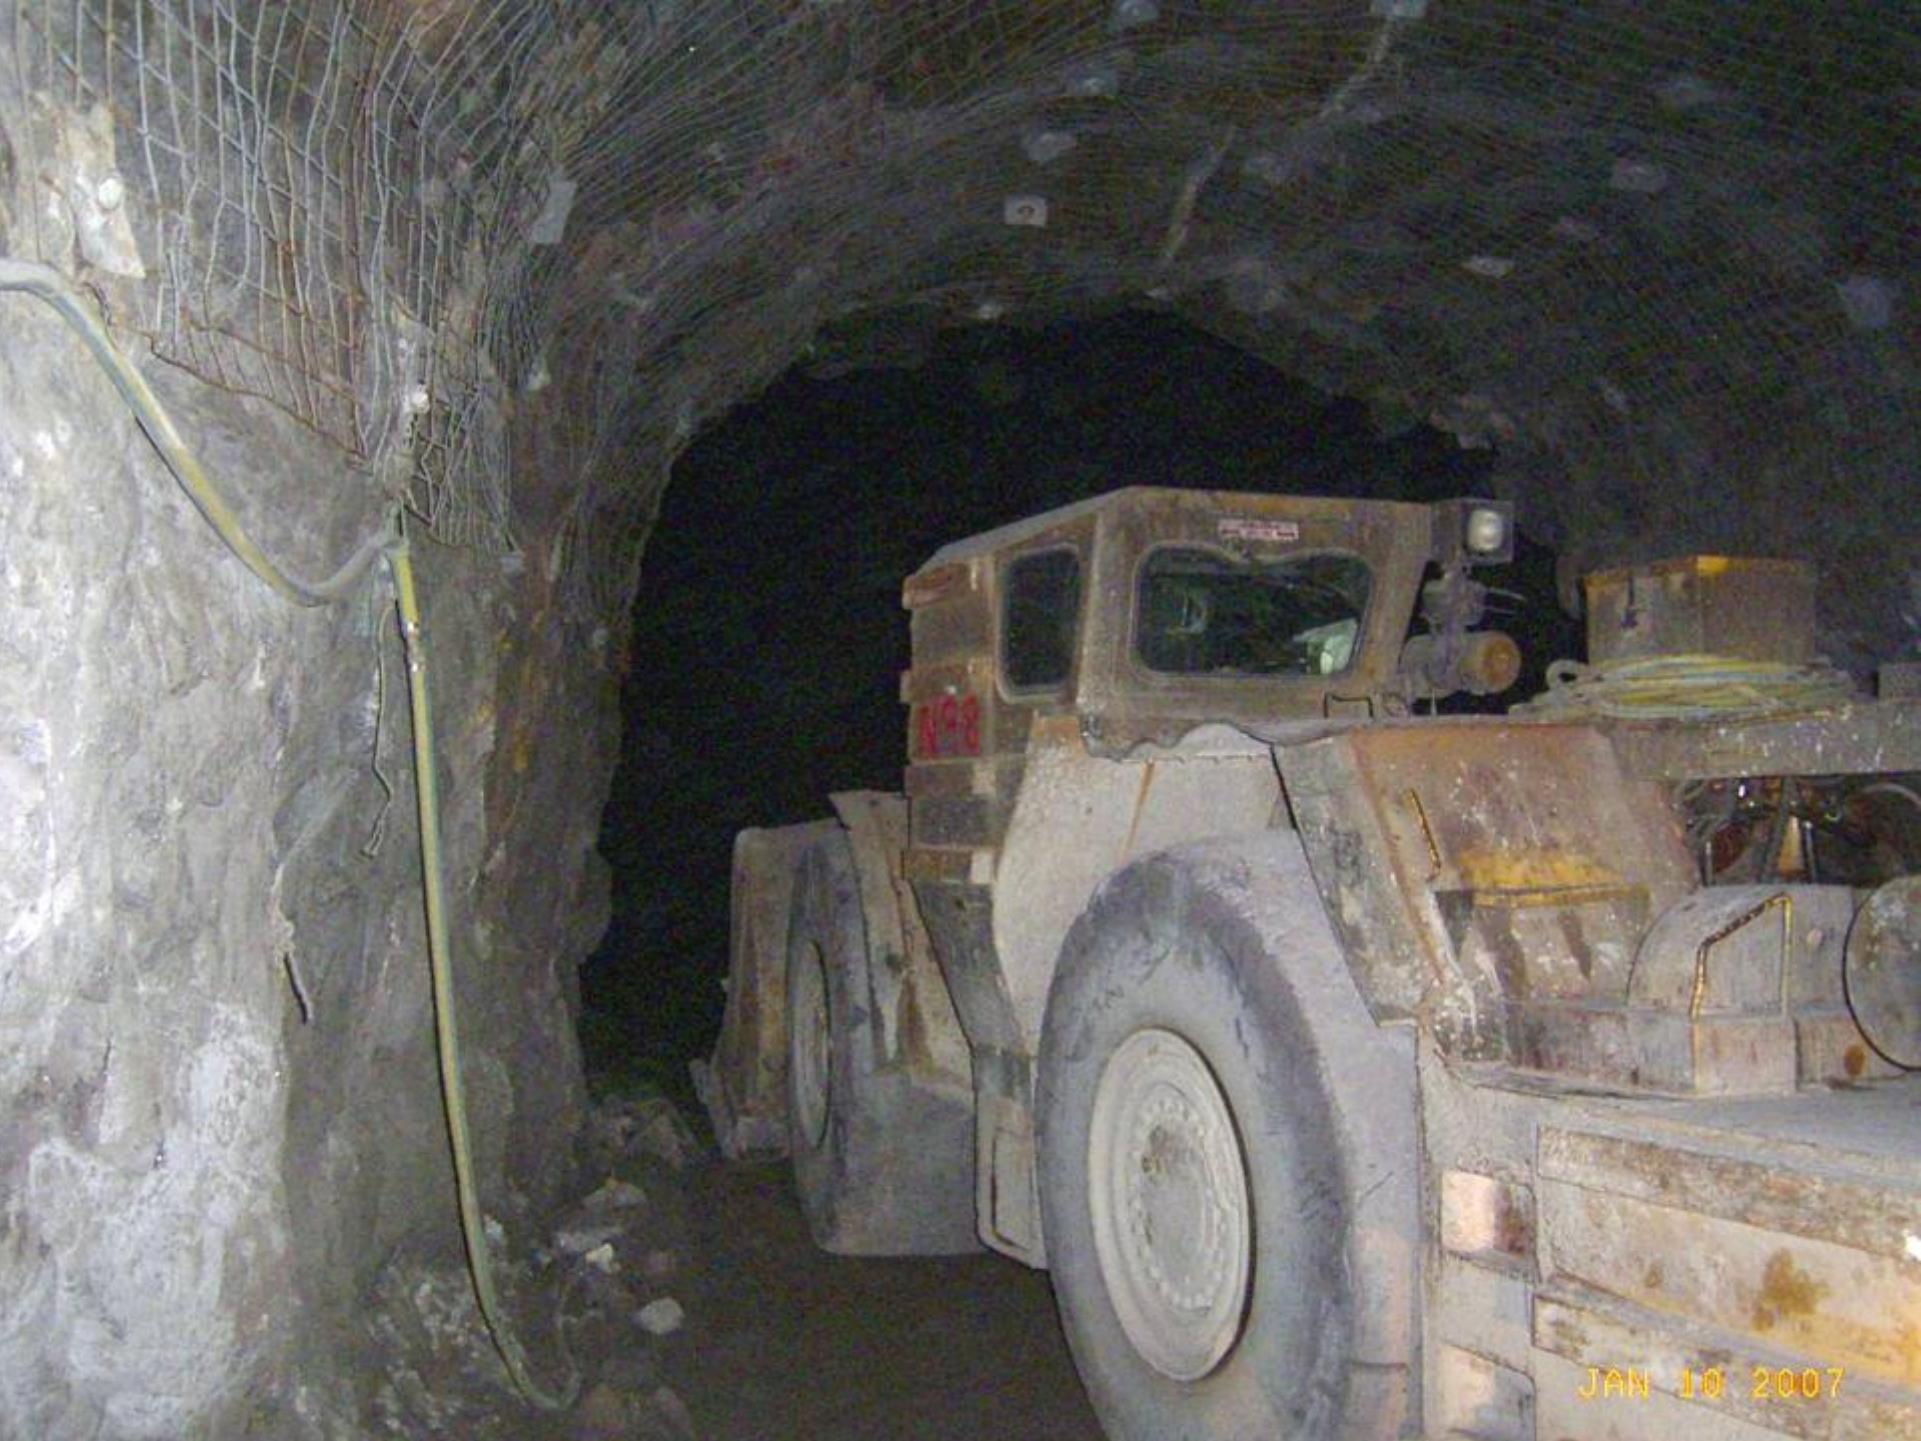
JAN 10 2007

- Mine worker using a remote controlled loader to empty a long hole stope.
- He was attempting to clean around a large boulder in the stope so that it could be fired.
- He was working alone and unobserved
- He was found trapped between the loader and the wall of the drive.

- Absence of any engineered controls to prevent the operator from approaching the loader while operating.
- Insufficient measures to ensure that documented procedures were being followed in practice.
- Reliance on procedural risk controls over higher order controls.

- Physical means to ensure operator cannot operate the machine when out of the safe area. *(eg tether transmitter to safe location.)*
- Laser beam barriers or similar to detect intrusion into unsafe area and automatic shutdown.
- Training and supervision levels to ensure safe procedures are entrenched in the workplace.

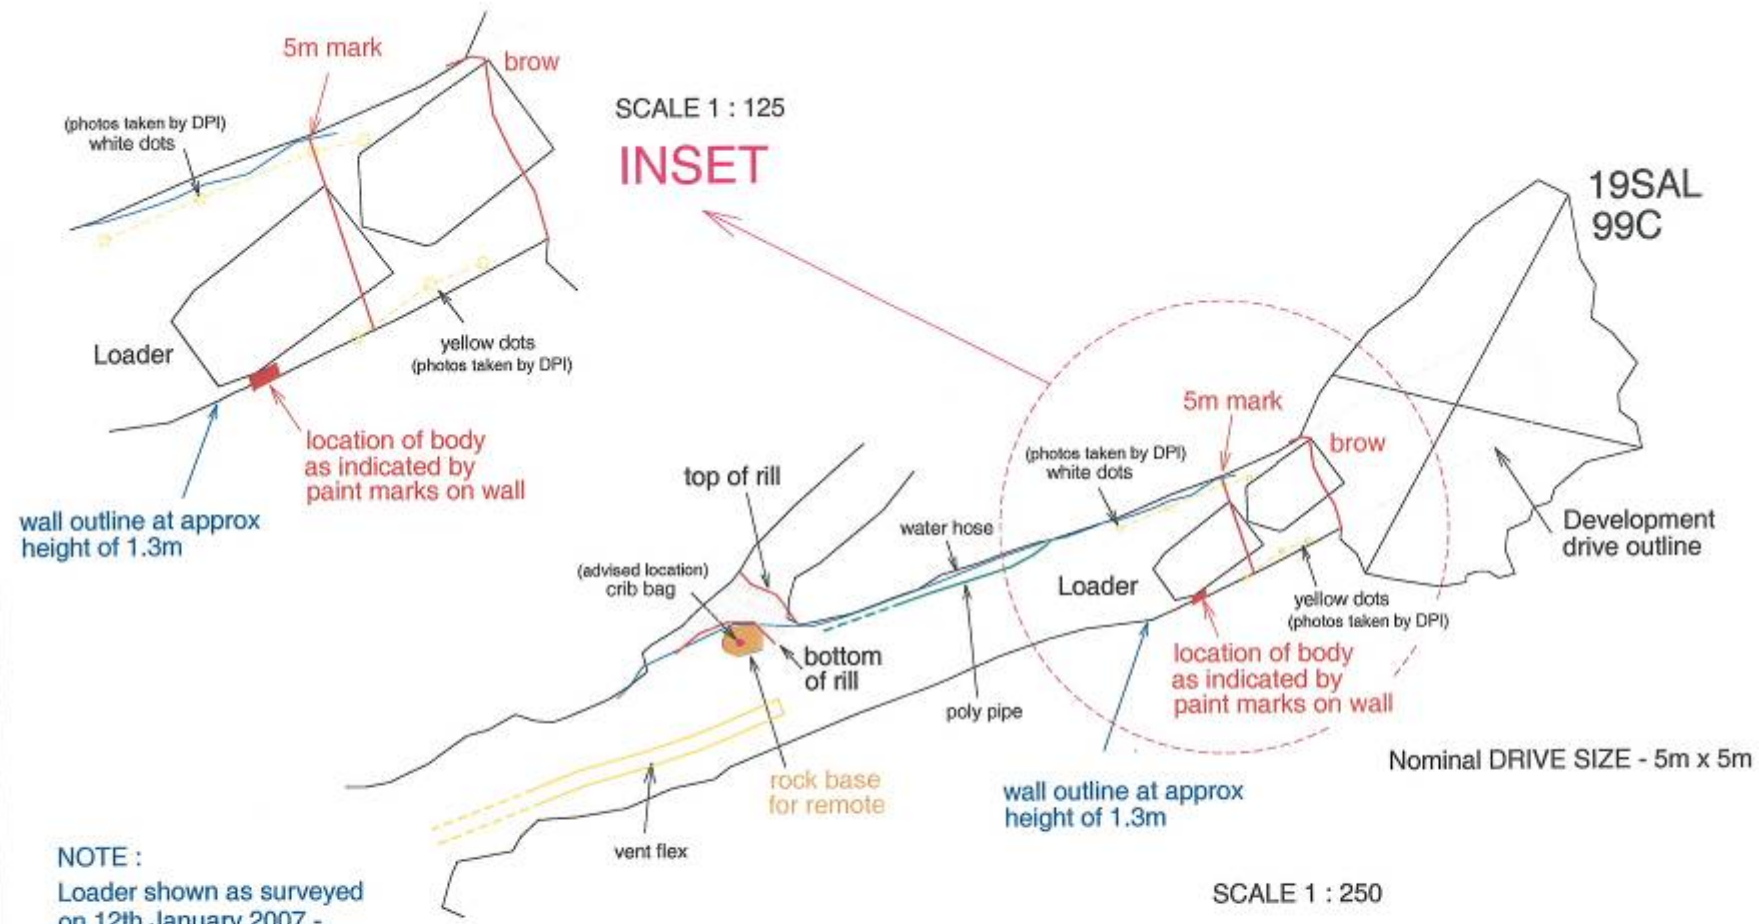
perilya		PERILYA BROKEN HILL LIMITED			
Scene of Fatality - 9th January 2007 19 LEVEL - 19SAL99C DRAWPOINT PLAN VIEW					
Surveyed	B.J.G./S.VM	Drafted	F.D.O.	Approved	
Date	12.1.2007	Date	15.1.2007	Date

**NOTE :**  
 Loader shown as surveyed on 12th January 2007 - loader had been moved for body removal and placed close to original position

Minimum distance between bash plate and wall at time of survey was 127mm
