SA18-03 February 2018

Two workers suffer serious high pressure fluid injuries in separate cleaning incidents

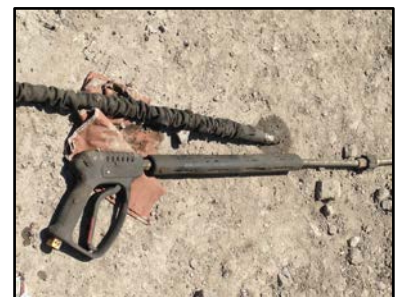
Incident 1

A worker suffered a fluid injection to his arm from the class B high pressure cleaning unit he was using when the hose connection fitting became unscrewed from the base of the gun. The worker was taken to a nearby hospital where he was air-lifted to Royal North Shore Hospital in Sydney, where he underwent surgery.

For the first incident, an investigation revealed the connection between the hose and the gun had been leaking since the start of the shift. Closer inspection indicated little or no damage to the male (tapered) thread or female thread in the gun. It appears that during use, torque has developed in the hose caused the fitting to unscrew to the point where it could no longer support the fluid pressure resulting in the injury to the worker. In the second incident, investigations are continuing, however human and organisational factors may have influenced the failure to isolate and test for dead before undertaking the extension changeout.

High pressure fluid system componentry must be designed, selected and assembled by people competent in high pressure fluid delivery systems. Hose fittings and connections must be compatible and work together as a system. Replacement parts should be original equipment manufacturer's (OEM) replacement parts or of equivalent specification.

3. inspect delivery hose, connection fittings and guns are to OEM specification and are fit for purpose
4. inspect delivery hose to gun connections for the ability to permit freedom of rotation of the gun relative to the hose. Connections without freedom of rotation need to have controls to prevent hose torque that may cause the connection to become unscrewed.

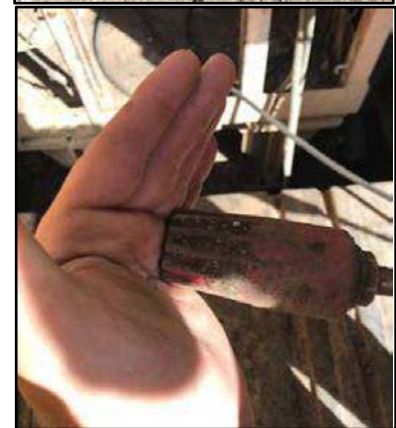
Incident 2

Two workers were using a high pressure cleaner for descaling steel sets in a service shaft before stopping to add an extension piece on the gun. With the pressure cleaner turned off, one of the workers held the gun while the other began changing the extension. The worker holding gun operated the trigger, releasing residual pressure in the hose causing a fluid injection injury to the left palm of the other worker. The injured worker was taken to hospital for surgery.

Mine operators are reminded that effective isolation and energy dissipation is a critical risk control when working on high pressure fluid systems.

1. review and communicate the recommendations of this safety alert to workers under their supervision
2. ensure workers are trained and competent to perform effective isolation and energy dissipation and know when isolation and dissipation needs to be applied
