A case study of two NSW DPI incident investigations and the results from testing conducted on a winder haulage rope and chain components

Tony Smith - Senior Investigator NSW DPI

Case Study One – Failure of a Winder Haulage Rope

Failure of a Chain Connector

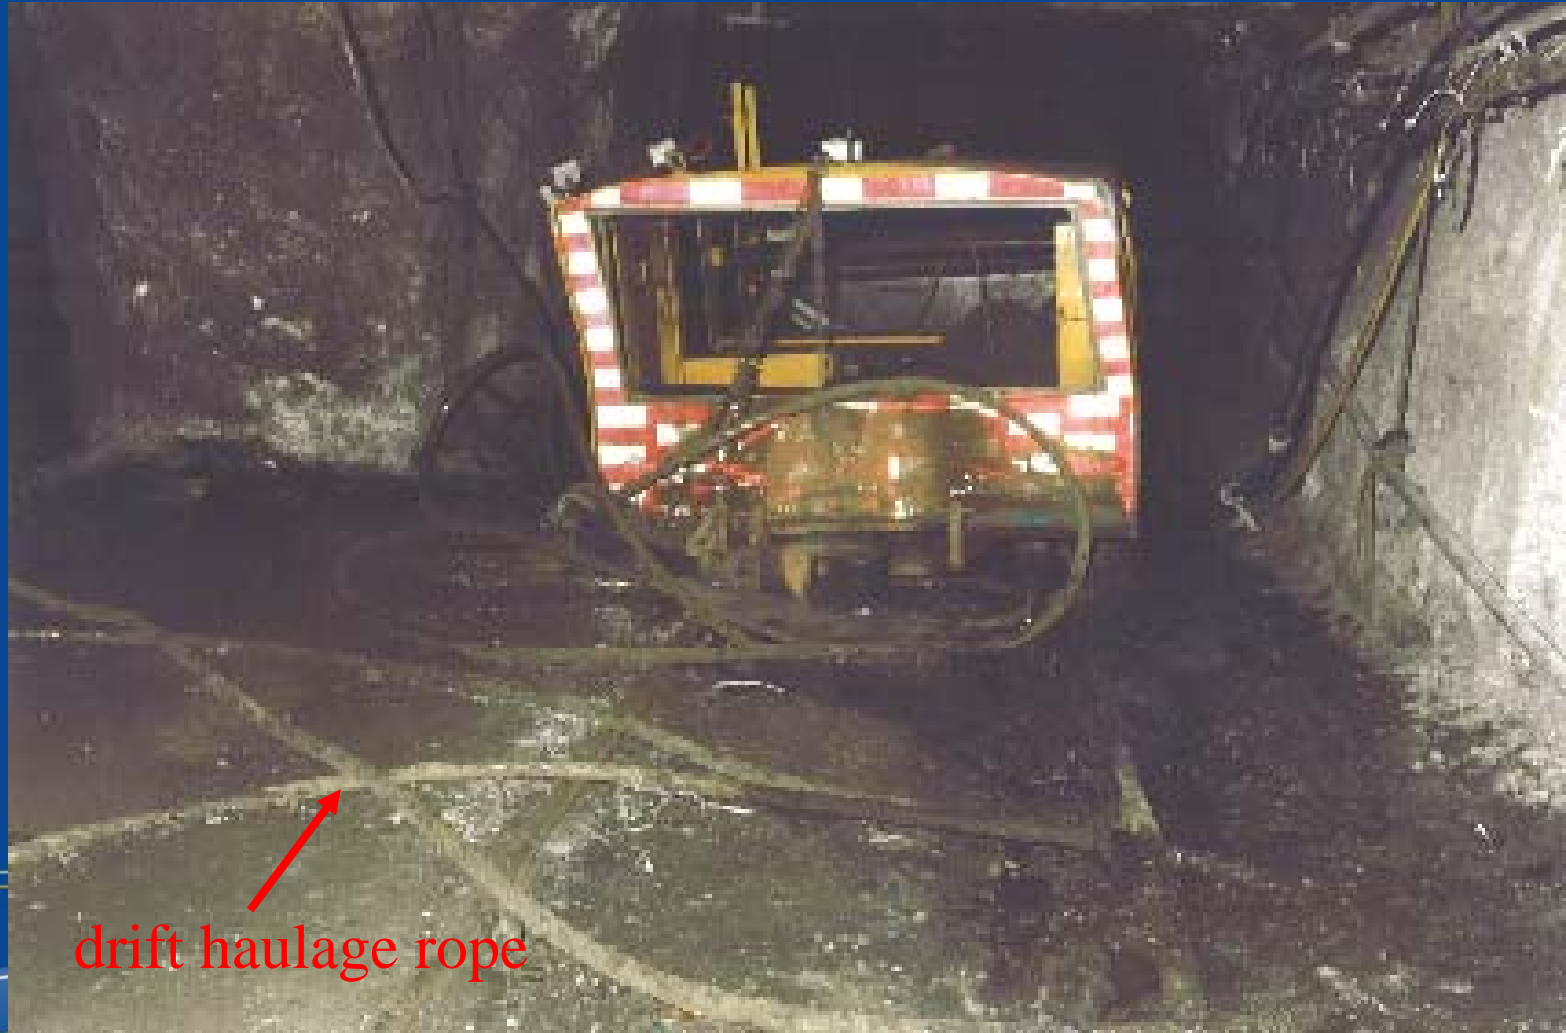
Consequence of Failed Rope

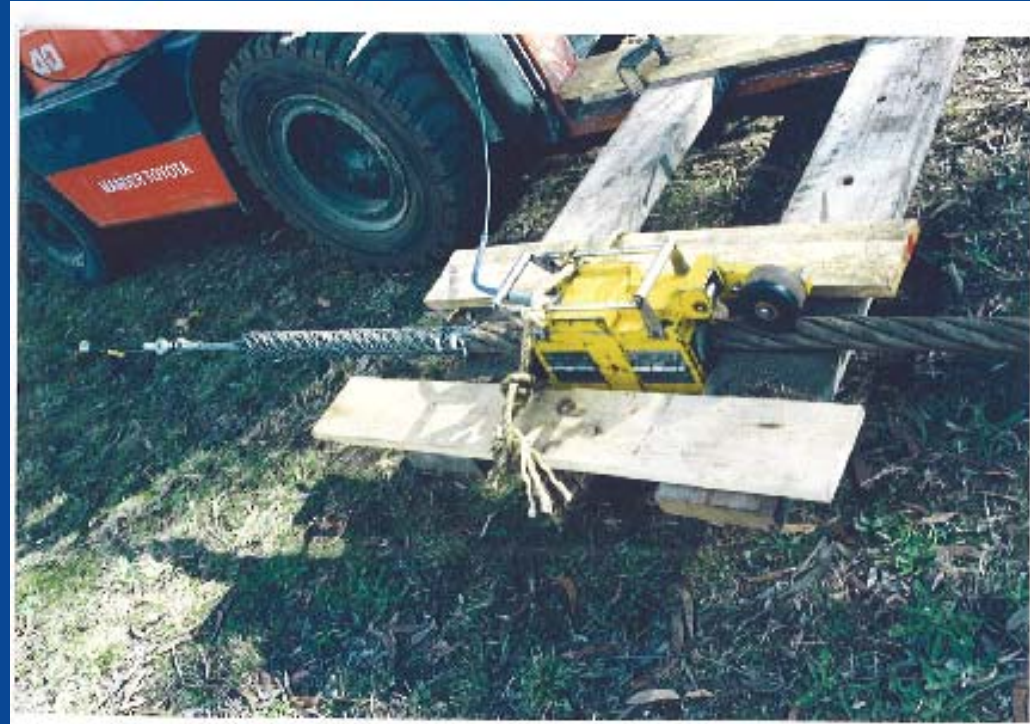
- Non destructive testing
 - Inbye 90m of rope NDT
 - Outbye rope NDT examined at wire rope plant

Photograph No. D26 – NDT set-up

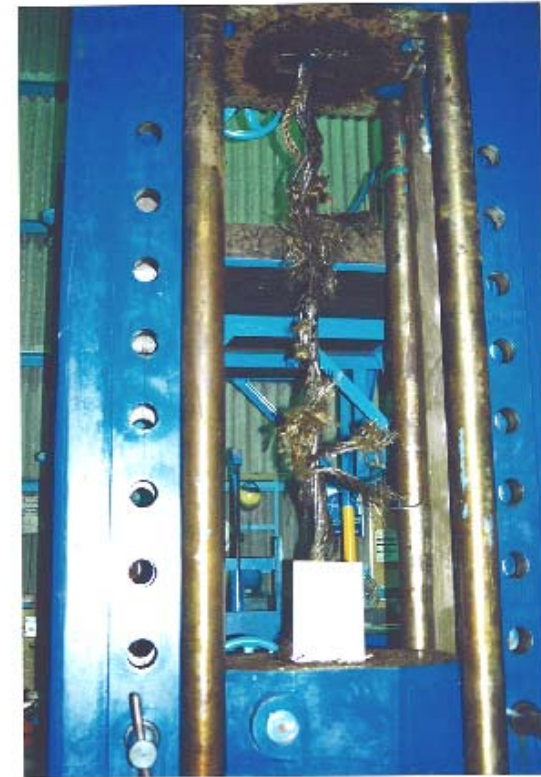
Phot No. 1Y/2- Rope sample after testing

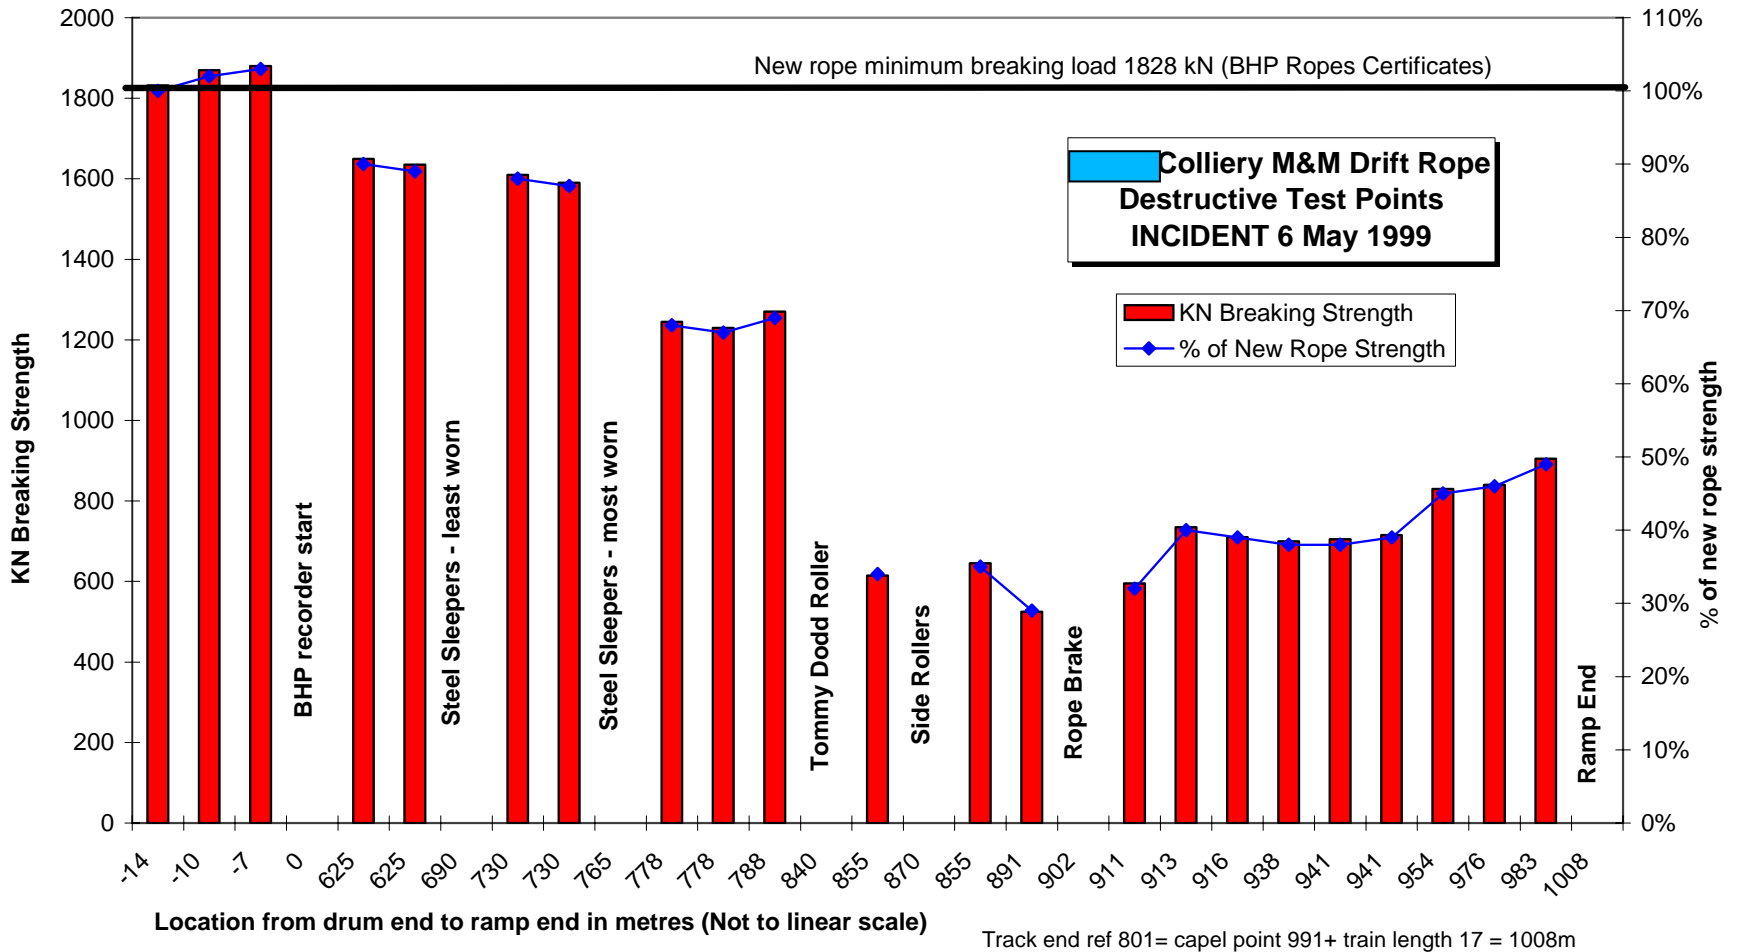
Destructive Test Results

Breaking Force Vs LMA

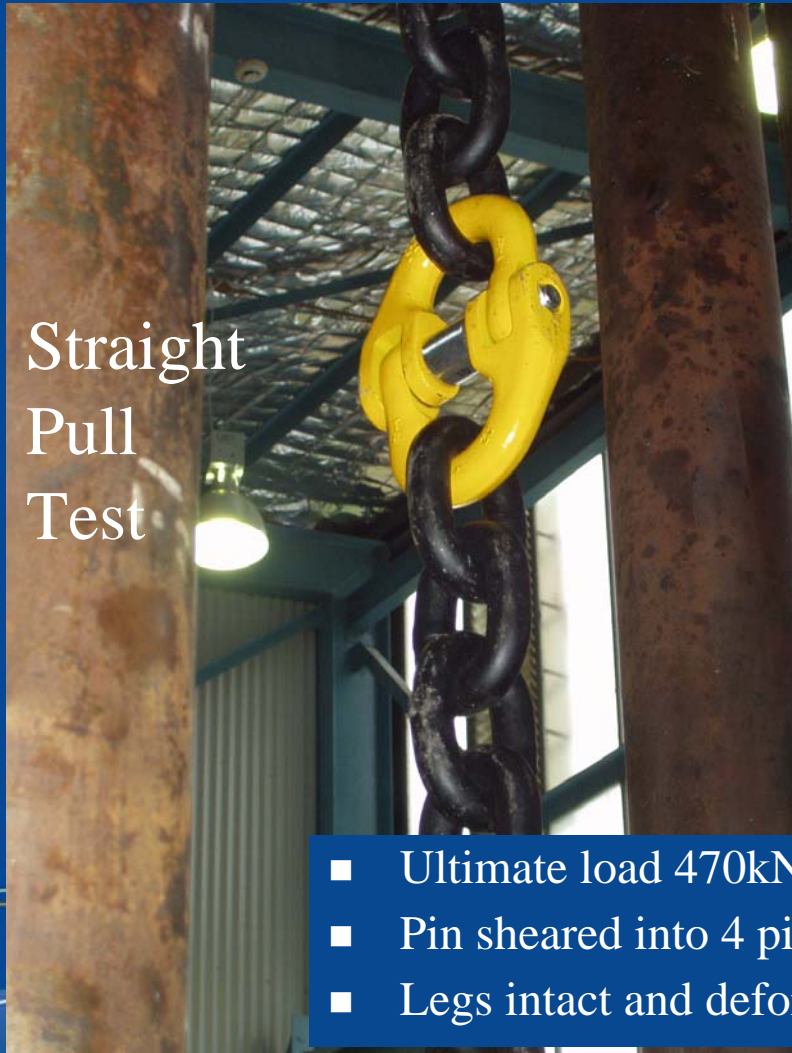
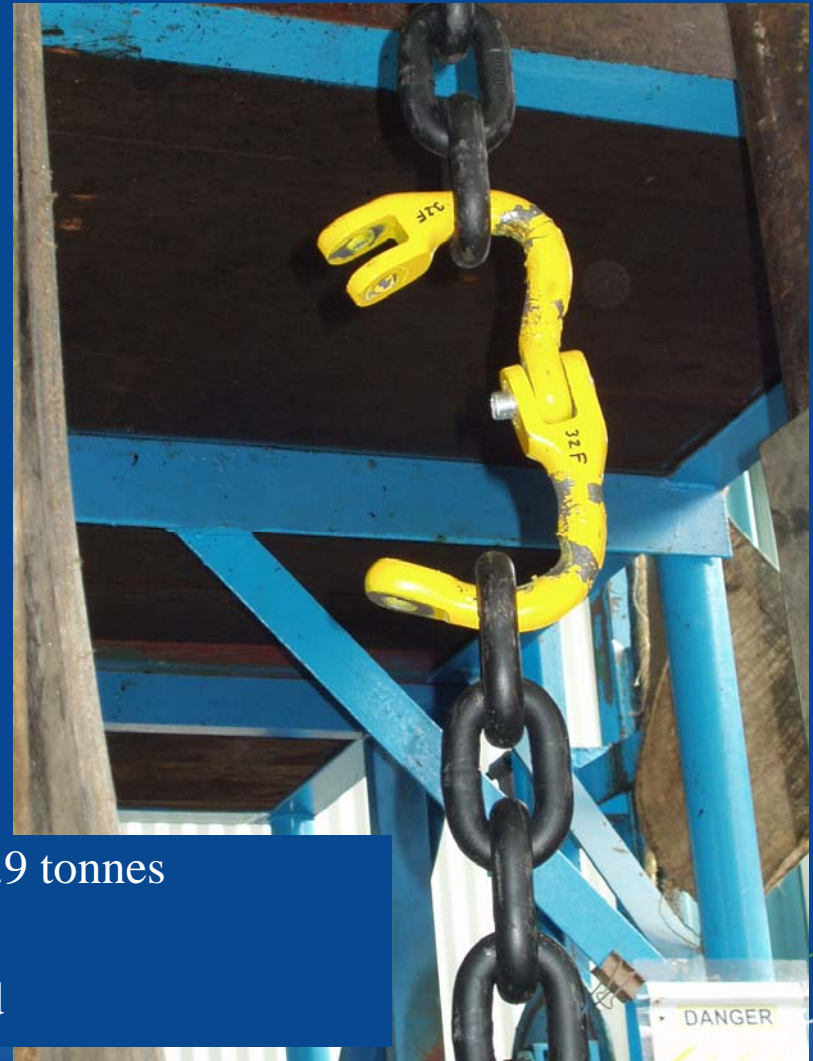
Straight
Pull
Test

Connector straight pull test

- Ultimate load 470kN 47.9 tonnes
- Pin sheared into 4 pieces
- Legs intact and deformed
