INVESTIGATION REPORT

# DANGEROUS BLASTING INCIDENT

Albury Quarry – 10 April 2018

Title: Investigation Report: Dangerous blasting incident – Albury Quarry – 10 April 2018

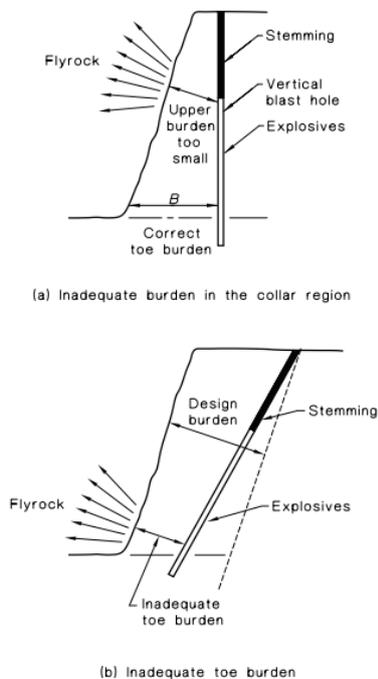
Figure 2 – Figure E1 extrapolated from Standards Australia

Because the potential for severe injury or property damage exists, precautions against flyrock and fly should be foremost in the mind of any shotfirer. The closer to persons or property that blasting is carried out, the greater should be the awareness, care and degree of protection exercised in avoiding flyrock and fly incidents.

A number of incidents have been recorded where persons have been killed or injured as a direct result of fly from blasts. An even greater number of instances report property damage and near misses.

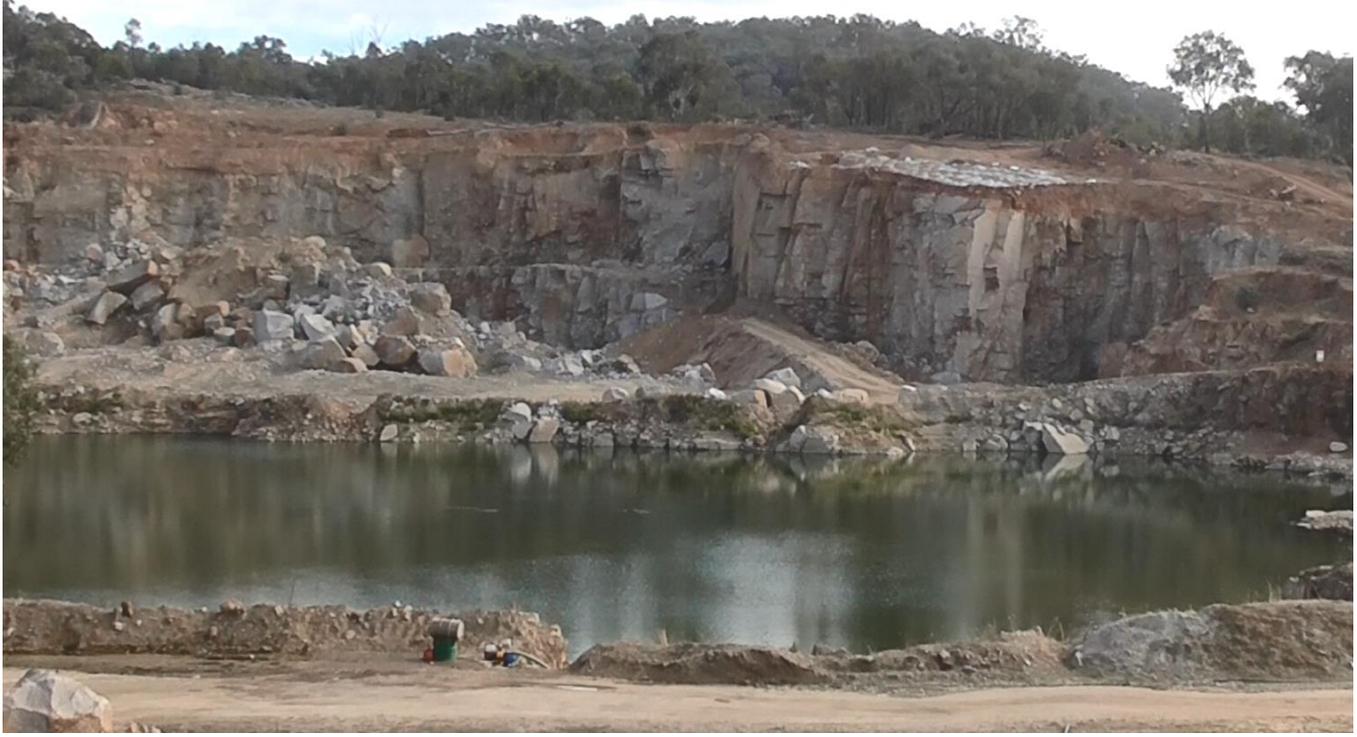
*Figure 3- Blast area prior to blast*

- An overburden blast along a large bench in the south-western area of the quarry (the main blast).
- Smaller 'toe' shots (secondary blasting) to break up oversize rocks on the quarry floor beneath the face of the main blast area that resulted from an earlier primary blast (the toe blast).

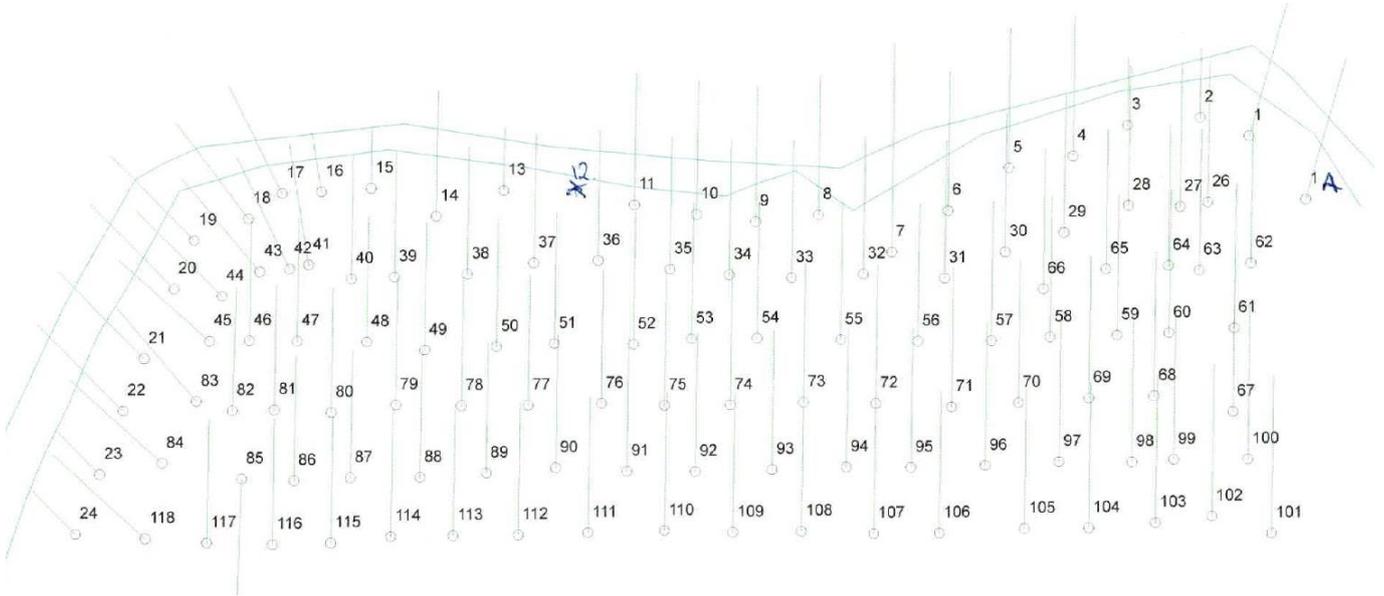
Figure 4 - Blast hole locations

On 22 March 2018, the shotfirer surveyed the blast holes using a laser system designed to measure borehole deviation. He had concerns that the burden (the distance between the face and the first blast holes) was insufficient due to some deviation in several holes. As a result, he arranged for two of the holes closest to the face to be redrilled (numbers 17 and 18). The original holes were abandoned and left unstemmed (empty).
