# INVESTIGATION REPORT

Serious injuries sustained by a worker at  
Cowal Gold Mine on 29 July 2018

First published: October 2020

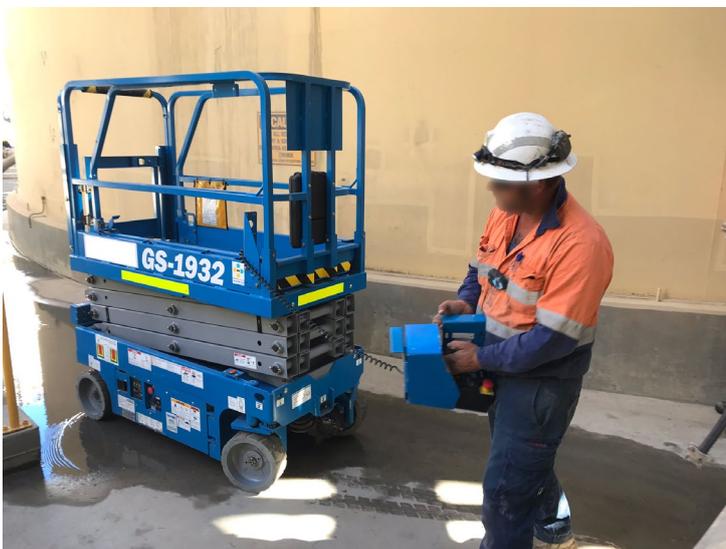
*Figure 8 Operator ‘walking’ a GS1932 scissor lift using wired controller*

About 11.00 am, the leading hand rigger arranged for a third worker to transport a scissor lift to the work area. That worker 'walked' the scissor lift along a pathway to the work area, using its wired control unit (in the manner illustrated in Figure 8). There is no record in the scissor lift's logbook of a pre-start inspection having been completed on the day of the incident.

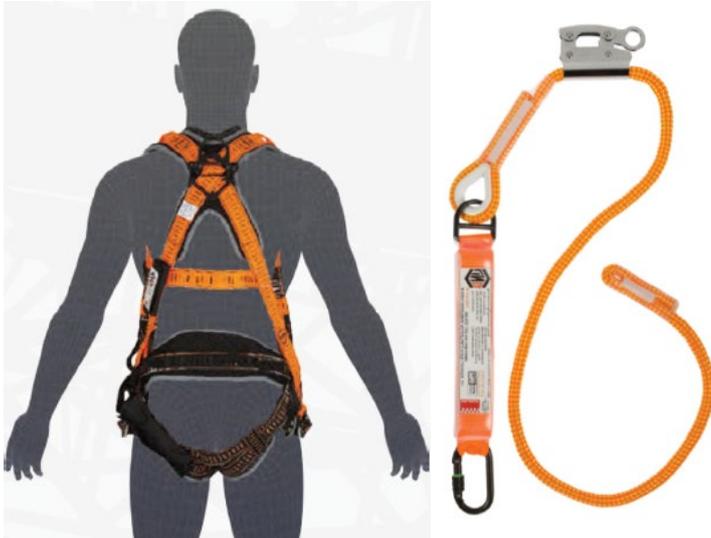
Figure 11 Fall restraint system worn by the worker (Credit: LINQ Height Safety)

The harness was attached to a single leg LINQ Height Safety 'Kernmantle Rope Lanyard'. The length of the lanyard was able to be varied by using its rope grab (refer to Figure 11). The harness and lanyard were part of the fall restraint system. When properly adjusted and connected to an approved anchor point, the system is designed to prevent a worker from falling from heights. They are different to fall arrest systems, which are designed to arrest a fall that has already occurred.

The worker was still wearing his safety harness, but he did not attach it to an anchor point on the scissor lift. He was wearing a hard hat.
