COLLISION BETWEEN SEMI-AUTONOMOUS DOZER AND AN EXCAVATOR

Causal investigation

Published by NSW Resources Regulator

First published: October 2019

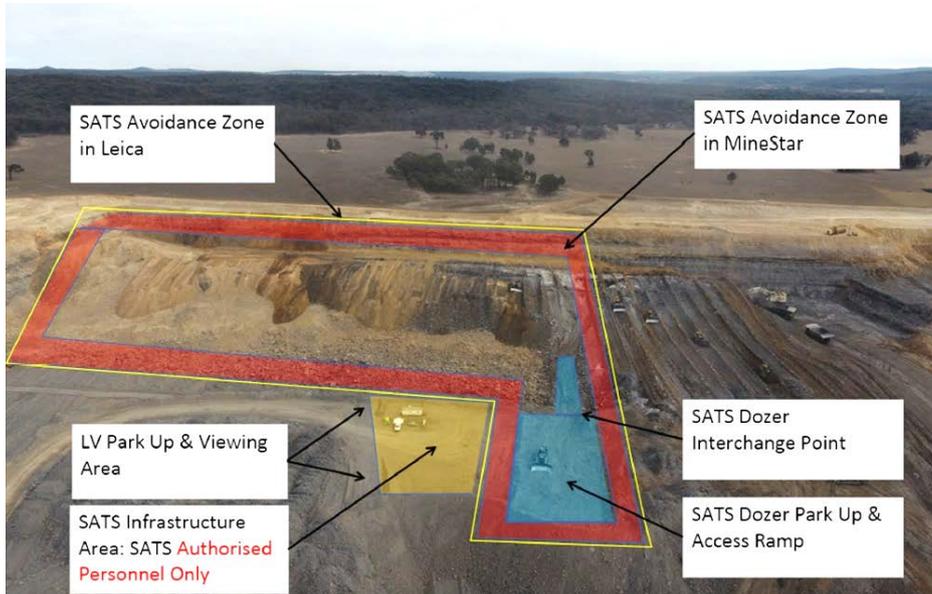
Figure 3 An example of a SATS area set up

The Caterpillar MineStar system is a proprietary system using high precision GPS and machine monitoring to gauge the current and future positions of the machine. The Caterpillar MineStar geofence is established inside the boundaries of the Leica MineOPS system. This avoidance zone is intended to function as a 'barrier in' system and will result in a stop command to any SATS dozer attempting to cross the boundary.

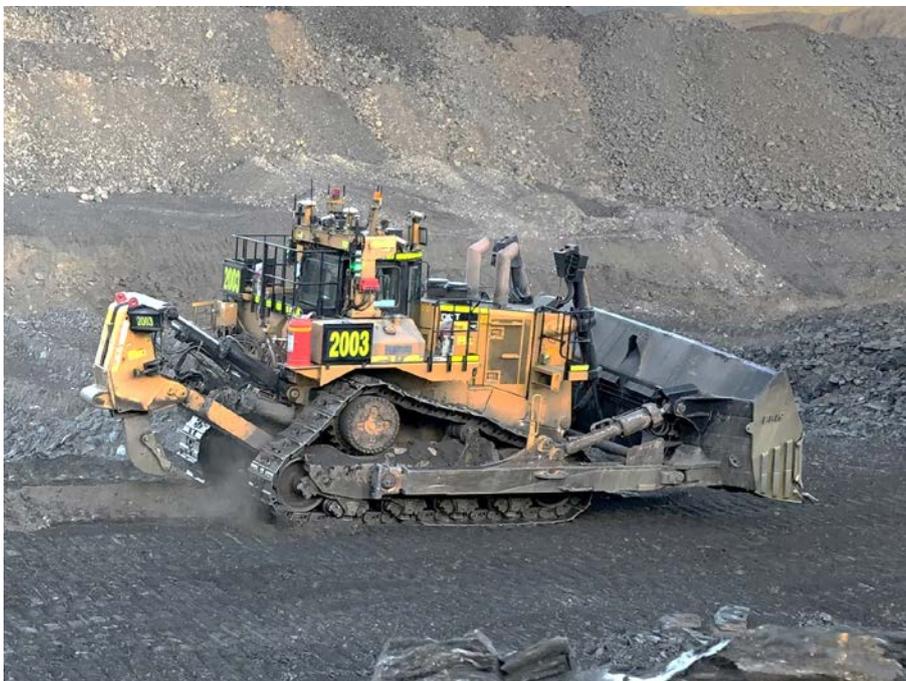
Figure 5 A dozer with modifications for semi-autonomous operations

If a dozer operating semi-autonomously fails to move as expected, it faults and requires an operator to select the machine and reinitiate the semi-autonomous operation.

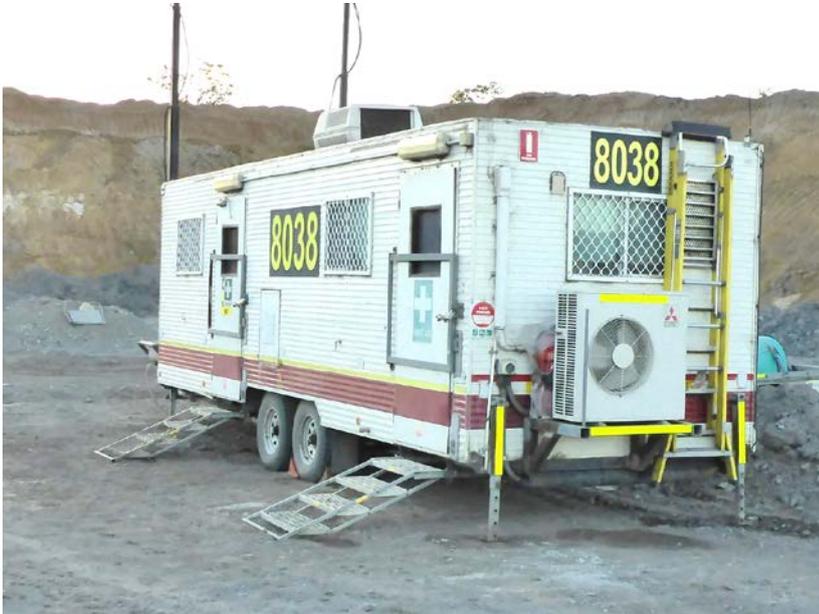
Figure 6 The command for dozer control centre

The SATS dozers are controlled by a SATS operator in a remote command for dozer control centre. The command centre is a transportable trailer which consists of a ROS. The ROS is used for tele-remote operations and setting up each slot in the dozer push area for semi-autonomous operations.

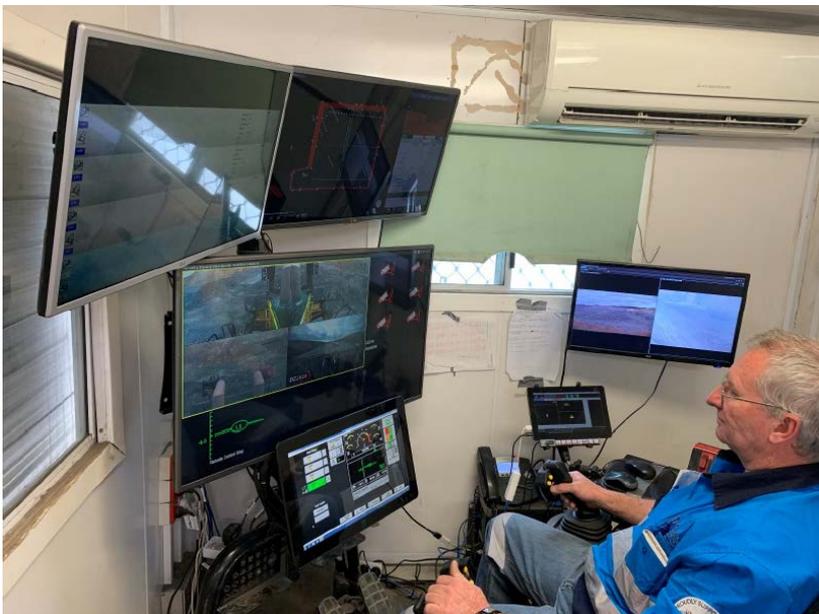
Figure 7 The remote operator station (ROS) inside the command for dozer control centre

Having additional monitors and keyboards, the ROS replicates the operator controls found within the cabin of a dozer. The ROS monitors and keyboards allow access to the operational screens and machine-mounted cameras from each SATS dozer. The ROS also contains an additional display allowing an aerial overview of the SATS push area. This display is also shared with the Leica MineOPS system.
