INVESTIGATION REPORT

REPORT INTO THE DEATH OF MR QUINTON MOORE

Title: Report into the death of Quinton Moore at Bengalla mine 3 November 2018

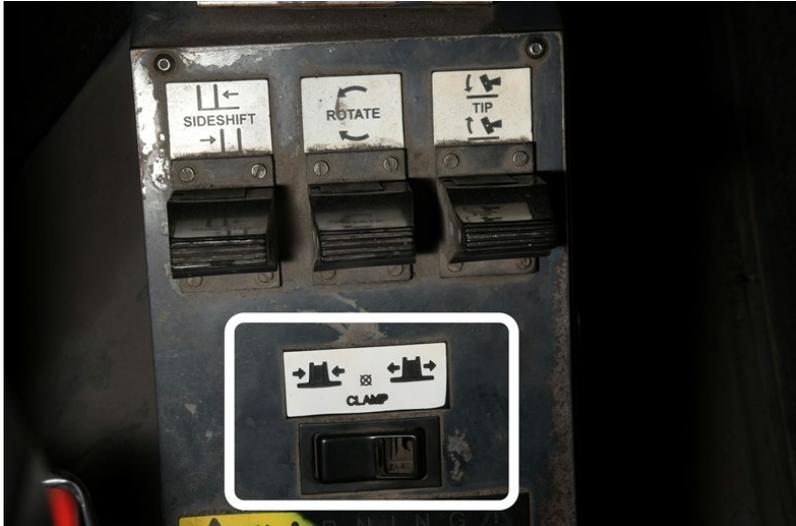
Figure 4 Clamp control in THL001

The clamp control button is spring loaded (refer to figure 4). Depressing the left side will clamp the tyre (refer to figure 5) and depressing the right side will release the tyre (refer to figure 6). The minimum distance between the grabs is 1450 millimetres and the maximum distance is 4500 millimetres. The only method available for operators to ensure a tyre was securely maintained in the grabs were visual cues observing bulges in the side wall of tyres.

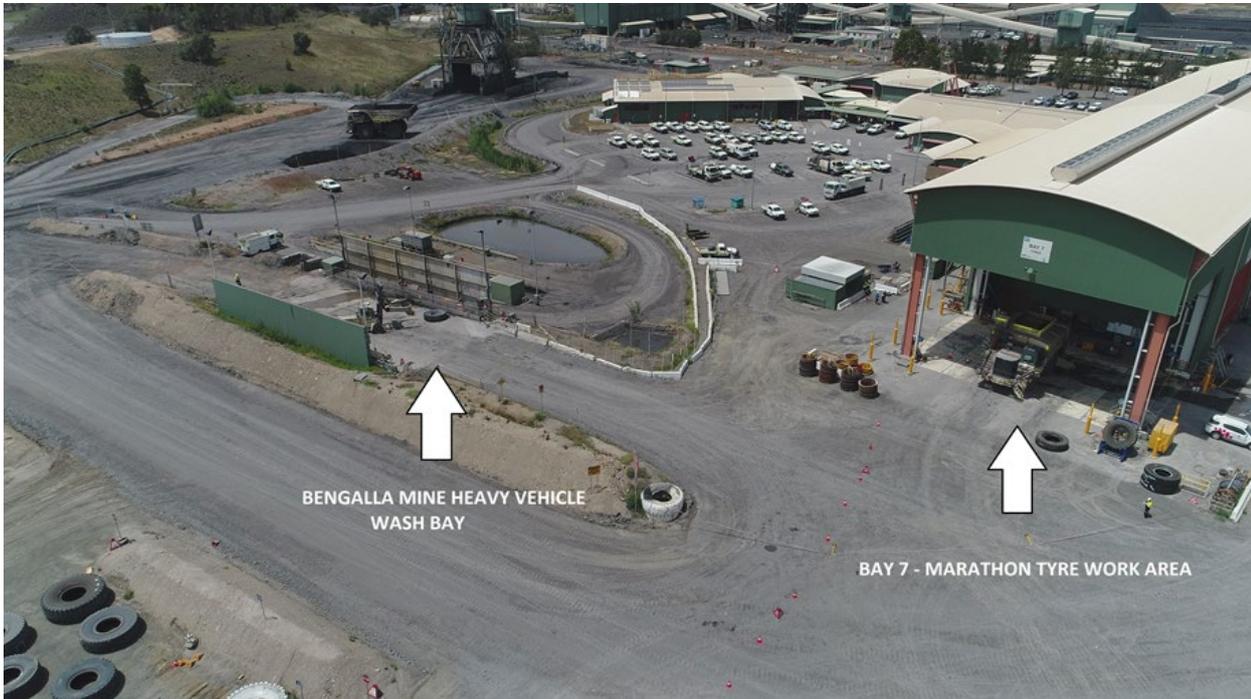
Figure 8 Bengalla mine – Marathon tyre work area and heavy vehicle wash bay

The incident occurred at the mine's heavy vehicle wash bay located approximately 30 metres from the Marathon Tyres' work area, known as bay 7 (refer to figure 8).

The heavy vehicle wash bay is generally used by both the mine and Marathon Tyre workers to clean heavy vehicles, including tyres, prior to completing planned and breakdown maintenance work. The wash bay consists of a large concrete bunded pad, with a slight grade sloping south to north. Located on the northern and southern sides of the wash bay are walkways with permanently mounted high pressure water cannons (the cannons). Two red flexible handheld hoses are located at the wash bay and are generally hung along hooks secured at both the northern and southern platforms.

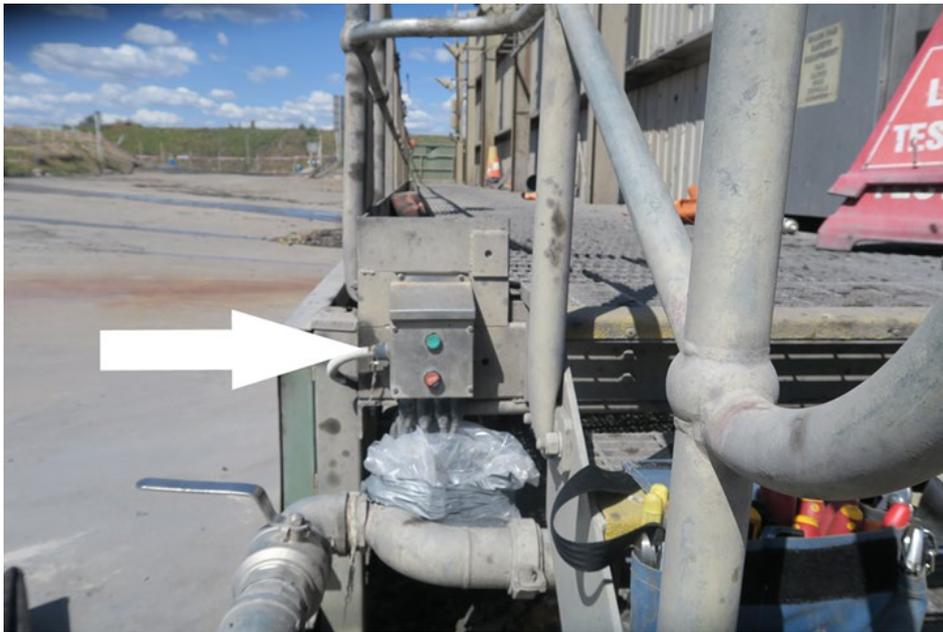
Figure 10 Pump activation control at heavy vehicle swash bay

To activate the high-pressure flow of water to the cannons and the red hoses, a small control box is located near the steps to the northern platform. The control box's green button activates the pump which provides high pressure water flow. The red button de-activates the pump, reducing the pressure.

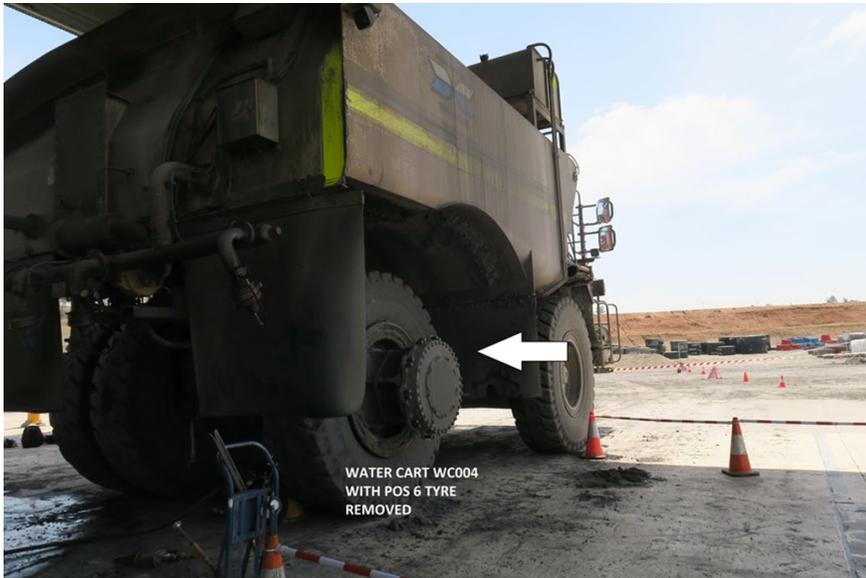
Figure 12 Photo of watercart WC004 in situ

Information obtained during the investigation supports that this process was completed in accordance with safe work procedures (SWP), in particular, SWP 4-04-018 'unbolt and bolt off tyre and wheel on the front or rear of a caterpillar OTR truck using a FLTH'. Mr Moore and his co-worker each completed a take-5 personal risk assessment regarding the tyre removal task.

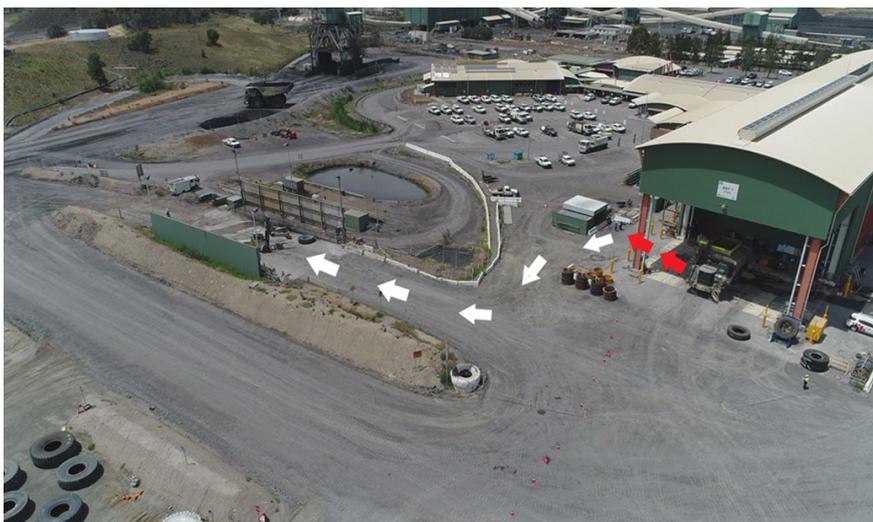
Figure 13 path taken by Mr Moore in tyre handler to wash bay

After removing the tyre from the water cart, Mr Moore trammed the tyre in the grabs of the tyre handler to the heavy vehicle wash bay (refer to figure 13) with the tyre in a horizontal position. Mr Moore did not complete a take-5 personal risk assessment regarding the task of washing the tyre at the wash bay.

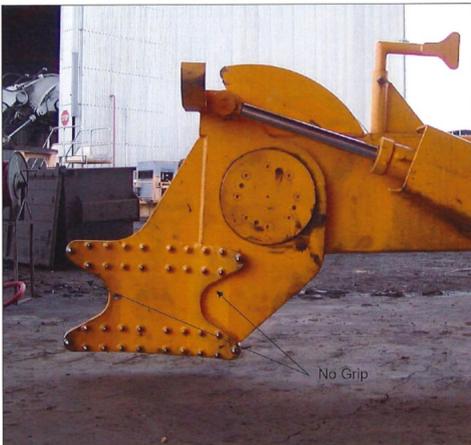
Figure 19 Photo depicting current OEM design

The investigation identified that neither the mine nor Marathon Tyres were aware of the report. In examining the security of tyres while being manoeuvred, one of the study's objectives was to increase the security of the tyre grip, especially while the tyre was maintained in the vertical position. Figure 19 represents the current OEM design at the time of the report, which the authors claimed lacked sufficient tyre surface grip.

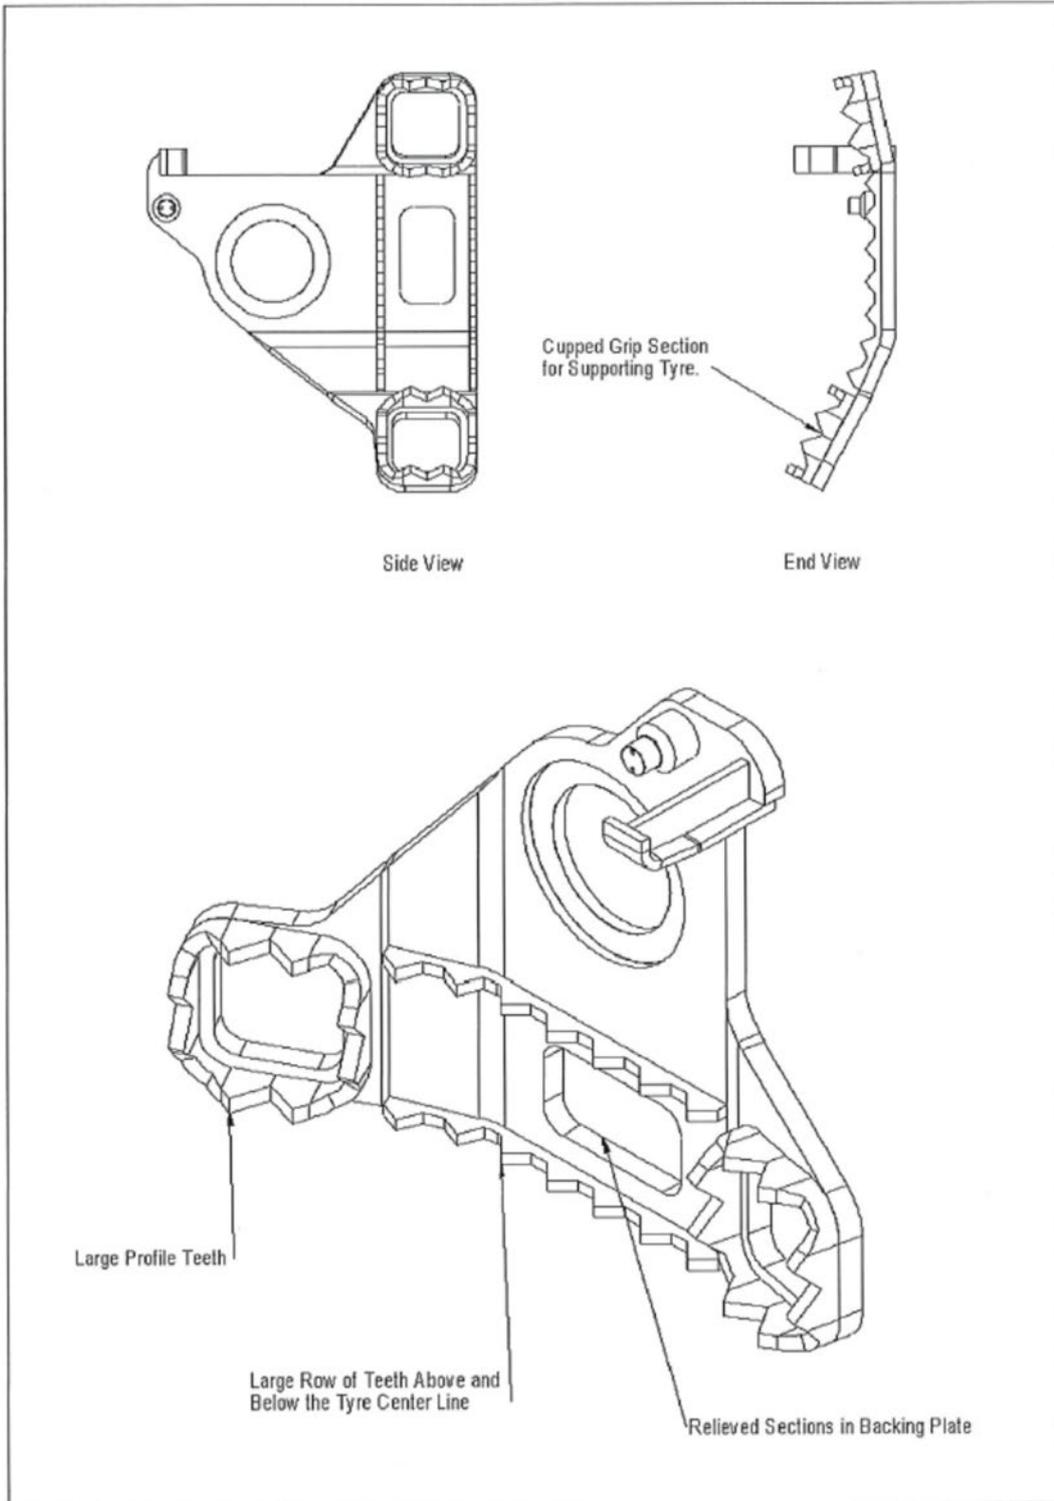
Figure 21 grab design by CMP Engineers Pty Ltd

Figure 21 represents an alternate grab design by CMP Engineering. The design incorporates a cupped grip section at the top and bottom of the grab for greater surface coverage of tyres, which is claimed to result in increased grip force if the tyre was to slide downwards, when in the horizontal position.

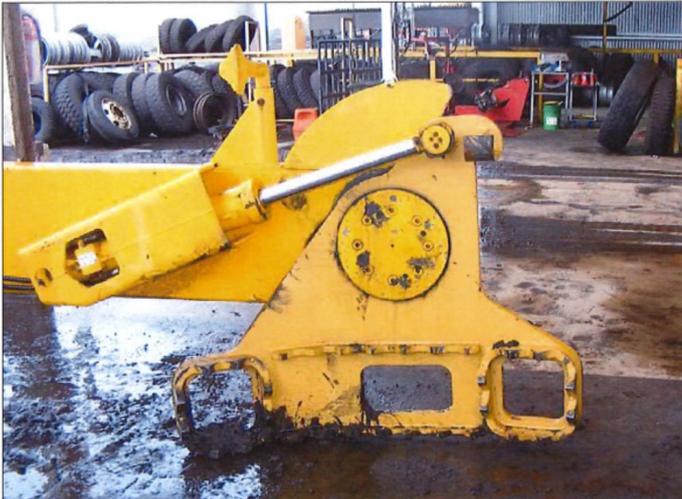
Figure 22 Manufactured grabs as per new design

As part of the project, CMP Engineering manufactured grabs as per their new design. The grabs are suitable to operate on the Cascade attachment without any requirement for modification.

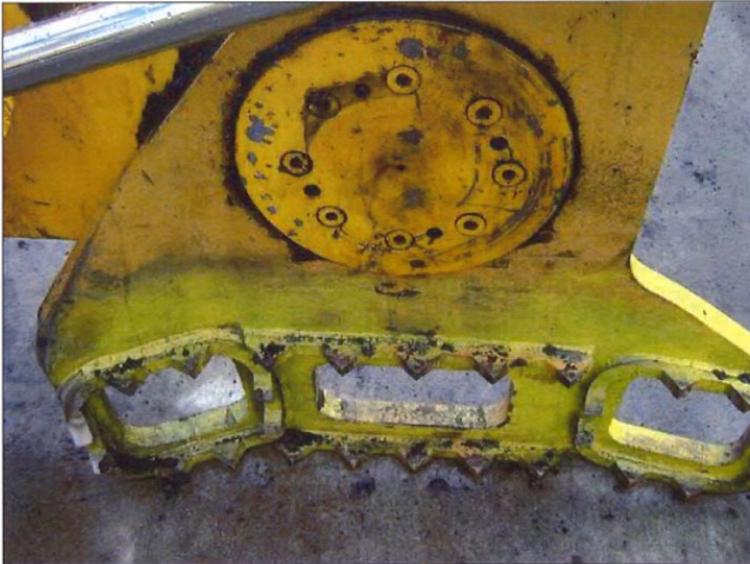
Figure 24 Modified grab hand

Two issues were identified by tyre handlers, regarding reduced capability to rotate smaller tyres when remounting, and issues accessing the tyre when obstructed by guards and/or mud flaps. This resulted in minor modification to the new grab design, reducing the grab hand by 310 millimetres while maintaining the increased tyre grip design feature (refer to figure 24).
