COMPLIANCE AUDIT PROGRAM

PERILYA BROKEN HILL OPERATIONS

Perilya Broken Hill Limited

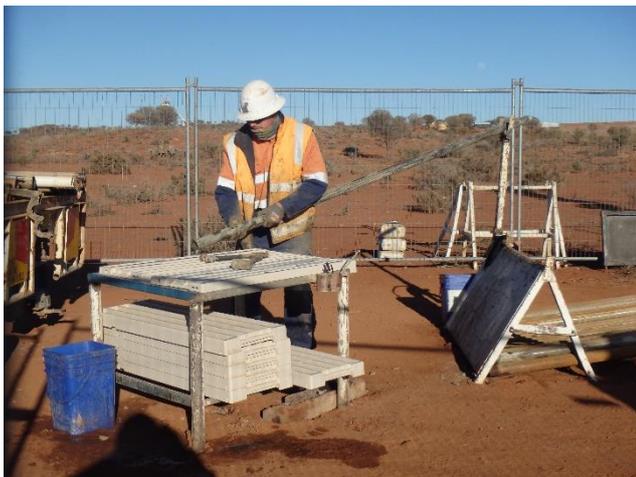
Core from the drilling in progress on CML5 was observed to be placed into modular plastic core trays by the drilling crew (refer to Figure 24). The driller marks the core trays as core is placed, including noting

Figure 24 Driller placing core in trays at the drill site

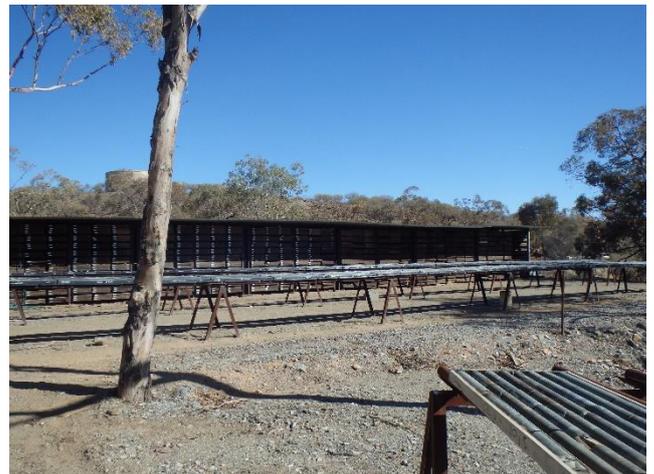
Examples of cores from exploration on the mining leases and the exploration licences were reviewed at the core yard. Generally, all core is stored in core trays, either in core tray racks or in the core shed (refer to Figure 25 and Figure 26). Trays were observed to be labelled with hole number, depth, and tray number (refer to Figure 27) and any loss of core noted.

Figure 26 Core trays racks at North Mine with core layout tables in the foreground

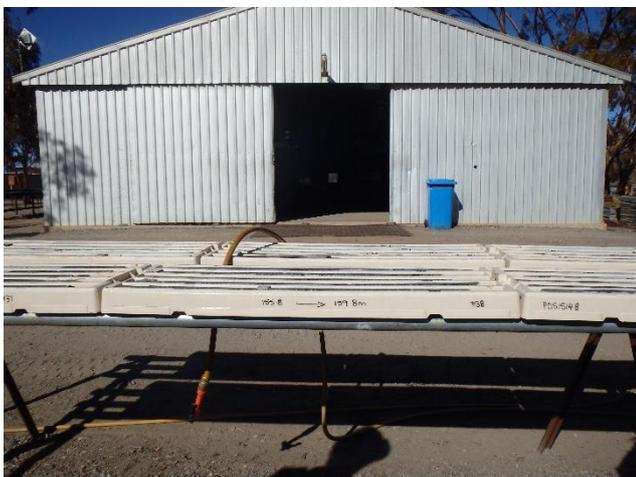
Figure 25 Core shed at North Mine with labelled core trays in the foreground

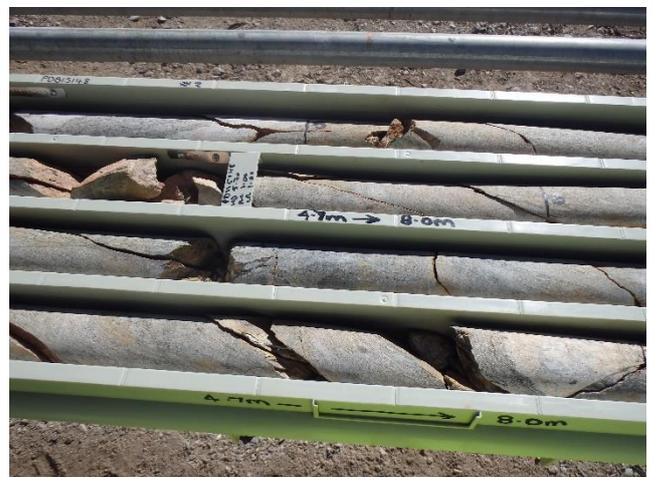
Figure 27 Example of labelled core tray
