TECHNICAL REPORT

Subject: Analysis of Blakefield South Mine (BSM)
Explosion

Date: First Draft 16 Feb 2012
Revised 20 Feb 2012; 29 Feb 2012

Report Prepared By: Drs Hsin Wei Wu and Stewart Gillies

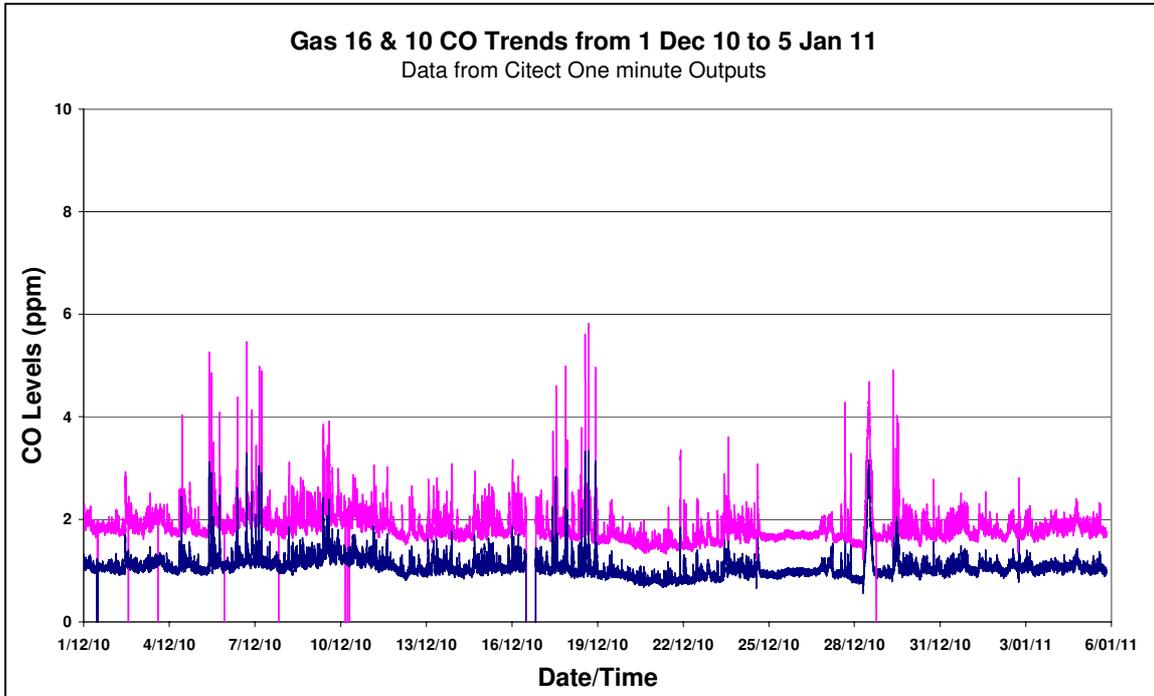
Figure 3.1 CO gas trend recorded at Gas 16 & 10 Stations (1/12/10 – 05/01/11).

CO gas levels in a mine atmosphere are of interest as they may indicate the onset of a fire or spontaneous combustion heating (or may show an indication of exhaust fumes from a diesel powered vehicle). In the various figures above both Gas 16 & 10 Stations' data indicate that CO levels are below 4.0ppm almost all the time and never record greater than 6ppm and then only for a very short period. Furthermore readings are very stable with no indication of a long term rising trend that may indicate onset of a heating.

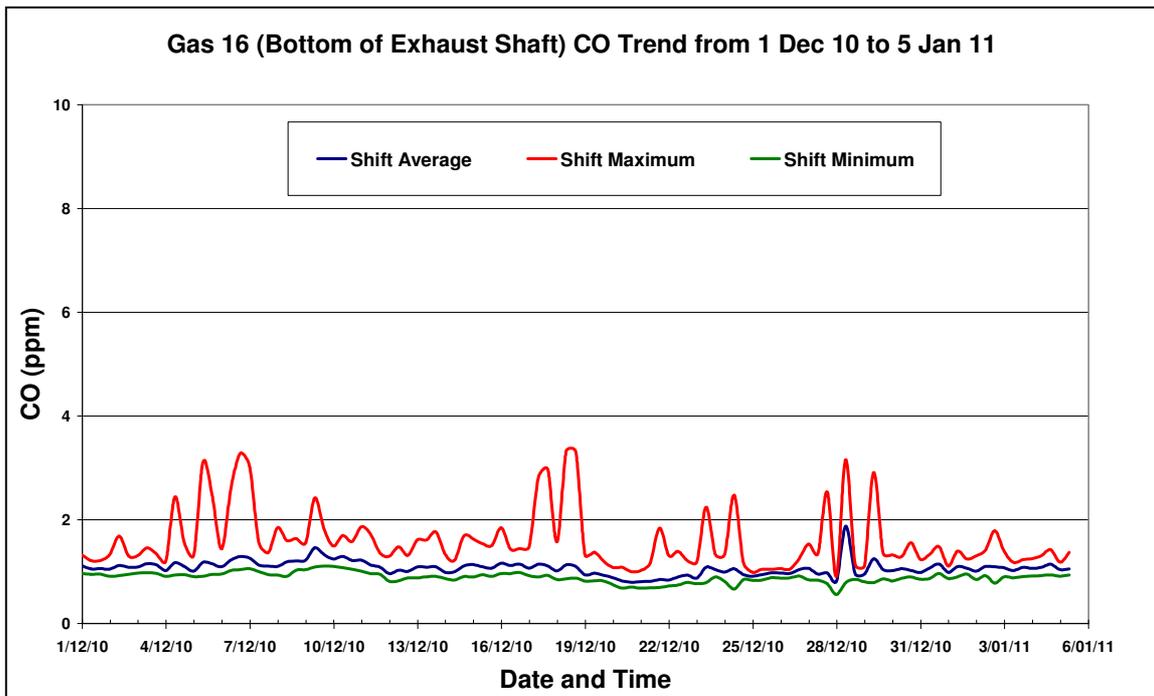
Figure 3.2 CO gas trends of shift average, maximum and minimum at Gas 16 Station – Bottom of Exhaust Shaft (1/12/10 – 05/01/11).

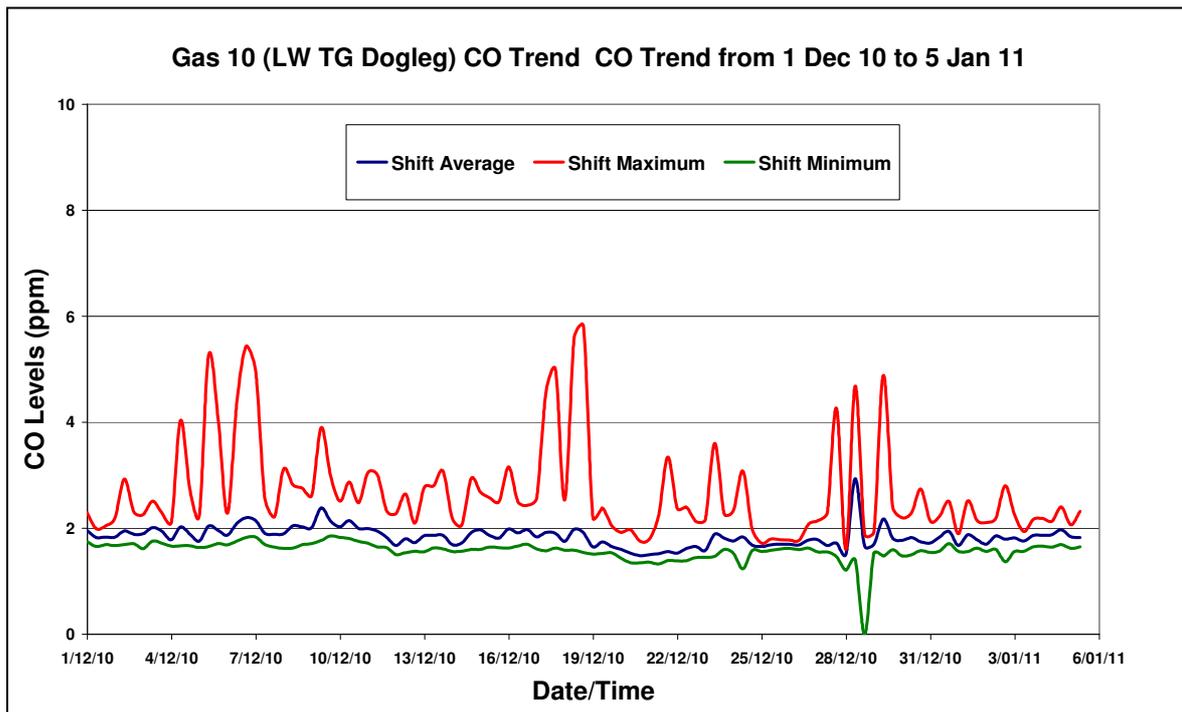
Figure 3.3 CO gas trends of shift average, maximum and minimum at Gas 16 Station (1/12/10 – 05/01/11)

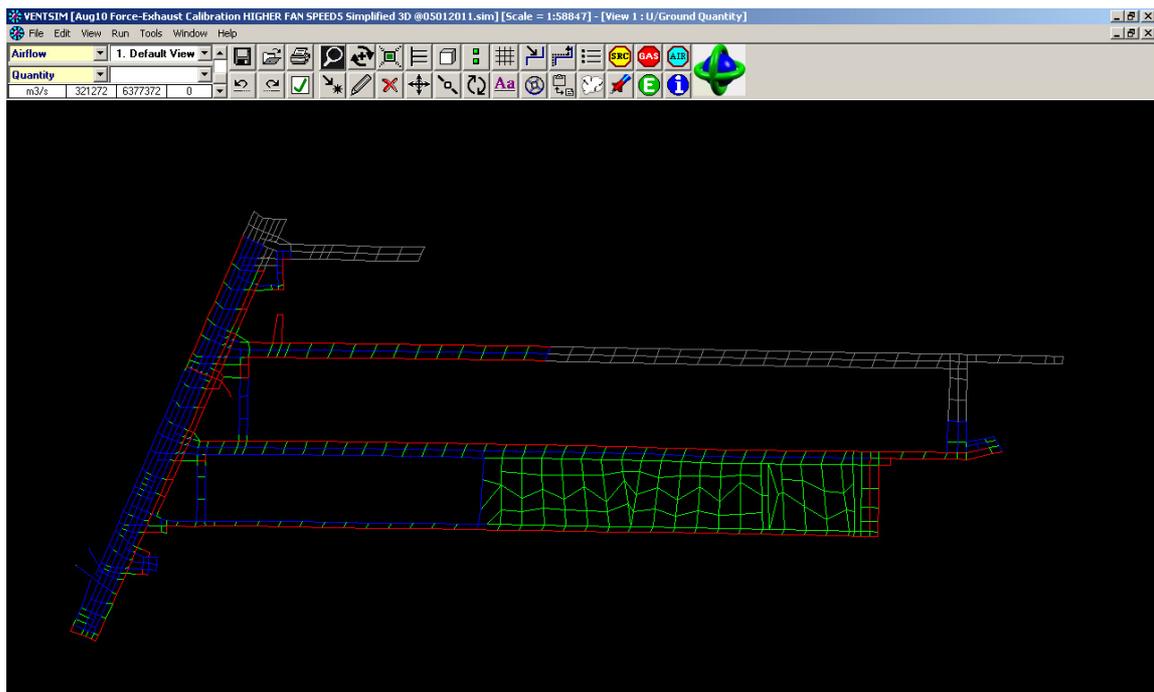
These circumstances indicate that BSM's mine ventilation management system needs improvement when compared with the standards of current Australian underground coal mine ventilation accepted practice.

Figure 6.2 Screen snapshots of the updated 3D Ventsim model as at 5 January 2011.

To be able to undertake proper Ventgraph model and simulation for the January 2011 incident, the 3D Ventsim model is to be updated to the status of the ventilation network just prior to the incident using the relevant information available from monthly ventilation reports and plans. This task is currently being undertaken and the following figure shows a screen snapshot of the updated 3D Ventsim model at 5 January 2011 prior to the incident.

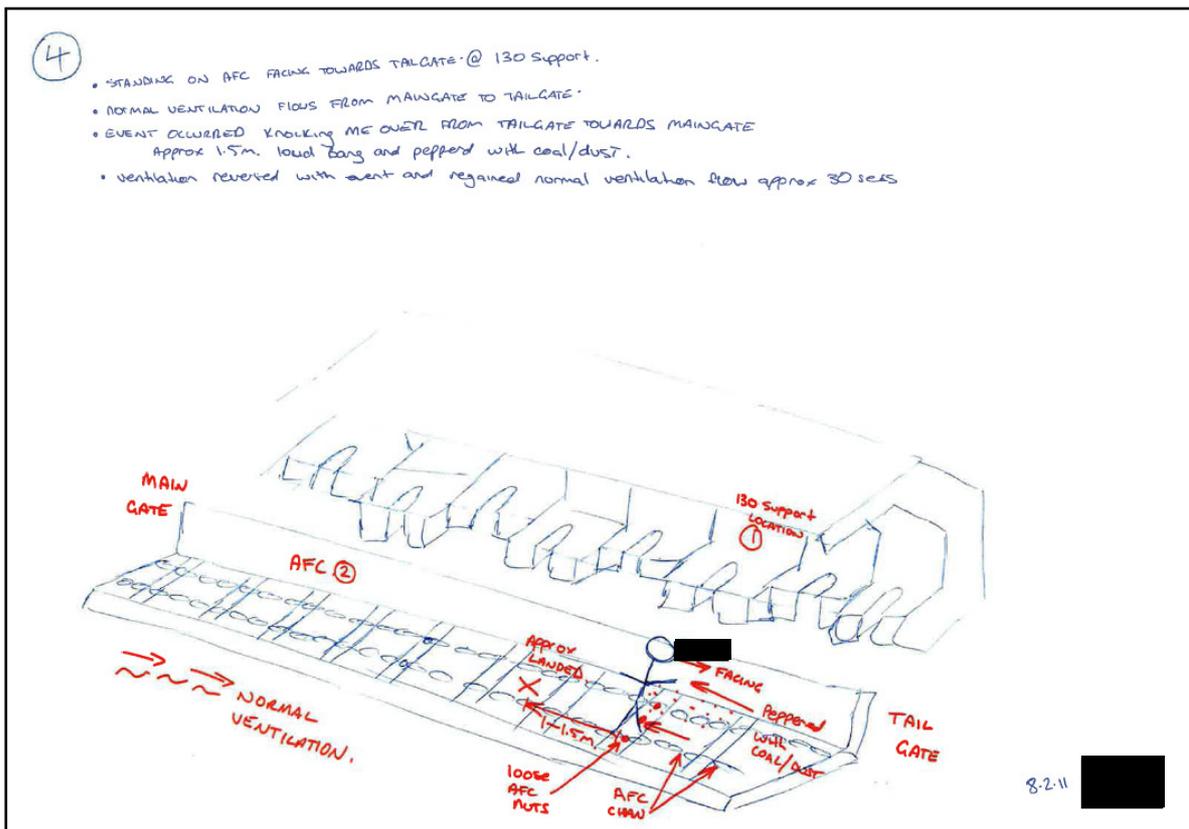
quickly move to [REDACTED]. One or more of the LW miners also at the MG followed the Deputy as he started to move up the LW face. The Deputy met [REDACTED] about a third of way along the face from the MG. [REDACTED] verbal account records that he stated that he had been standing working at Chock position 130 at the time of the incident and had been knocked over by the windblast. Figure 8.1 shows LW Maintenance Supervisor, [REDACTED], hand drawing indicating his position on LW face at Chock 130 at time of incident.

Figure 8.2 LW Maintenance Supervisor, [REDACTED], hand drawing indicating his position on LW face at Chock 130 at time of incident.
