FIRES ON MOBILE PLANT

January-March 2019

Mobile plant fires present safety and production losses

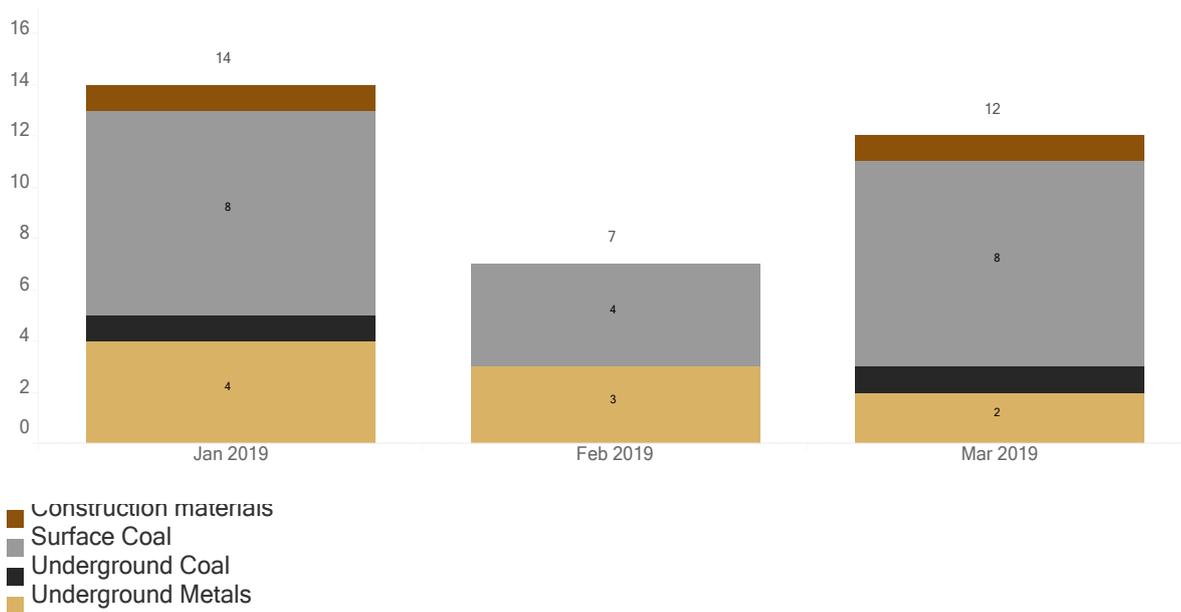
Figure 3 Fires on mobile plant for quarter 3, 2019 sorted by depth layers

Note: The January event for coal-underground (black) occurred on the surface of the underground mine.

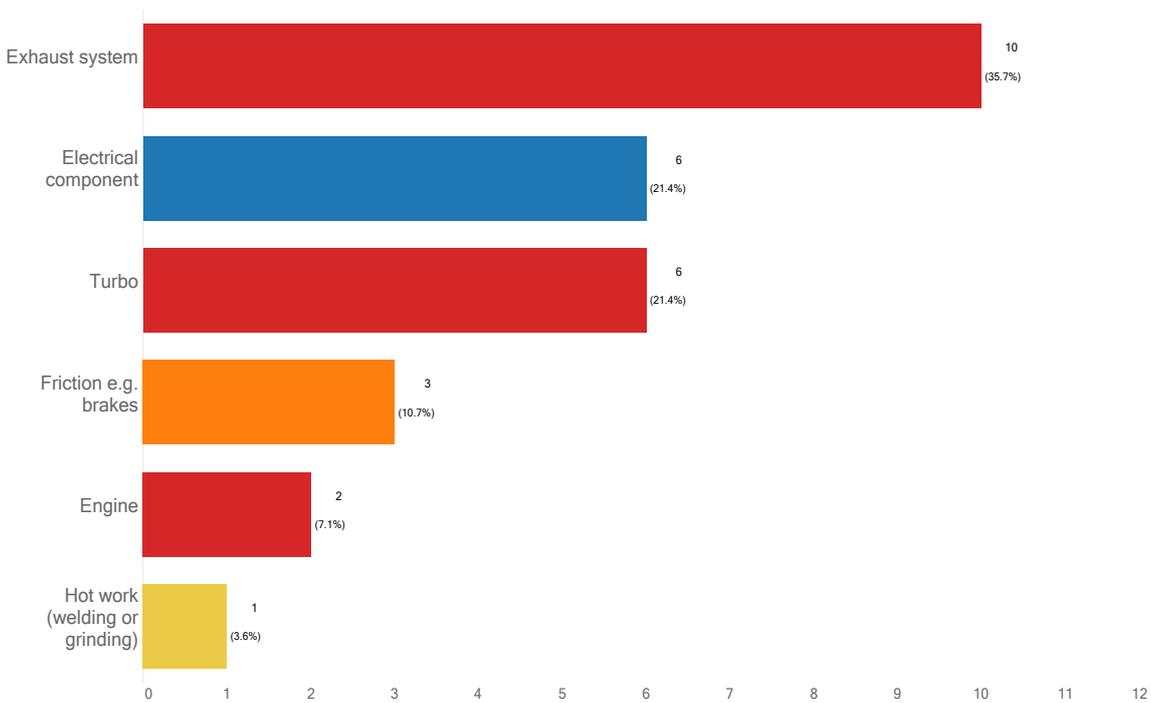
Figure 5 Heat sources as identified on ancillary reports

Surface temperature control has been demonstrated to eliminate the risk of engine exhaust fires on mobile plant in underground coal mines. Reduction of surface temperatures may eliminate or reduce the ignition and heat source, when a combustible fluid escapes containment.

Mine operators and equipment manufacturers are required to implement engineering solutions to control surface temperatures, so far as is reasonably practicable.
