# Investigation report

**Report into the death of Lee Peters at the Ridgeway Mine, Cadia, NSW on 6 September 2015**

Published by NSW Department of Industry, Skills and Regional Development, NSW Resources Regulator

**First published:** March 2017

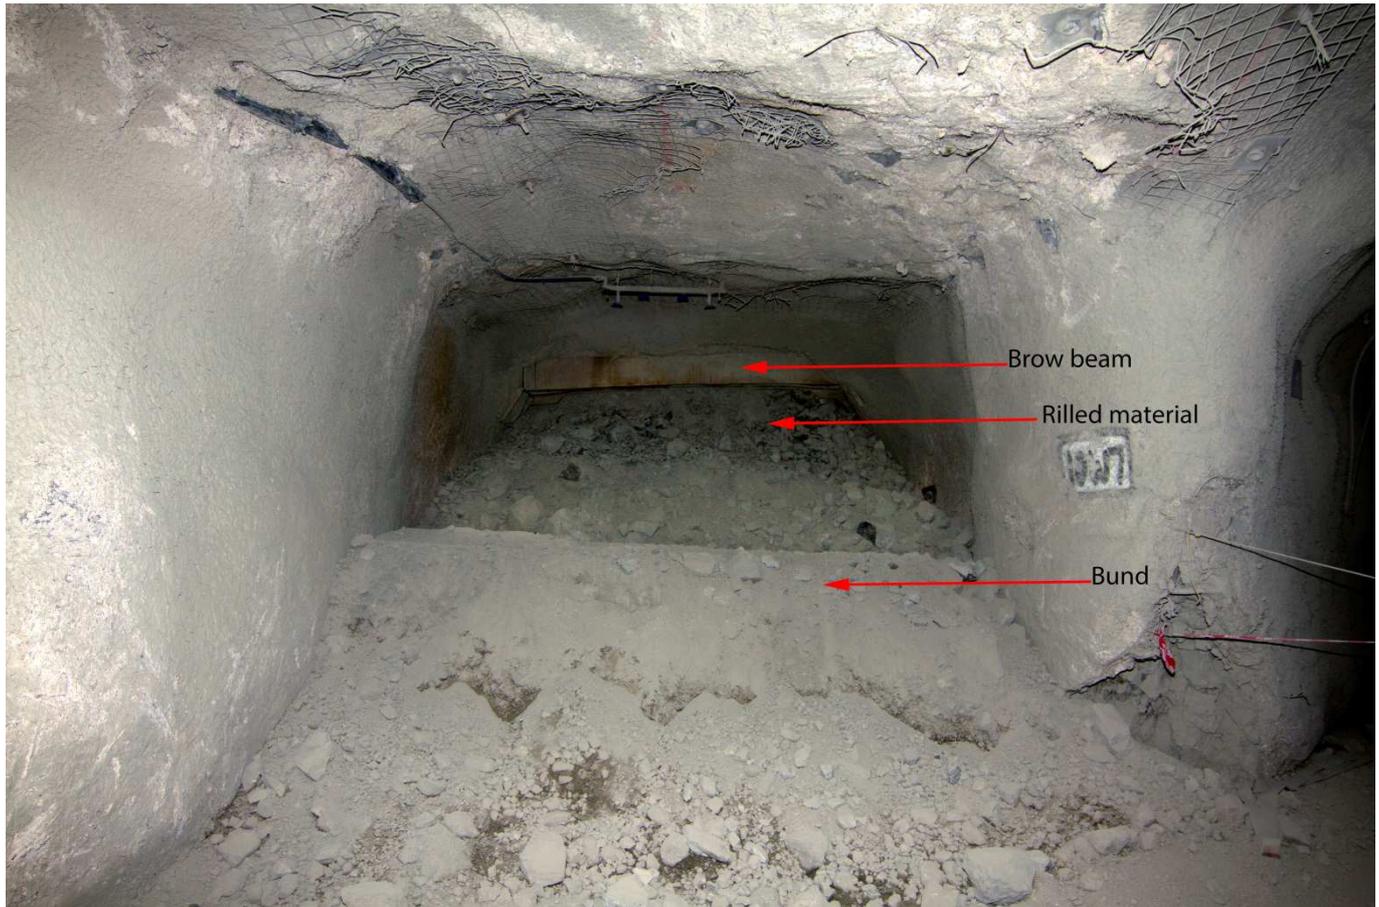
Figure 6 Photograph of 10W7 closed draw point and bund.

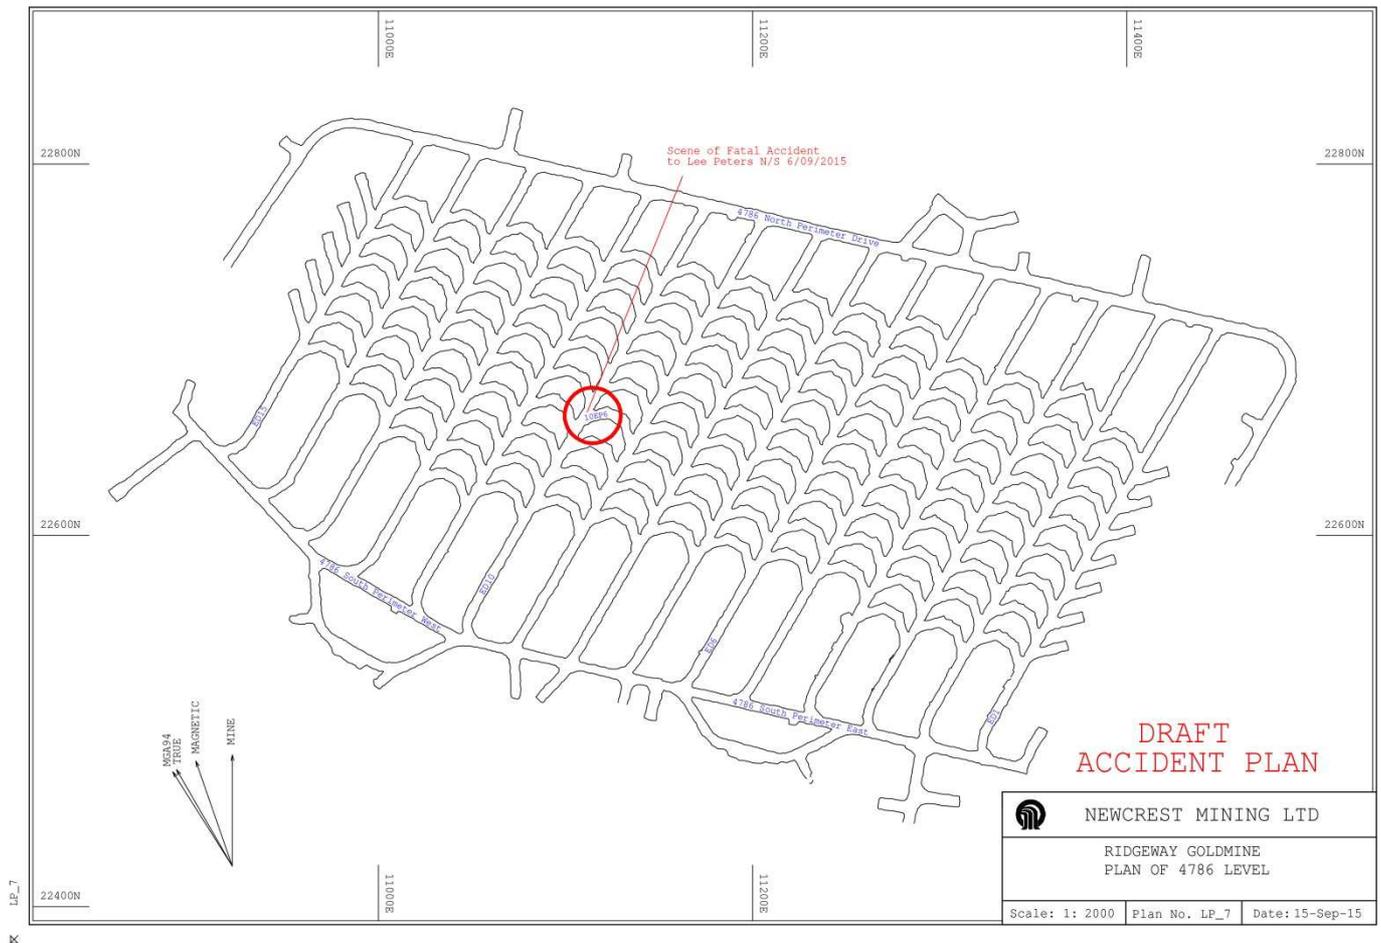
There are a total of 15 extraction drives on the 4786 level that access a total of 248 draw points. At the time of the incident, production in extraction drive 10 was suspended to permit secondary breaking operations at draw points. The incident occurred at the sixth draw point on the eastern side of extraction drive 10 (10E6) on the 4786 extraction level. The location of extraction drive 10 is marked in Figure 10.

Figure 10 Incident location map which identifies extraction drive 10, draw point East 6, on 4786 production level as the incident site.

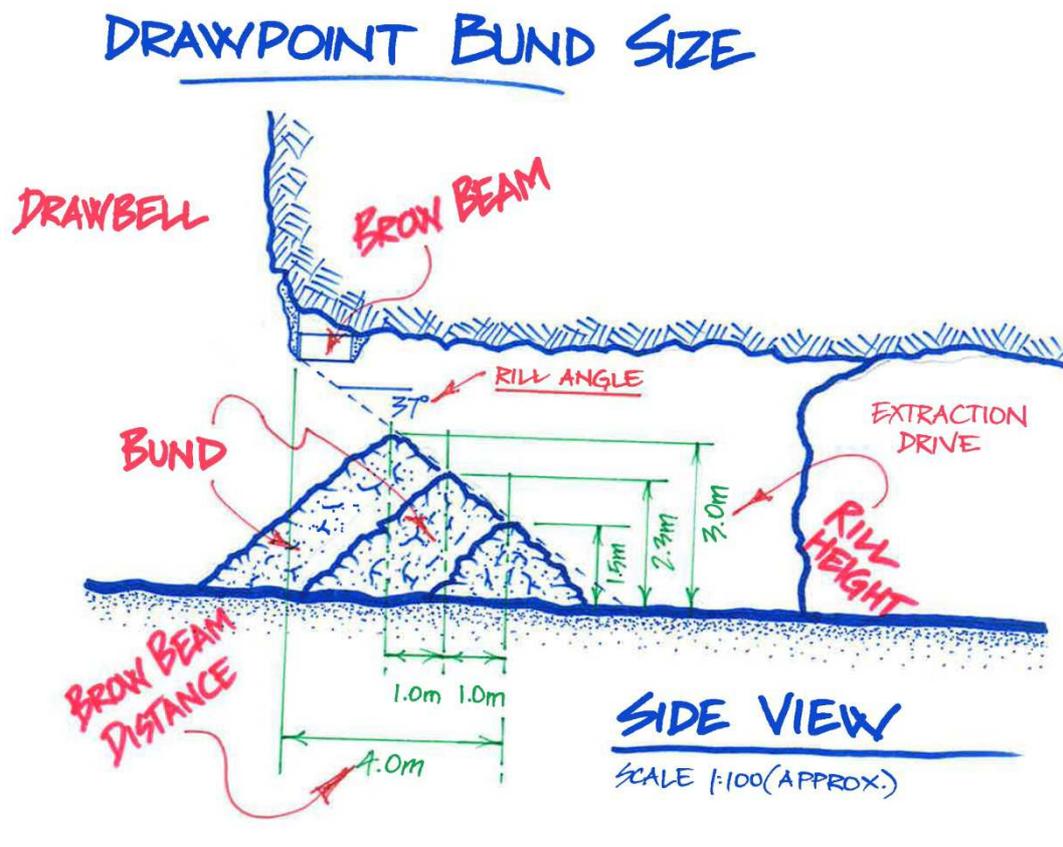
Figure 15: Picture of Ridgeway Mine bunding requirements shown at Ridgeway Mine panel start meetings of 19 March 2015 and 26 March 2015.

Note the bunding requirements shown in Figure 15 are:

- not to scale
- all bund dimensions are premised on the material used to construct the bund having an angle of repose of 37°.

The sketch and the accompanying panel start documentation did not provide an explanation for the three different bund sizes shown in Figure 15.

The investigation established that the sketch of bunding shown in Figure 15 was reproduced on the shift sheets at the Ridgeway Mine. The shift sheet did not include an explanation of the different types of bunds.

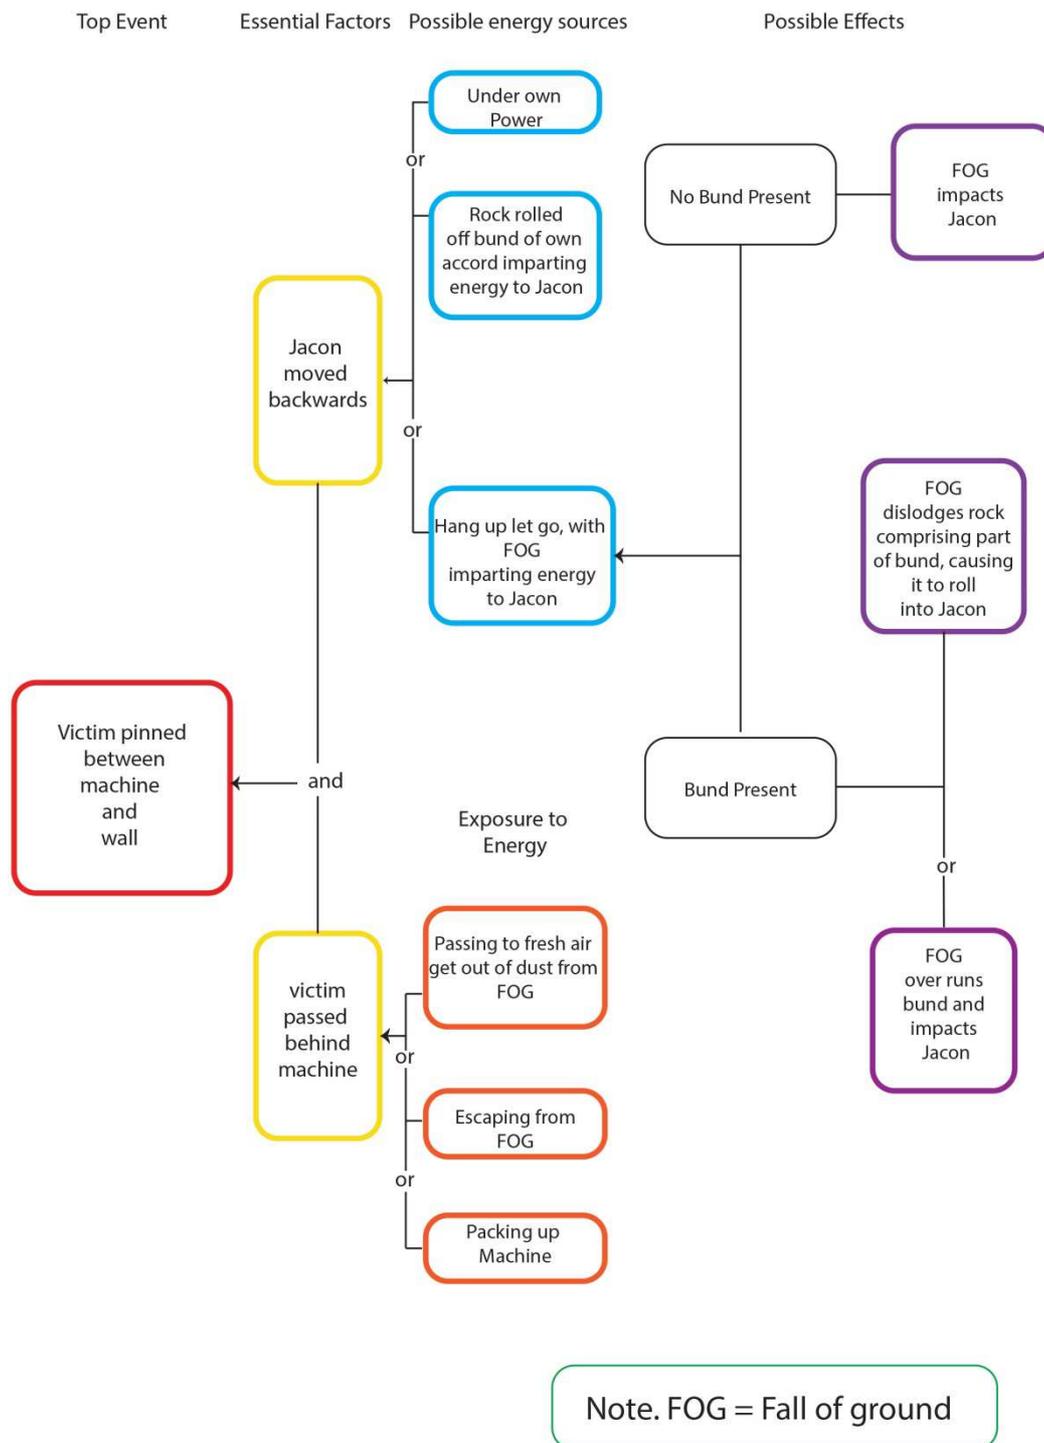
Figure 20 depicts a causal analysis undertaken by investigators. The causal analysis was one of the tools used by investigators to determine lines of enquiry. It illustrates the salient points that led to the incident involving Mr Peters.

Figure 20 Causal analysis of incident.

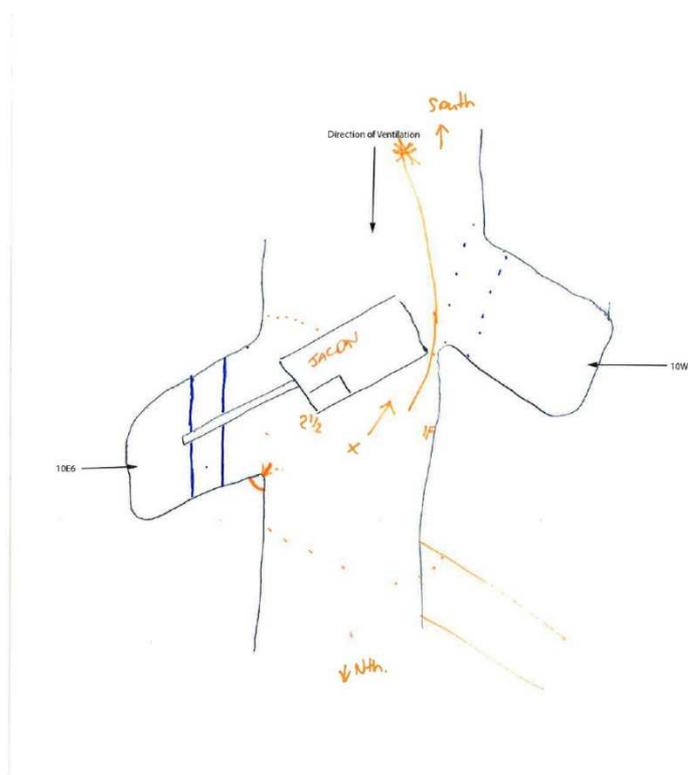
Some operators and supervisors indicated that as soon as a hang up looked likely to come down, they would immediately walk or run around the back of the water cannon to the up wind side of the extraction drive. An example of an operator's response is shown in Figure 24. Explanations for this non-compliance with the stipulated safe work procedure centred around the fact that when a hang up comes down, it creates a dense cloud of dust. The direction of ventilation meant that if the operator was to move to the North of the draw point they could be exposed to significantly reduced, and sometimes zero, visibility. Not all workers chose to wear a dust mask before a hang up letting go. Some even chose not to wear a dust mask after a hang up had let go.

Figure 24: Drawing completed by a mining technician during interview with an investigator on 25 November 2015.
