# **Investigation Report**

Injury resulting in death involving a mobile  
bolter at the Myuna Colliery on

24 July 2008

Report prepared for the Director General of the  
Department of Industry and Investment by the  
Investigation Unit, Thornton

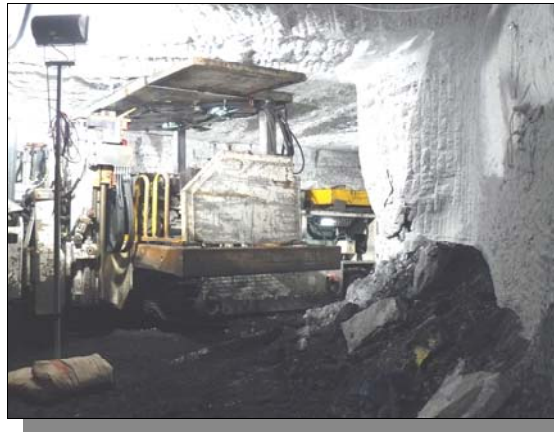
The front of the Sandvik Mobile Bolter RB901 underground at the Myuna Colliery. The temporary roof support (TRS) and extended platform on the LH of the machine (right-side photo) can be seen. These structures are to facilitate rib bolting.
