## Investigation report

Report into the death of James Leslie Stocks, found at the bottom of a shaft on Mineral Claim 32904 at Lightning Ridge on 7 March 2013

Prepared by Investigation Unit, Thornton

July 2014

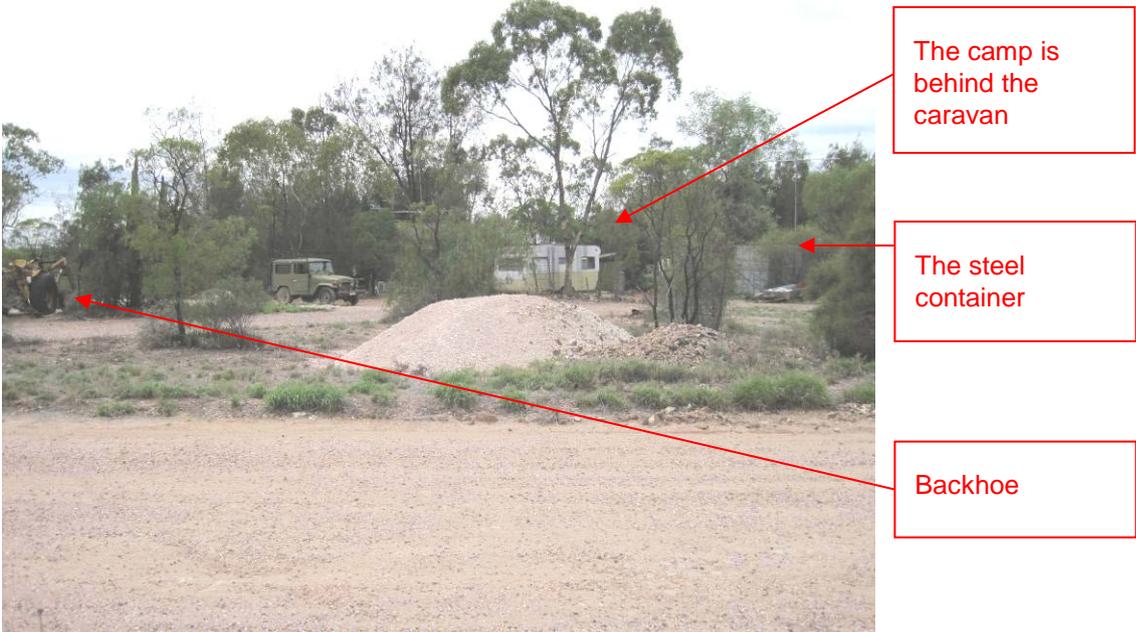
Figure 5 and Figure 6 show the mineral claim on 9 March 2013. The backhoe marked in Figure 5 and the truck marked in Figure 6 were on the mineral claim at the time of the incident.

**Figure 5.** Mineral claim on 9 March 2013.

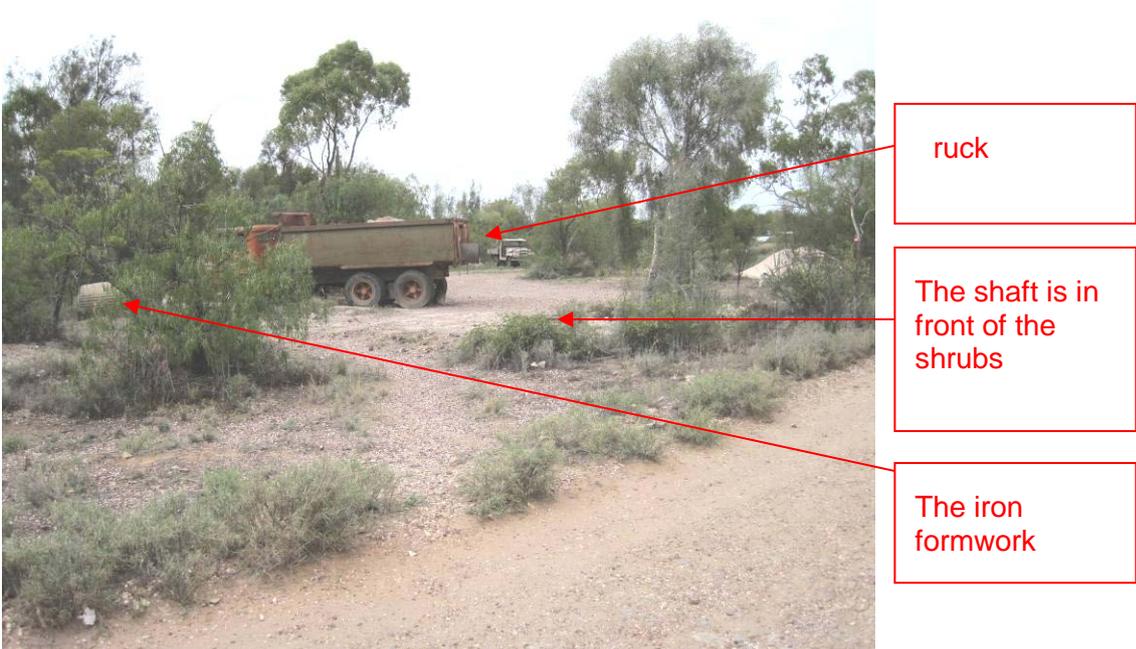
**Figure 6.** Mineral claim on 9 March 2013.

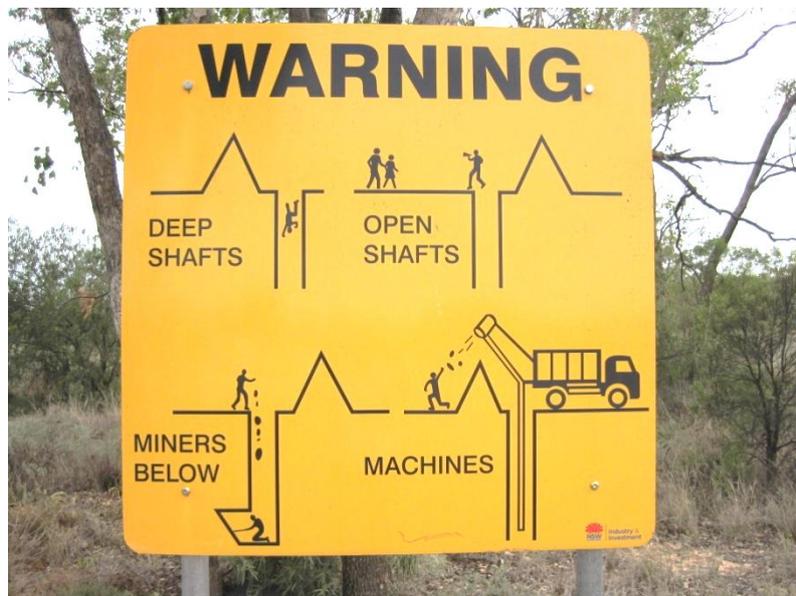
It should be noted that there are signs displayed throughout the opal fields, designed, installed and paid for by the department’s Mine Safety Operations branch (see figure 9 below).

**Figure 9.** Department sign on the Canfell’s opal field, 13 March 2013.
