# SAFETY BULLETIN

DATE: NOVEMBER 2019

## Hoist rope unravels over head sheave

This safety bulletin provides safety advice for the NSW mining industry relating to small gemstone mine person-riding hoists (winding systems).

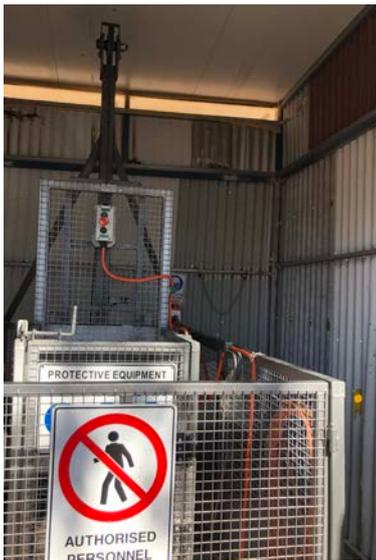
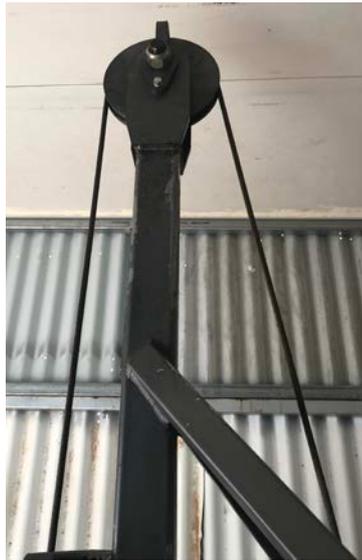
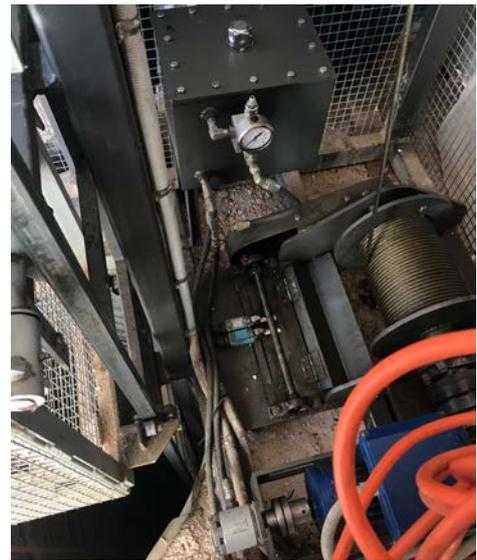
The 33-metre wire rope was installed on a man-riding hoist that was registered to carry one person at a small gemstone mine shaft.

The 8-millimetre diameter non-rotating wire rope lay in a 12-millimetre diameter head pulley groove.

*Figures 2, 3 and 4: Arrangement of the hoist showing the conveyance, head sheave and winch drum.*

The rope condition is believed to be affected by compatibility factors associated with the head sheave groove dimensions.

- carry out a visual inspection of hoist ropes to look for evidence of protruding wires or strands. If protruding strands are found, the rope must be replaced.
- measure both the head pulley groove diameter and rope diameter. Ensure that power to the hoist is isolated, all energy has been dissipated and safe access for working at heights is in place before taking measurements.
- consult the hoist designer to determine if the rope in service is compatible with the head sheave design.
