**NSW
Resources
Regulator**

INVESTIGATION REPORT

REPORT INTO THE DEATH OF MR ANDREW BRAY

Snapper Mineral Sands Mine 12 August 2019

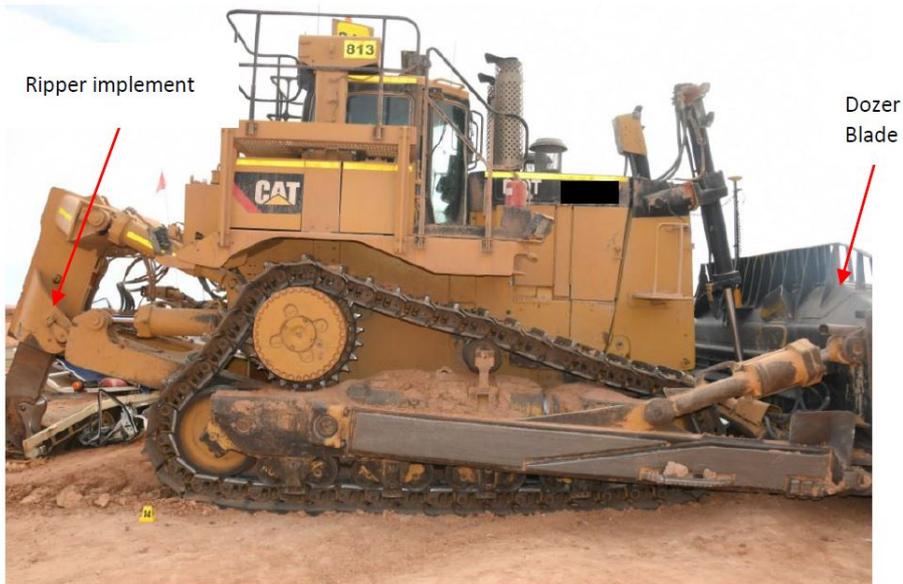
Figure 1: Caterpillar D10T dozer DZ 813

The involved dozer was a Caterpillar designed and manufactured D10T model track-type dozer fitted with a front blade and rear ripper implement (see Figure 1). The D10T dozer has an operating weight of about 70,000 kg. The dozer was manufactured in June 2007 and purchased by BSL from a mining equipment reseller in March 2017.

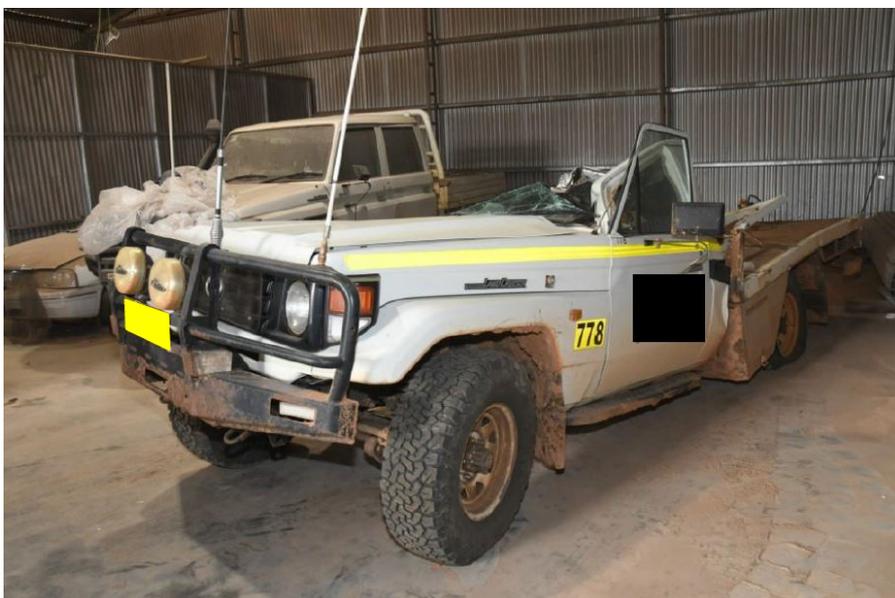
Figure 2: Toyota Landcruiser LV 778

The involved light vehicle was a 2002 Toyota Landcruiser 4WD single cab tabletop utility with NSW road registration (see Figure 2). The light vehicle formed part of BSL's operations and had been assigned mine identifying number 778 'LV 778'. At the time of the incident, BSL maintained full control of the operation, maintenance, service and repairs of LV 778.

It is also not known if LV 778 was stationary or moving at the time of impact. After the incident, the light vehicle was found with its engine idling, gear stick in neutral position and park brake not applied, providing some indication that it may have been stationary at the time of impact.

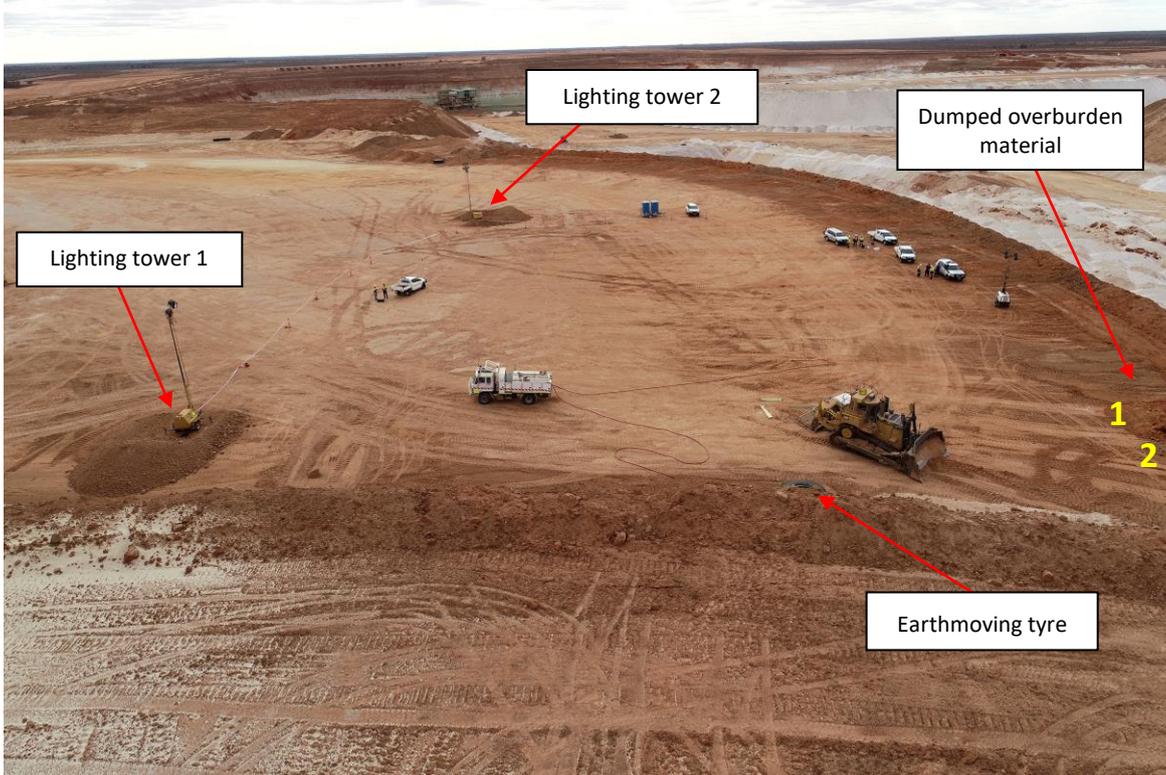
Figure 4: Snapper Overburden Western Tip Head

At the time of the incident, lighting towers were positioned at the Western Tip Head to provide additional lighting and aid visibility during low light hours and night shift (see Figures 4, 5 and 6). In addition to BSL's dump trucks and dozers, light vehicles were also required to access tip head areas to conduct various tasks.

Around this time, the DZ 813 operator moved the dozer to the area near location 1 and 2 depicted on Figures 4 and 5 where he continued to shift the dumped loads of material. The DZ 813 operator then observed a light vehicle parked in the vicinity of light tower 1 (see Figures 4 and 5) and a person who he recognized to be Mr Bray outside of the car turning on the light tower.

The DZ 813 operator estimated that at this time the dozer was approximately 20 metres back from the tip face, in an area close to a large earthmoving tyre lying flat on the ground (see Figures 4 and 5).

DT 844 dumped a load of overburden material at, most likely, location 1 depicted on Figures 4 and 5 and then commenced leaving the tip head area, heading towards the access ramp. At this point, the DT 844 operator observed Mr Bray driving a single cab light vehicle on the tip head in the vicinity of light tower 2 (see Figures 4 and 5).

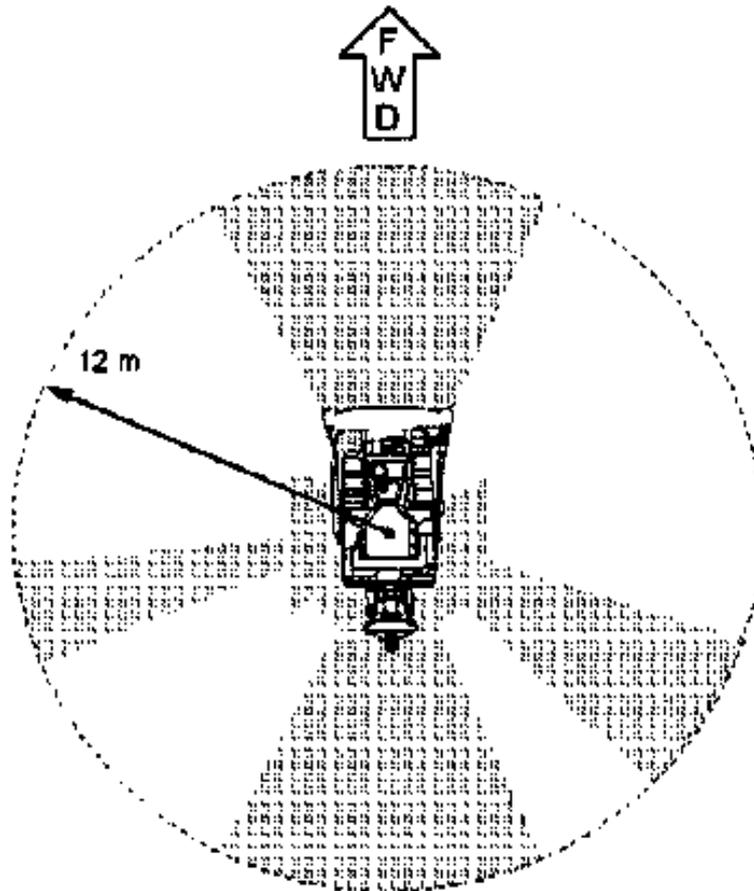
Figure 9: Caterpillar D10T OEM operator's manual visibility diagram

BSL operations at the Snapper mine comprised a fleet of four Caterpillar D10T dozers. The design and configuration of the dozers' access platforms, roll-over protection system, ripper implement and other componentry caused areas of limited visibility, particularly from both side and rear cabin windows. Figure 9 shows the visibility diagram contained within the CAT D10T OEM operator's manual with the shaded areas depicting the approximate areas with significant restricted visibility. Figure 10 depicts the view from the operator's cabin of DZ 813 at the incident location.
