## Investigation report

Investigation into the death of Jeremy Mathew Junk at  
the CSA Mine, Cobar NSW on 16 March 2013

Report prepared by the NSW Mine Safety  
Investigation Unit

June 2014

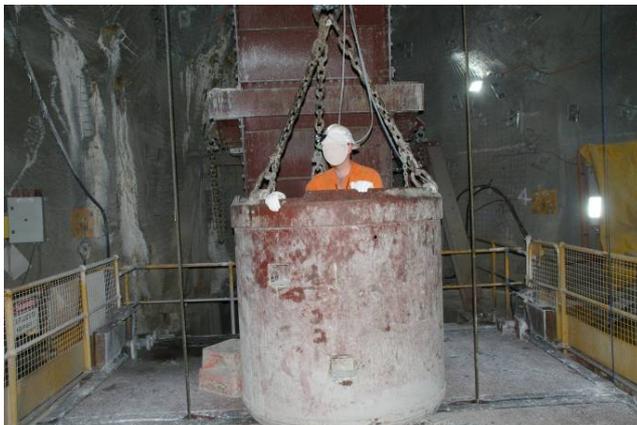
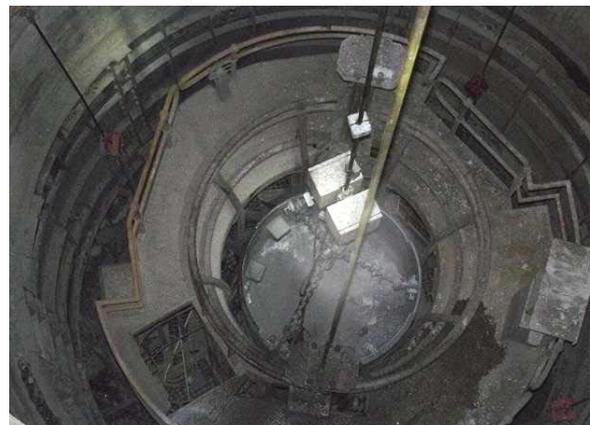
Figure 8. A man standing in kibble at the 9240 level brace. Figure 9. The kibble traversing through stage’s kibble well.

During shaft sinking operations, kibles are commonly used as a form of conveyance. The shaft sinking kibble used in this project was manufactured in July 2006. It comprised a heavy duty steel bucket designed to extract earth and materials from the shaft. It had a capacity of 4.5 tonnes and weighed about 1.1 tonne when empty. It was 1.63 metres in height and had a diameter of 1.61 metres. Three chains secured it to the kibble winder cable. According to MMS’s procedures, people were permitted to ride in the kibble. A maximum of five people were permitted to ride in the kibble at any time. The following photographs depict a man positioned in the kibble and the kibble traversing through the upper platform of the stage.

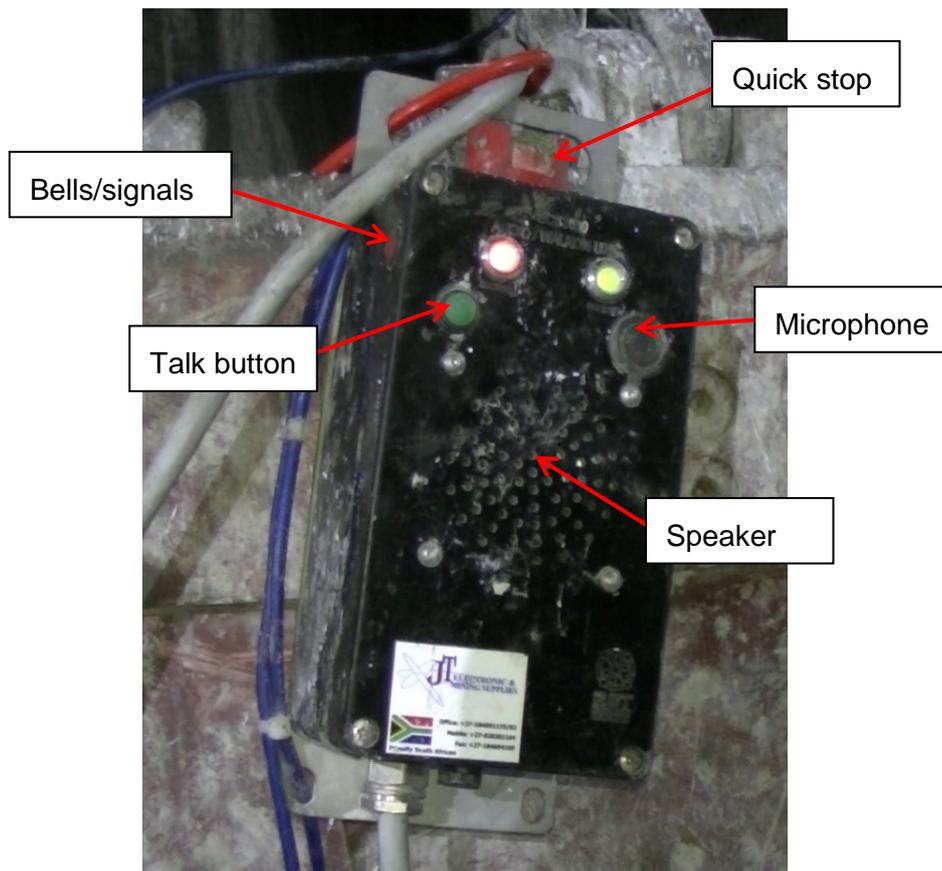
Figure 17. The kibble's JT communications 'walk on unit'.

The JT communications system was only installed in the kibble when it was being used as a man riding conveyance. Any fault with the JT communication system would cause a winder fault and stop the winder. The investigation confirmed that the JT communications 'walk on unit' was installed in the kibble when the incident occurred. There were no communication faults reported during the shift when the incident occurred. However communication-related faults were common occurrences during the project. The following photograph depicts the kibble's JT communications 'walk on unit'.

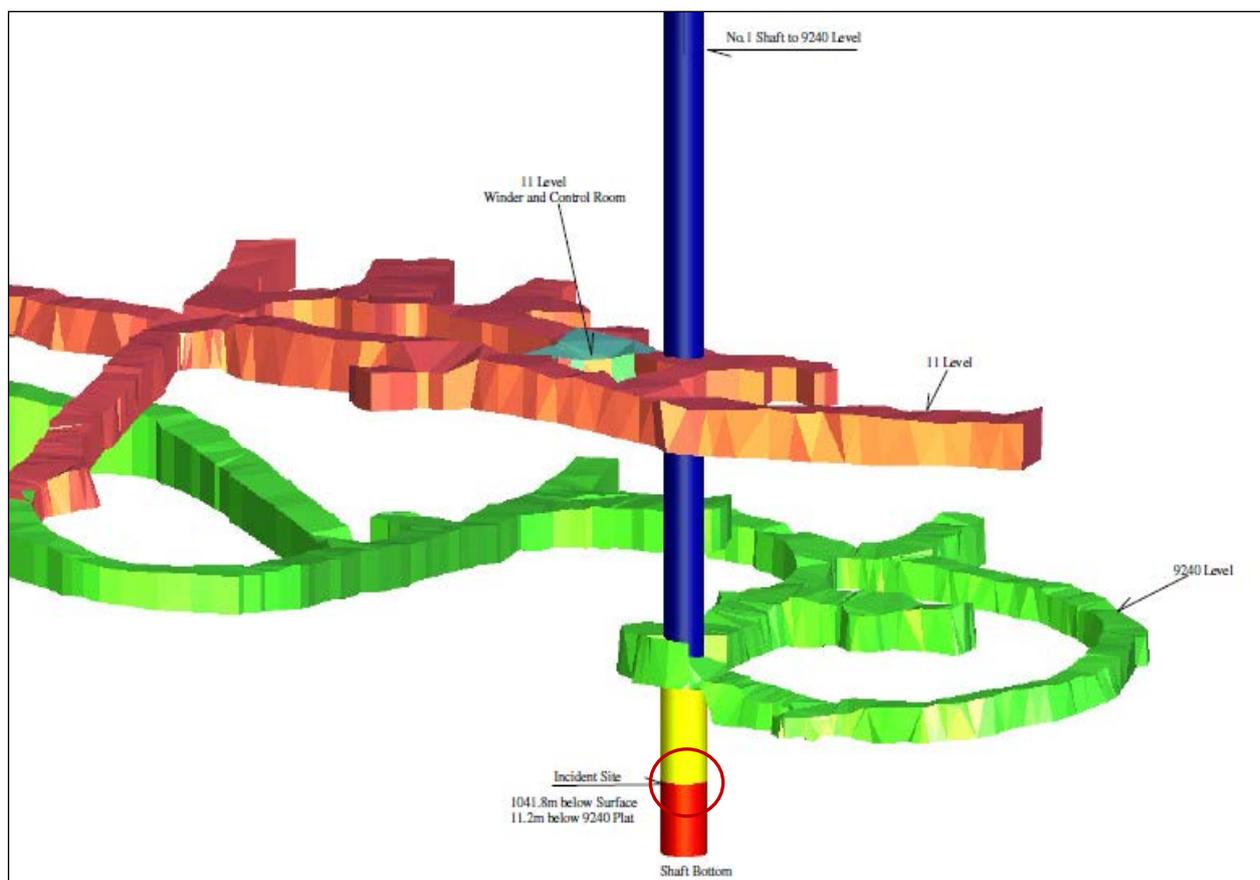
Figure 19. CSA mine plan depicting location of incident site in the No.1 shaft.

The incident site was identified by investigators to be situated in the No.1 shaft, 1041.8 metres below the surface of the mine. The following diagram depicts the mines No.1 shaft and incident site in relation to the 11 Level and 9240 level.

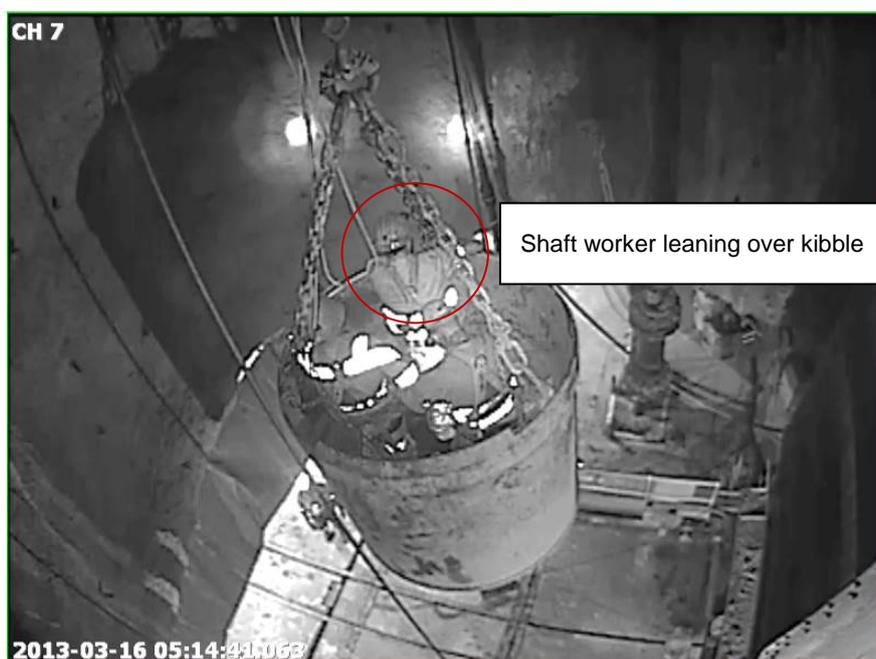
Figure 22. CCTV Footage of three shaft workers being raised in kibble after the incident occurred.

Following the emergency response and transport of Mr Junk via ambulance away from the 9240 level, the kibble was reconnected to the kibble winder and lowered into the shaft to retrieve the other three shaft workers from the stage. The three workers climbed into the kibble and were transported to the 9240 brace. The CCTV footage shows one of the workers leaning over the edge of the kibble with his arms extended outside the perimeter of the kibble before it was lowered onto the brace. These actions further demonstrate the lack of physical barriers to prevent such actions and are indicative of the inadequacy of the kibble riding procedure to prevent this behaviour. The following screen capture of the CCTV footage highlights this point.
