**NSW
Resources
Regulator**

INVESTIGATION REPORT

RIB FAILURE AT CLARENCE COLLIERY

4 July 2018

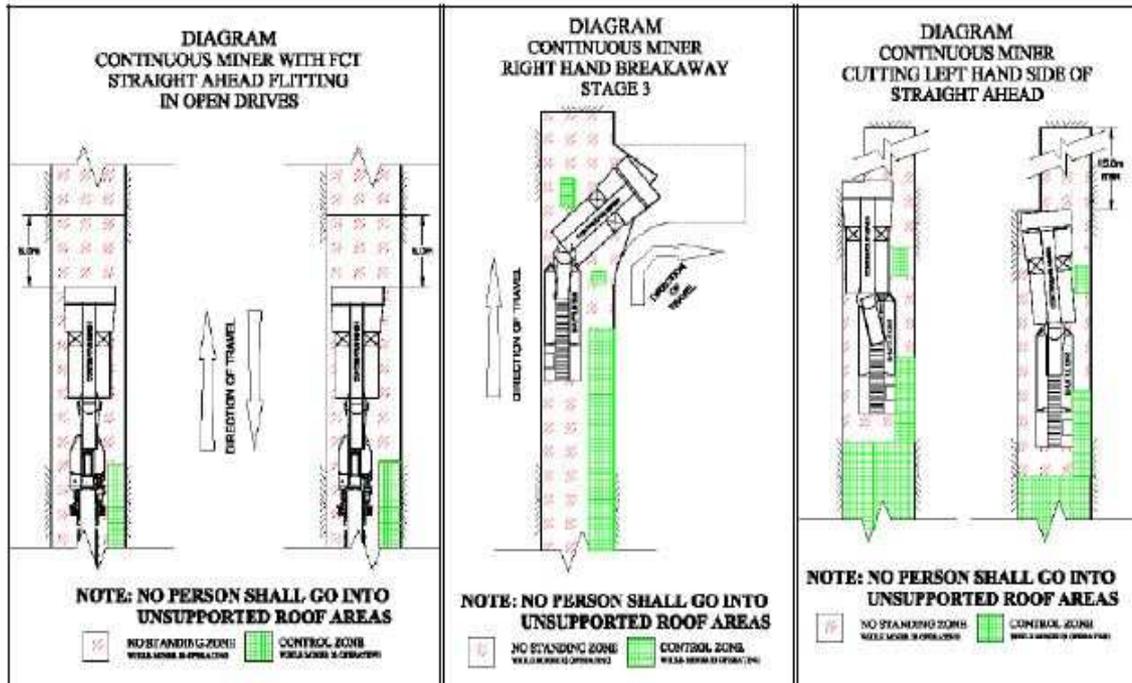
Figure 10 Continuous miner operation control zones

The operation of the continuous miner required both the continuous miner driver and cable hand to work in close proximity to the ribs. Figure 10 provides an example of the continuous miner control zones identified in green.
