**NSW
Resources
Regulator**

INVESTIGATION REPORT

REPORT INTO THE DEATH OF BRIAN BRYANT

Grawin Opal Fields, 14 October 2020

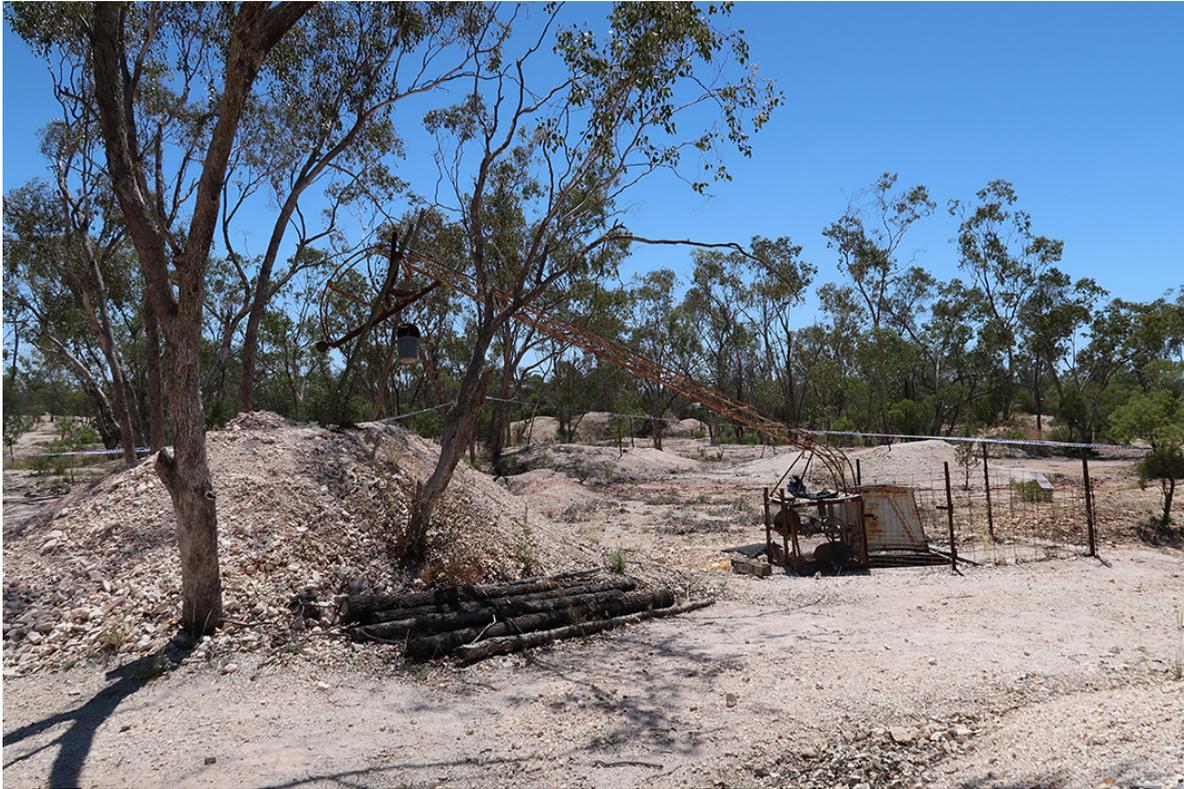
Figure 7: Hoist and opal dirt pile

The hoist was located within the main shaft on MC 51724 and used to raise opal dirt to the surface. The hoist system consisted of a steel frame and bucket guide rails, an electric motor, a hydraulic retarder, a hoist rope winder drum, steel wire rope and a steel bucket (Figures [7](#) and [8](#)). The investigation found that the hoist had been assembled using recycled components including a 30+ year-old electric motor and an agricultural spraying equipment pump.

The hoist was purchased second hand by Mr Bryant over 10 years prior to the incident from an elderly man known only as 'Gilgandra John' who died long before 14 October 2020. The investigation established that Mr Bryant was the sole operator of the hoist.

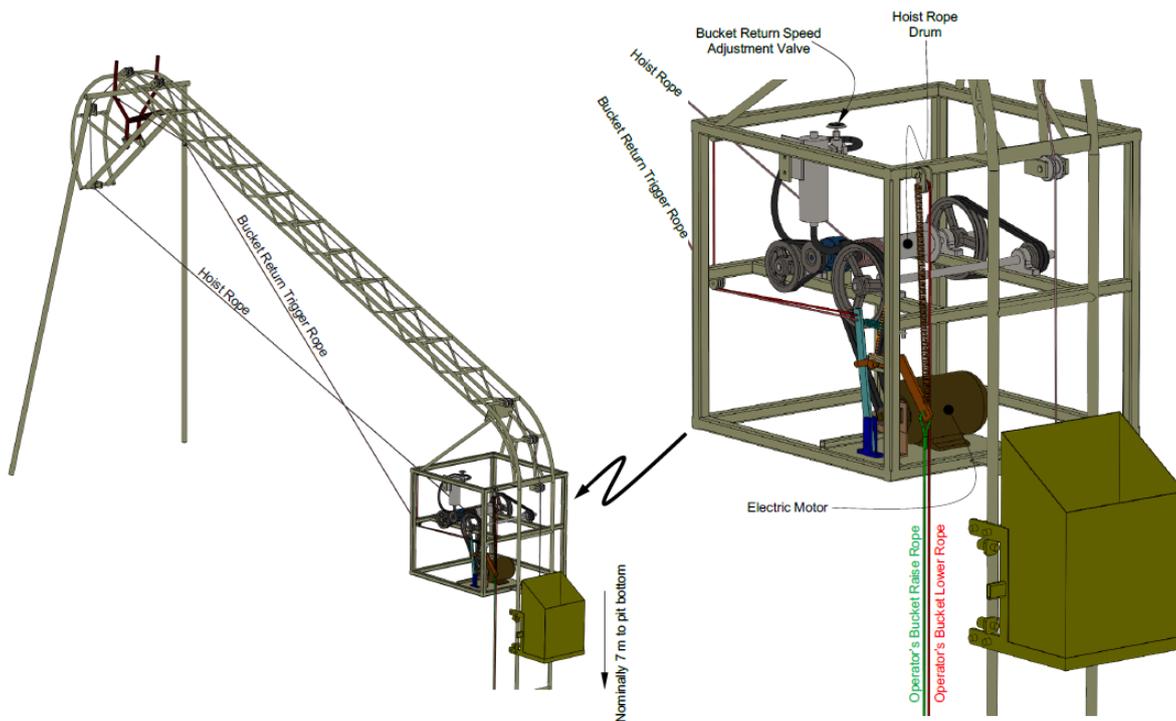
Figure 9: General view of hoist machinery cage

The steel bucket had no brake and, accordingly, there was no means to bring the bucket to rest or hold it stationary (except at the end of its travel at the base of the sump). Instead, the hoist was fitted with a retarder system to limit the bucket descent speed.

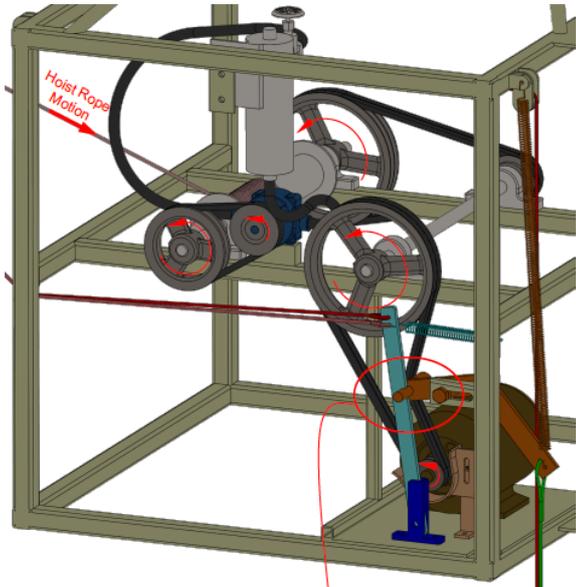
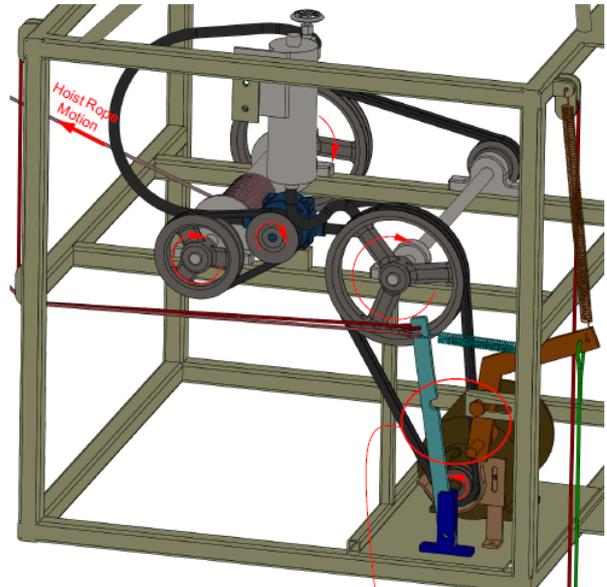
Figure 10: Hoist machinery operation

When the belt tensioner is latched into the hoist drive position, then the motor vee-belt is tensioned, and torque is transmitted to the hoist rope drum via the belt and pulley system. The hoist rope winds onto the drum and the bucket rises.

Bucket return initiates when the bucket activates the return trigger (see Figure 7) or when the operator pulls the rope shown red above. The motor continues running in the hoisting direction, but the belt tensioner is unlatched and returns by spring action to release the motor vee-belt tension (i.e., no motor torque is transmitted). The small shield around the motor pulley limits belt travel so that pulley/belt alignment is maintained at low belt tension.

The bucket descends under its own weight, but the speed of return is limited as the retarder pump recirculates fluid to the tank via the retarder valve. It should be noted that the pump runs in the wrong direction during bucket return, but this probably only influences efficiency.
