Investigation report

Report into the serious injury of a worker at Myuna Colliery

September 2022

Published by the Department of Regional NSW

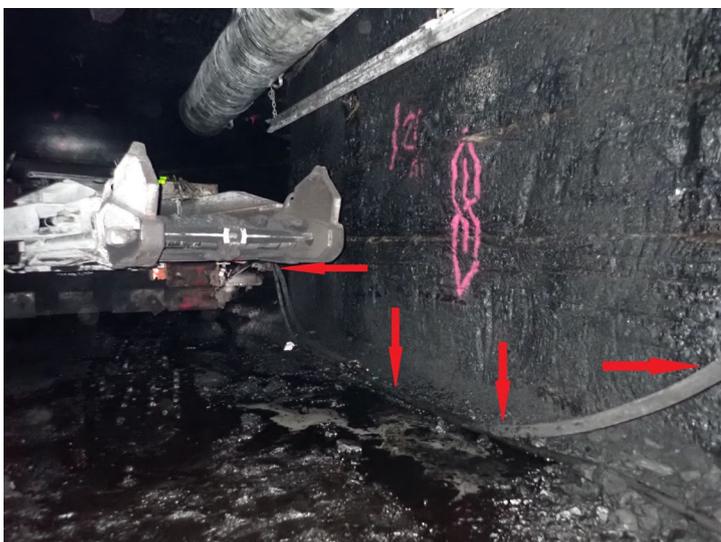
Figure 2 - Trailing electrical cable fixed to miner

CM313 was electrically powered. Power was supplied through a flexible cable that joined to CM313 at its rear right hand corner.

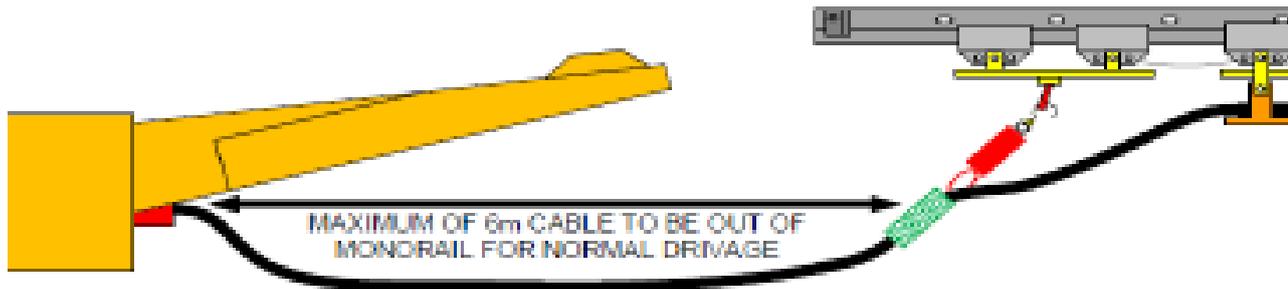
Figure 3 – Excerpt from Centennial Myuna cable training presentation

The length of the cable was managed with the assistance of a monorail system as shown in Figure 3.

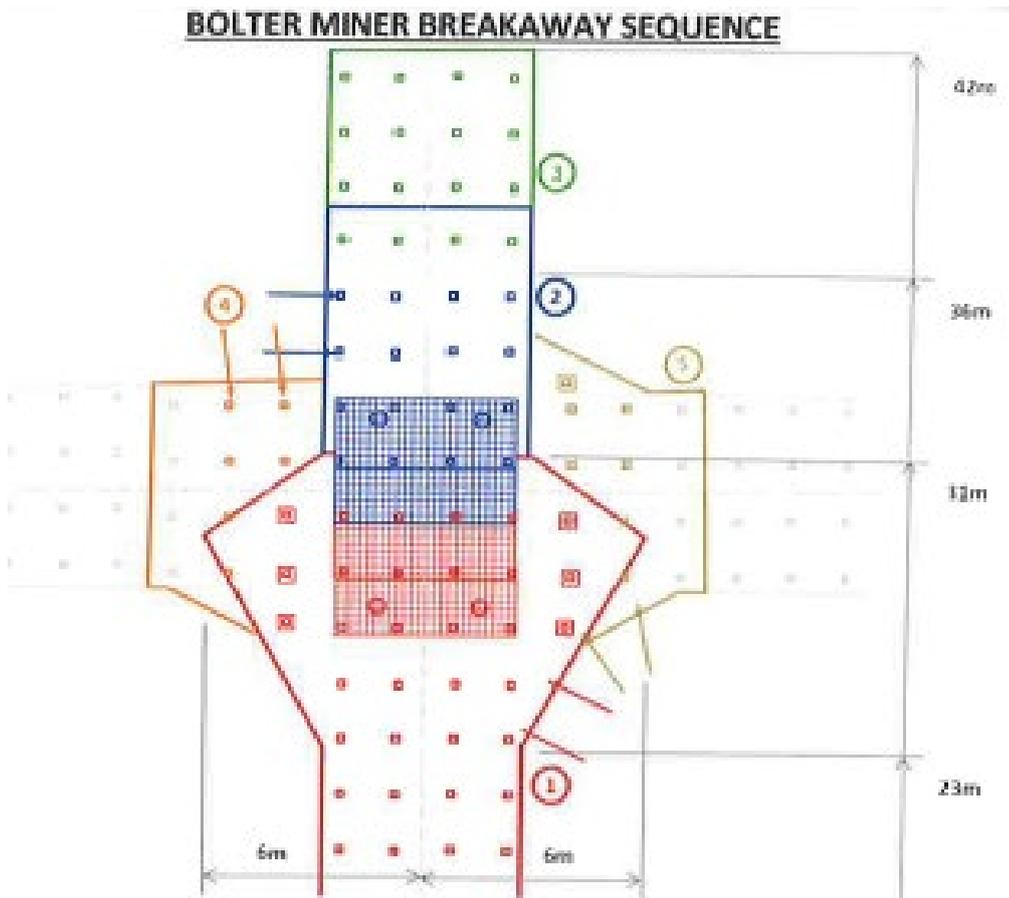
Figure 1 - Excerpt from mine's support rules

The mining sequence used to form intersections at the mine is shown in Figure 4.

While cutting coal, an issue arose on the feeder that required repair by an electrician. Had the issue at the feeder not arisen, the workers would have continued to cut coal until the cutting sequence shown in red in Figure 4 was complete. However, to advance production while the feeder was not in operation, the deputy (supervisor) instructed the workers to install roof bolts in the work area. Before starting this work, CM313's operator used CM313 to remove loose coal from the floor and loaded it into the shuttle car, which was being operated by the worker (who became injured). He parked the shuttle car at the feeder.
