**NSW
Resources
Regulator**

INVESTIGATION REPORT

REPORT INTO THE SERIOUS INJURY OF A WORKER AT APPIN NORTH MINE

8 June 2019

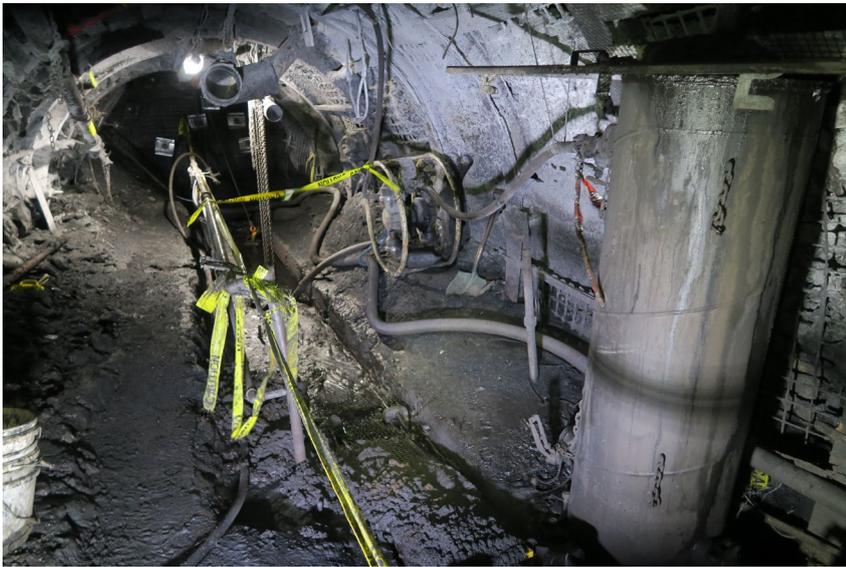
Figure 4. Concrete sump at Appin North (scraper conveyor pick up area)

The scraper conveyor is used at the mine to recover coal fines from a concrete sump, shown in figure 4, that have been washed down from belt conveyors that are located at higher levels in the conveyor system. The scraper conveyor then deposits the waste material onto the main belt conveyor to allow it to travel out of the mine. To assist in the waste removal process, the mine also uses a slurry pump to remove the waste-liquid (water mixed with coal fines).

Without the scraper conveyor in operation, the coal fines build up over time in the conveyor drift.

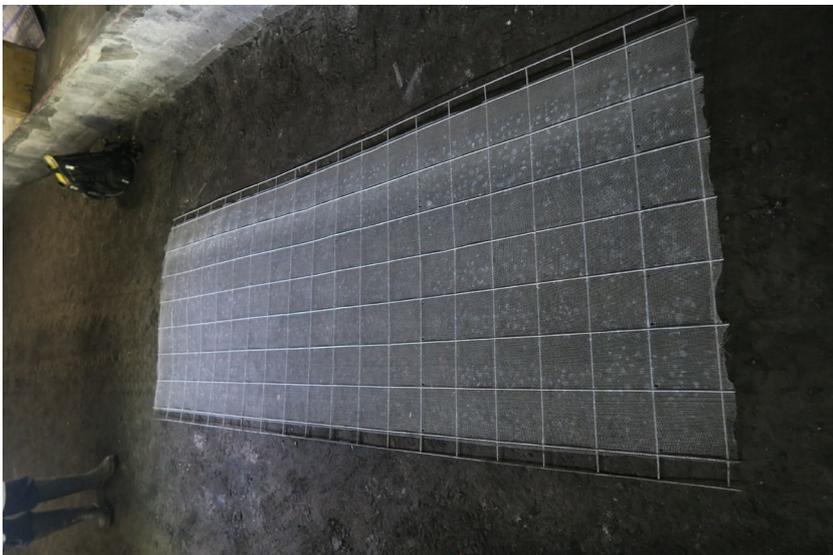
Figure 12. A sheet of tech mesh at the mine

The tech mesh that was installed on top of the yellow steel grate is made of a fine wire mesh gauze attached to a larger square steel mesh. Tech mesh is normally used to form the base for shotcreting and is also known as shotcrete mesh. An example of tech mesh is shown in figure 12.

A labour-hire worker was instructed by mine personnel from the coal clearance team to fit tech mesh to the top of the yellow steel guard as a safety control to prevent anyone putting their fingers through the holes and getting them entangled in the conveyor. This was a temporary measure while a new guard with smaller holes was being manufactured.
