INVESTIGATION REPORT

# SERIOUS INJURY

Unexpected movement of Powered Roof Support  
Ulan Underground Mine

7 December 2019

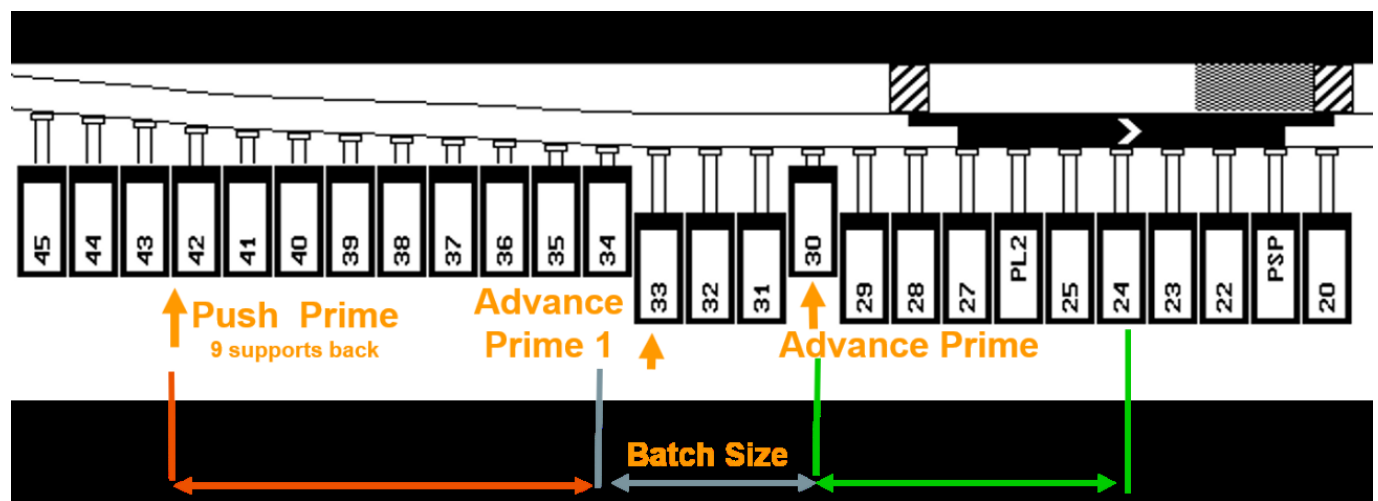
Figure 3 Longwall operating in multiple support advance mode

The shearer control and monitoring systems at Ulan Underground allow varying degrees of automation for shearer operations, with two modes of operation available when using the Shearer Initiation Control. Normally, the PRS will automatically advance in a sequential pattern following the movement of the shearer. When the shearer moves quickly multiple support advance is systematically initiated during which the advance prime will jump ahead a few supports and then a multiple advance will be activated. The batch area of supports will then advance one at a time in that area.

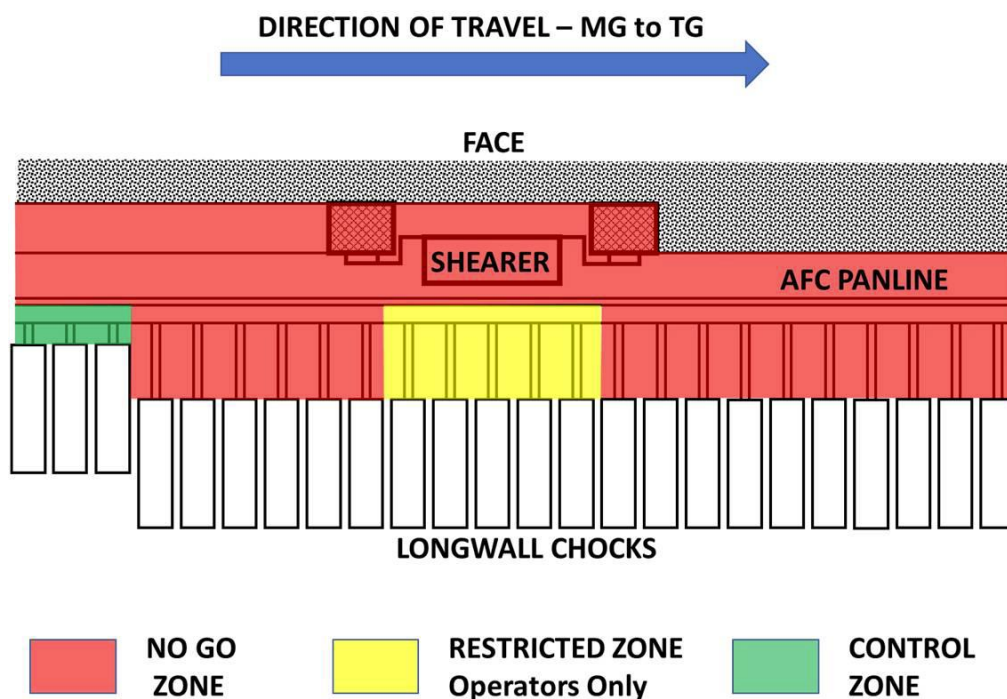
Figure 10 Longwall face access zones with shearer cutting to tailgate

2. 'No-Go Zones' where access is prohibited. A 'No-Go Zone' includes an area on or around a longwall face where there is a high risk to a person of being struck by any part of the longwall equipment if it is operated or moved to its limit either deliberately or unexpectedly.
  - a. Significantly, in the context of the incident, the area between the last advanced PRS and the trailing drum of the shearer is a 'No-Go Zone' whilst the shearer is operational. The shearer operator has responsibility for ensuring this area is clear of personnel prior to starting the shearer.
