LIEBHERR R9250 RISER DETACHMENT FAILURE AT GLENCORE MANGOOLA MINE

Report No: MTI/DS/694

Maintenance Technology Institute Department of Mechanical and Aerospace Engineering Monash University (Clayton Campus) PO Box 31 Clayton, Victoria 3800, Australia Telephone: +61 3 9903 1985 Facsimile: + 61 3 9903 2076 http://www.eng.monash.edu.au/mti/	Document No:	MTI/DS/693
	Title:	Liebherr R9250 Riser Detachment Failure at Glencore Mangoola Mine
	Client:	Glencore Mangoola Mine

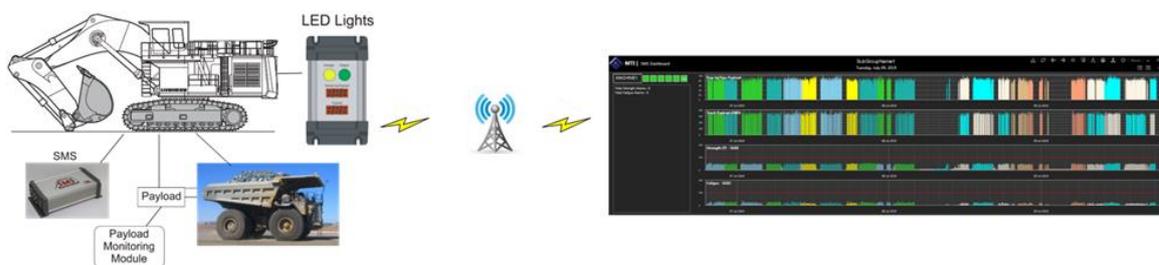
Figure 5-1: SMS provides real time feedback to operators and site management through the SMS Dashboard

The system provides real-time feedback to operators on the excavator performance with alarms set at pre-set threshold limits for strength and fatigue damage (see Figure 5-1). The system can determine the operator practices being conducted on the machine at any given time, with the feedback also displayed on the SMS Dashboard in real-time at various remote locations of the mine.

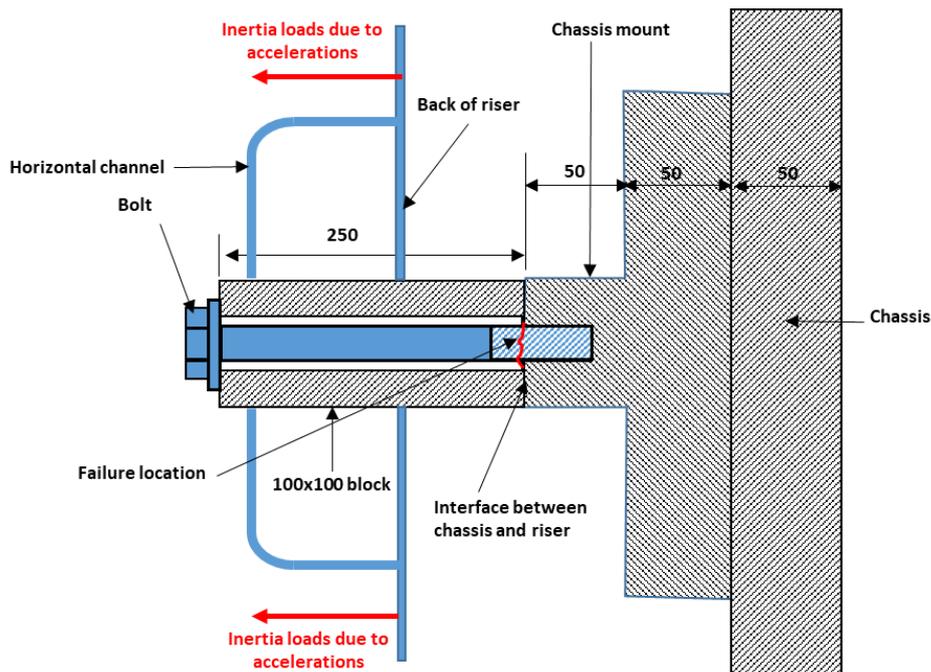
Figure 6-1: Geometry of Horizontal Bolt Connection used for Analysis

The parameters of the connection needed for the model were calculated from the geometry shown in Figure 6-1. The dimensions of the components were taken from the solid model of the chassis and the riser provided by OEM. The stiffness of the components at the connection were taken into account.

The loads applied in the form of inertia loads on the cabin in the direction shown in Figure 6-1 were considered for the analysis. They are the loads applied in the axial directions of the bolt. Although there are inertia loads in the forward and aft direction and also in the vertical direction, these inertia loads do not apply a force in the axial direction of the bolt (they cause bending in the bolt but not axial forces).

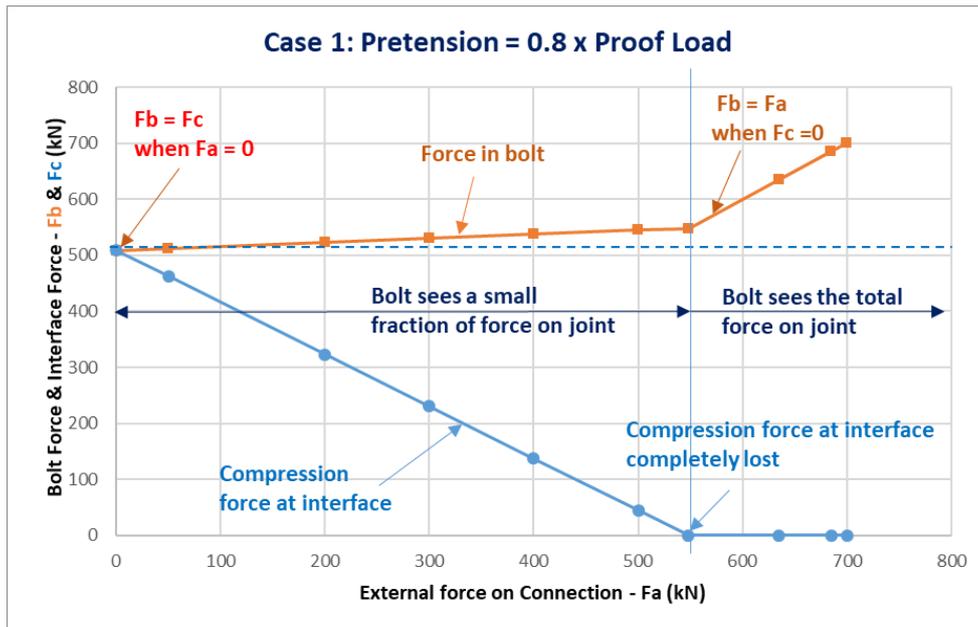
Figure 6-2: Connection Analysis – Case 1 (0.8 Proof Load)

The results of the analysis for the two cases are summarised in Figure 6-2 and Figure 6-3 below.

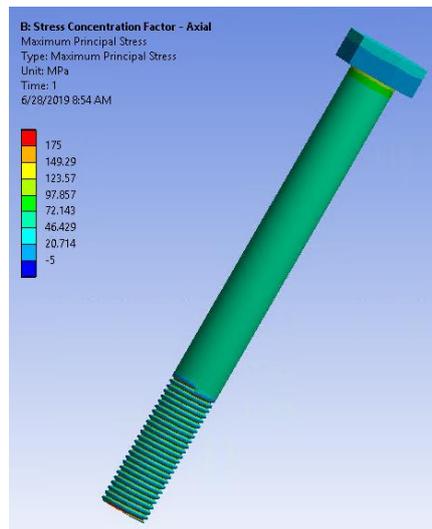
Figure 6-4: Axial load applied to M30x300 bolt to determine axial stress concentration factor

To take into consideration the increased stresses in the bolt thread notch, a finite element (FE) model of the M30 bolt identical to the attachment bolts of the riser was developed to determine the stress concentration factors due to both axial loading and bending of the bolt respectively.

A fixed load was applied in the direction of the length of the bolt, while the bottom surface of the bolt is held as a boundary condition. The ratio between the stress in the thread notch and the stress in the shank of the bolt is taken as the axial stress concentration factor. The stress concentration factor due to axial stress was applied to the stress measurements recorded by the strain gauge in each of the six instrumented bolts.

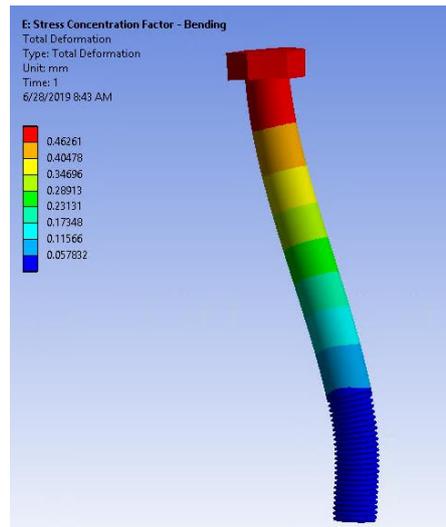
Figure 6-5: “S” Shaped bending in the bolt occurs when there is no loss in pretension stress

The recorded displacements measured by the transducers installed represent the relative movement between the chassis and the riser. Since bending stress in the bolts cannot be directly measured, the transducers were used to calculate the additional component of bending stresses induced on the bolts. The bending stress calculations are based on the formula for a solid circular cross-section and do not consider the notched geometry of the threaded section in the bolt, and the assumption is made that the 100x100 mm riser block, washer and bolt head remain bonded to each other due to friction (i.e. with no relative movement) which would result in an “S” shape bending of the bolt shown in Figure 6-5 below.

If the movement at the interface is reversing in direction, then the bolt will bend back and forth into the “S” shape causing fatigue. The maximum stresses in the bolt will then be induced at the cross section just above the attachment block – this is very consistent with the actual failure locations of the bolts.

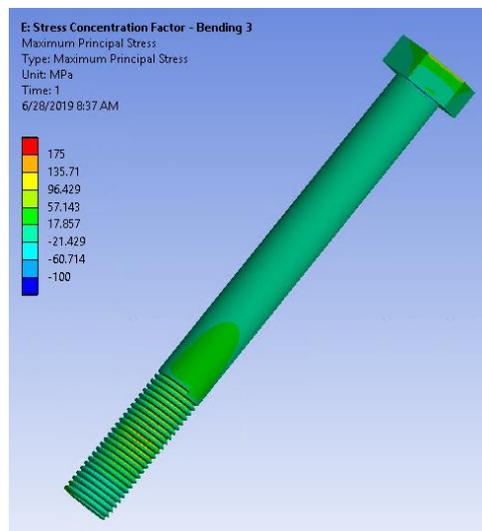
Figure 6-6: Displacement applied to M30x300 bolt head to determine bending stress concentration factor

To determine the stress concentration factor due to bending, a calculated deflection, based on SMS system measurements of the displacement transducers, is applied to the bolt head while the length of the shank between the bottom of the bolt and the point at which the interface between the chassis mount and attachment block is located is constrained. The ratio of the stress in the thread notch to the calculated bending stress is taken as the stress concentration due to the bending moment. The stress concentration factor due to bending of the bolts were applied to the calculated bending stress in each bolt.

The fatigue life calculations of the attachment bolts were completed with the factored stresses for both the axial (2.6) and bending (1.9) stress components induced on the bolts.

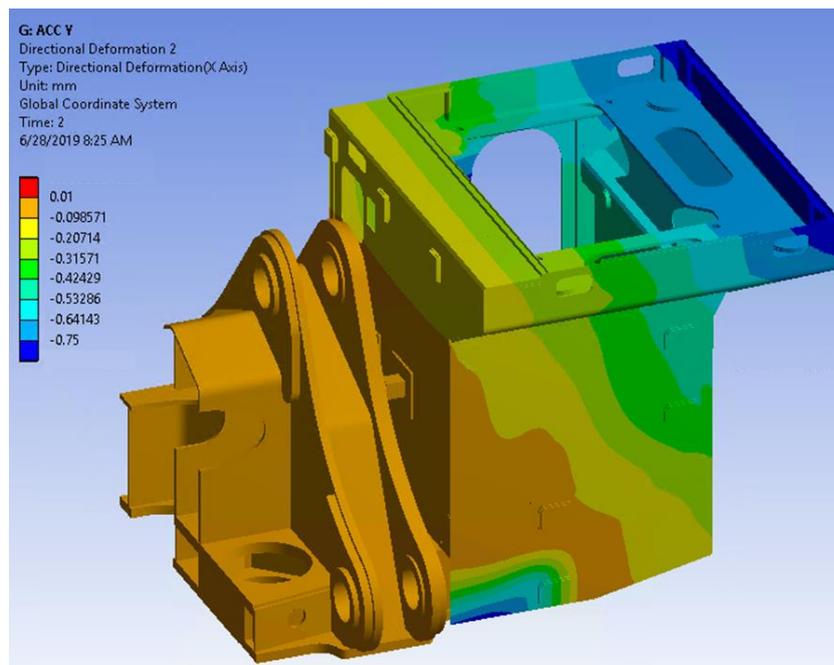
Figure 6-8: Deformation of the cabin riser in the longitudinal direction

Results from the FE model when an acceleration is applied in the forward (longitudinal) direction shown in Figure 6-8 above show very minimal displacements. This implies that an acceleration forward results in significantly minimal deflection of the riser body and walls when no loss in pretension of the bolts is assumed. The recorded measurement in the longitudinal direction of the displacement transducer also shows a very small displacement value, indicating that there is little to no relative movement between the chassis and the riser. Therefore, an acceleration in the forward direction occurring as a result of a sudden impact to the ground when a downward boom force is applied would not cause significant bending in the horizontal or vertical bolts.

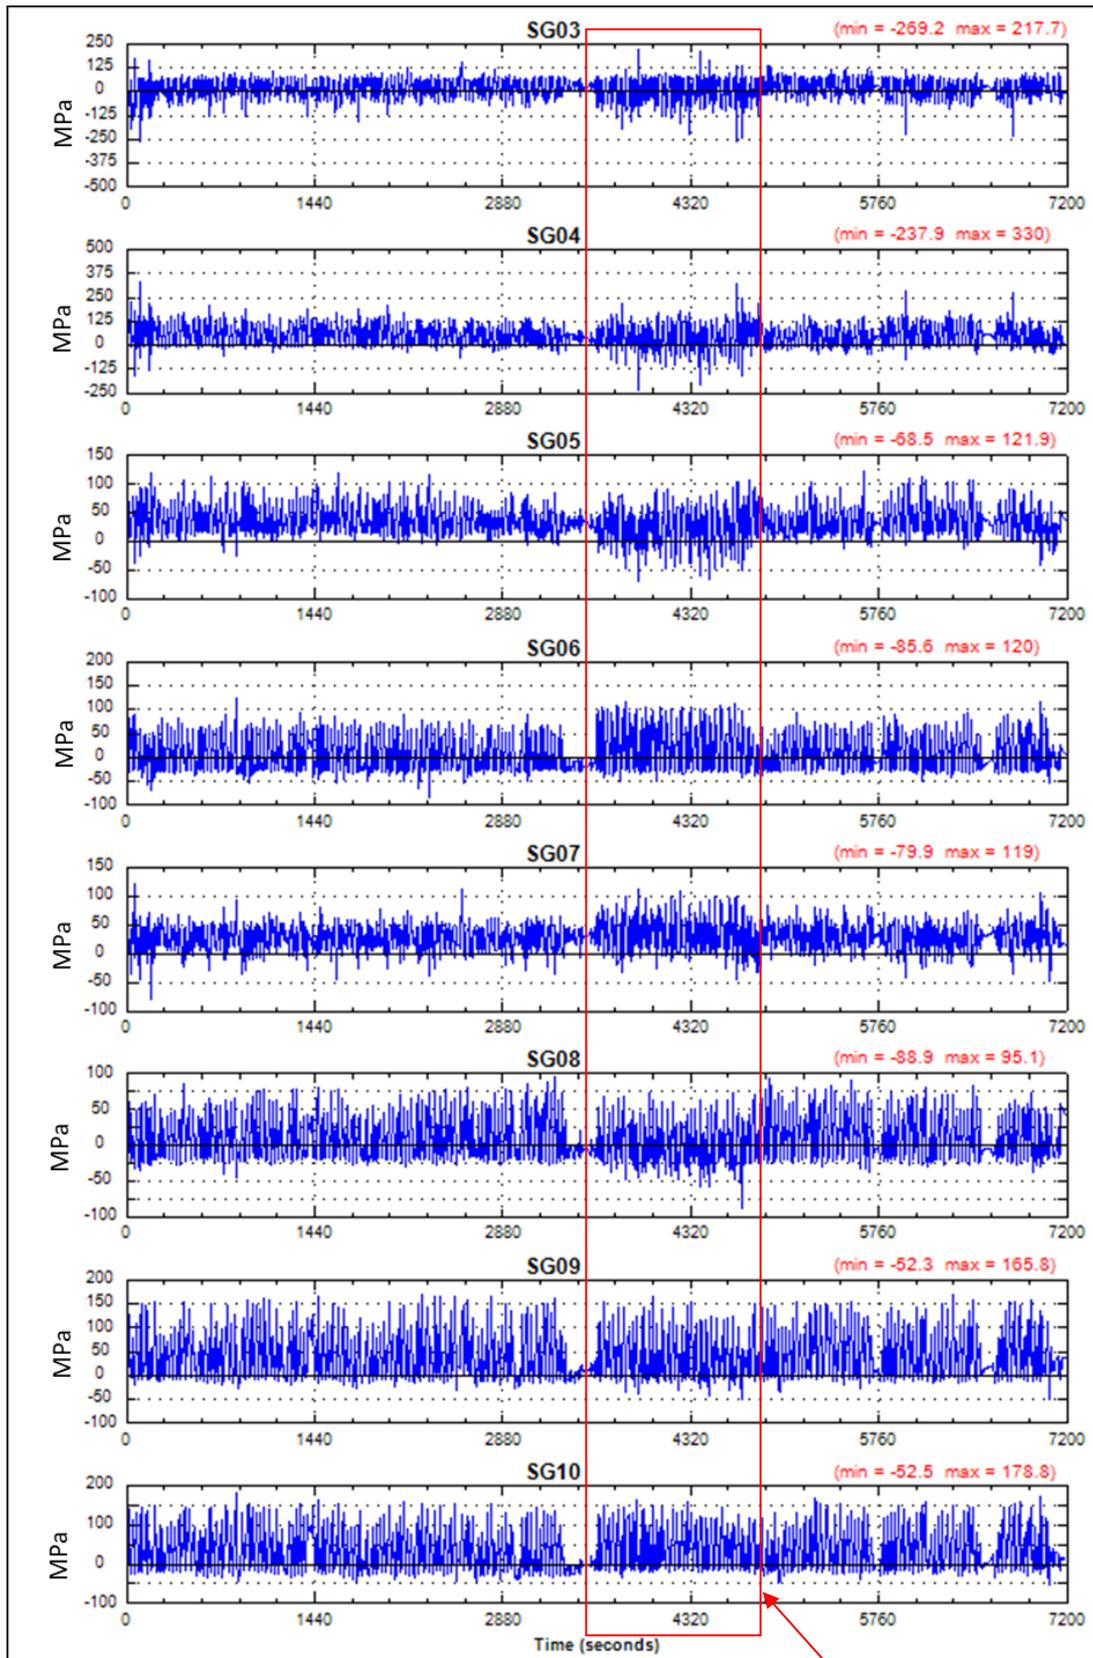
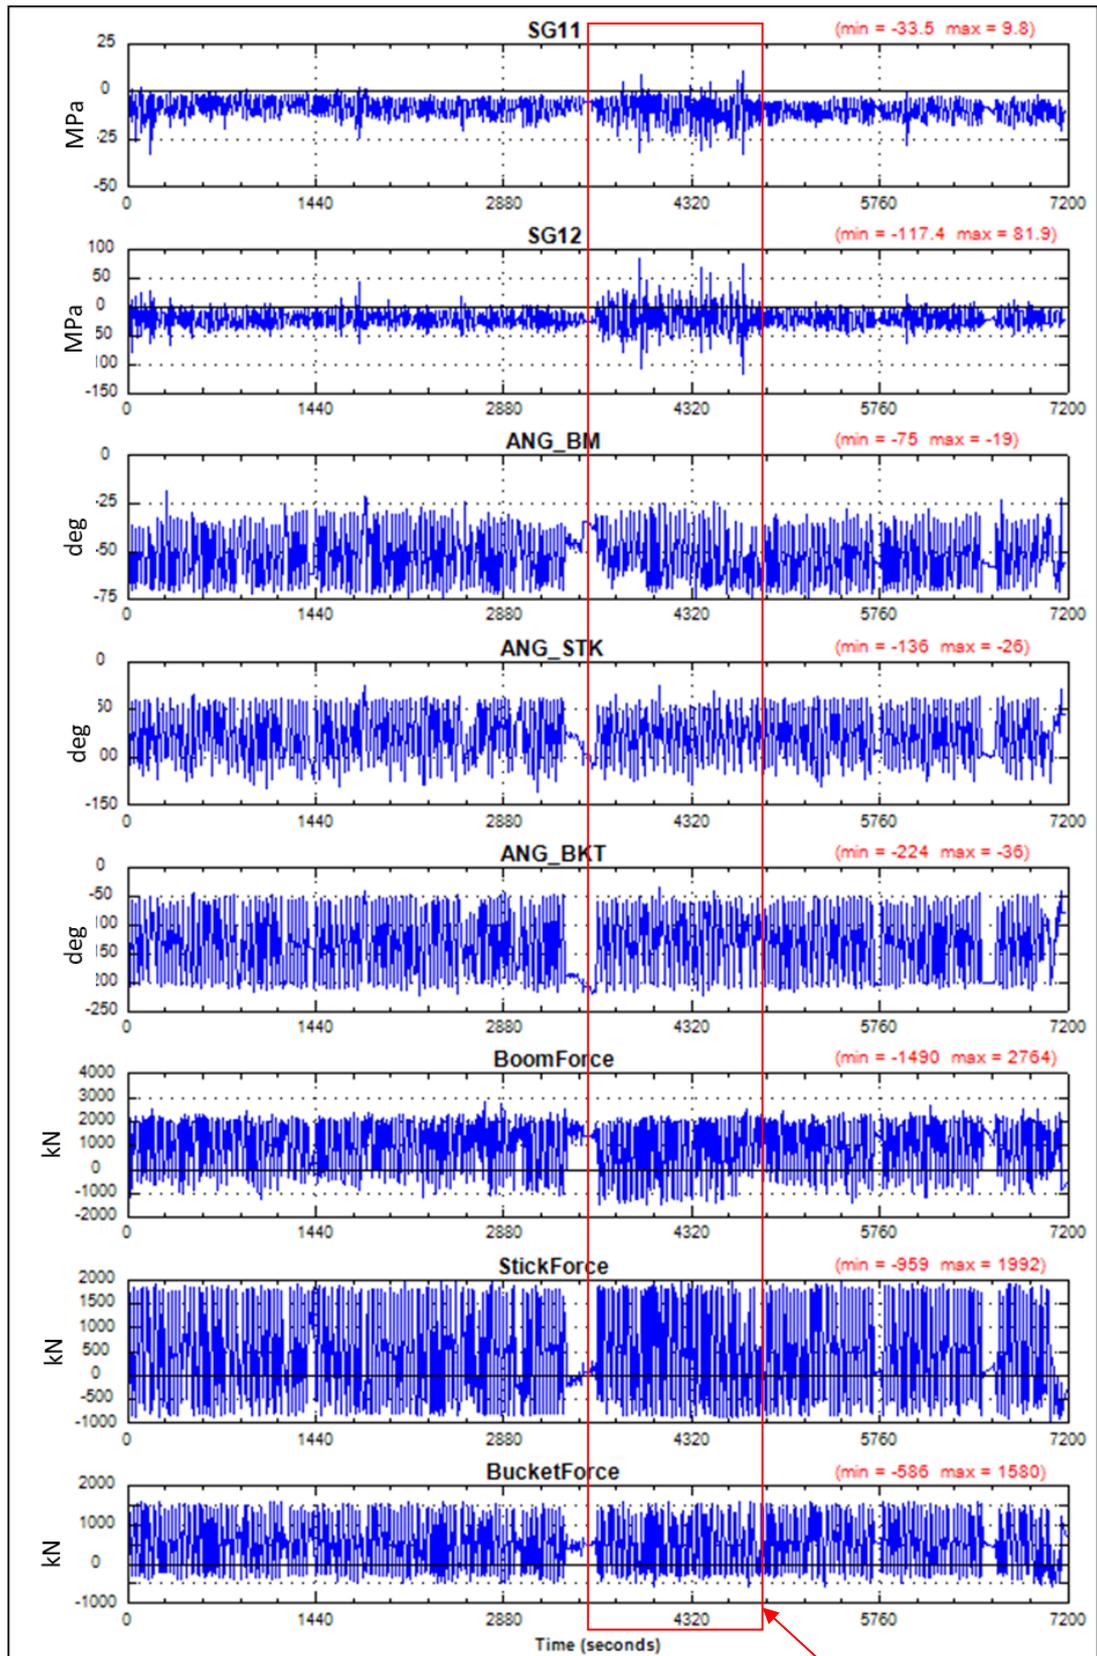
Figure 11-1: SMS Strain Gauge Data - 24th April 2019 10:00PM.

A sample of data from 24th April 2019 10:00PM is shown in Figure 11-1 and the corresponding measured data from the instrumented bolts, tri-axial accelerometer and displacement transducers are shown in Figure 11-2. The highlighted region in the data sample shows an increase in the stresses across all gauges in structure and in all the instrumented bolts compared to periods of regular digging in the other sections of the data sample. The operator was digging coal for the entire period. A detailed observation of a specific instance during this period is shown in Figure 11-3 and Figure 11-4 available in Section 11.2 of the Appendix.

Sudden impact with side load to break ground and scraping before start of dig

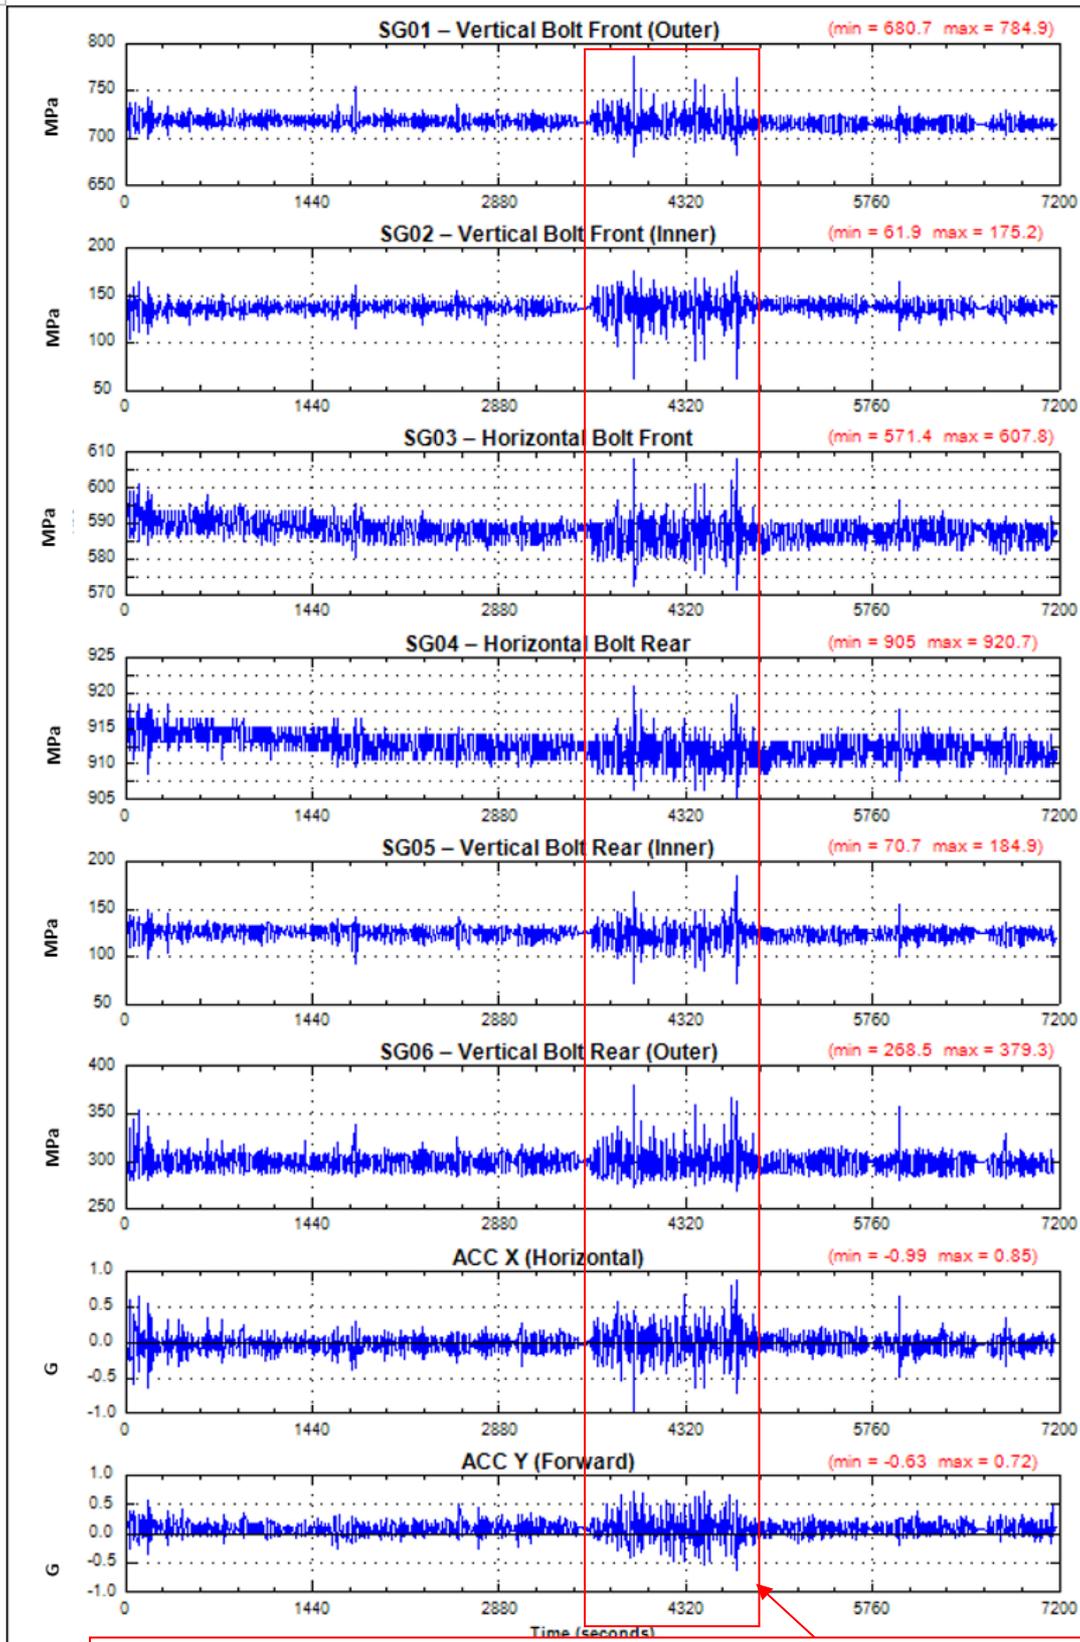
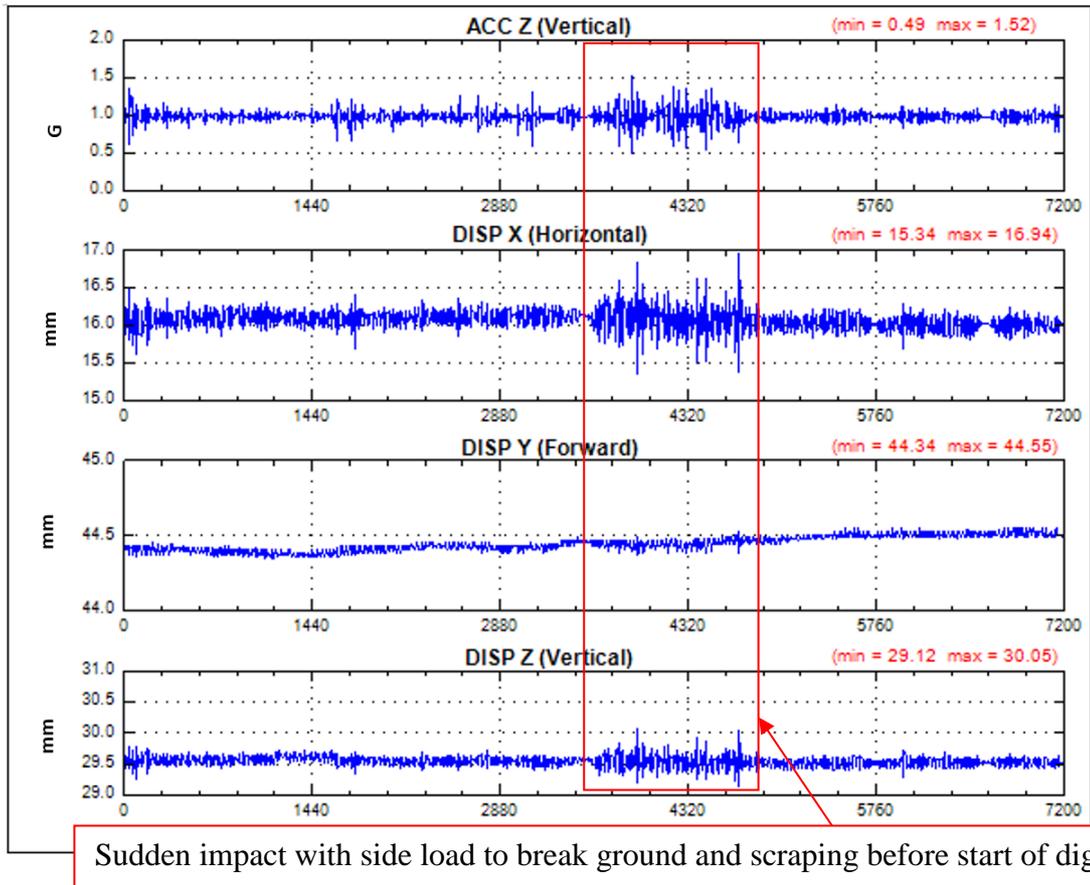
Figure 11-2: Instrumented Bolts, Accelerometer and Displacement Transducer Data - 24th April 2019 10:00PM.

Sudden impact with side load to break ground and scraping before start of dig

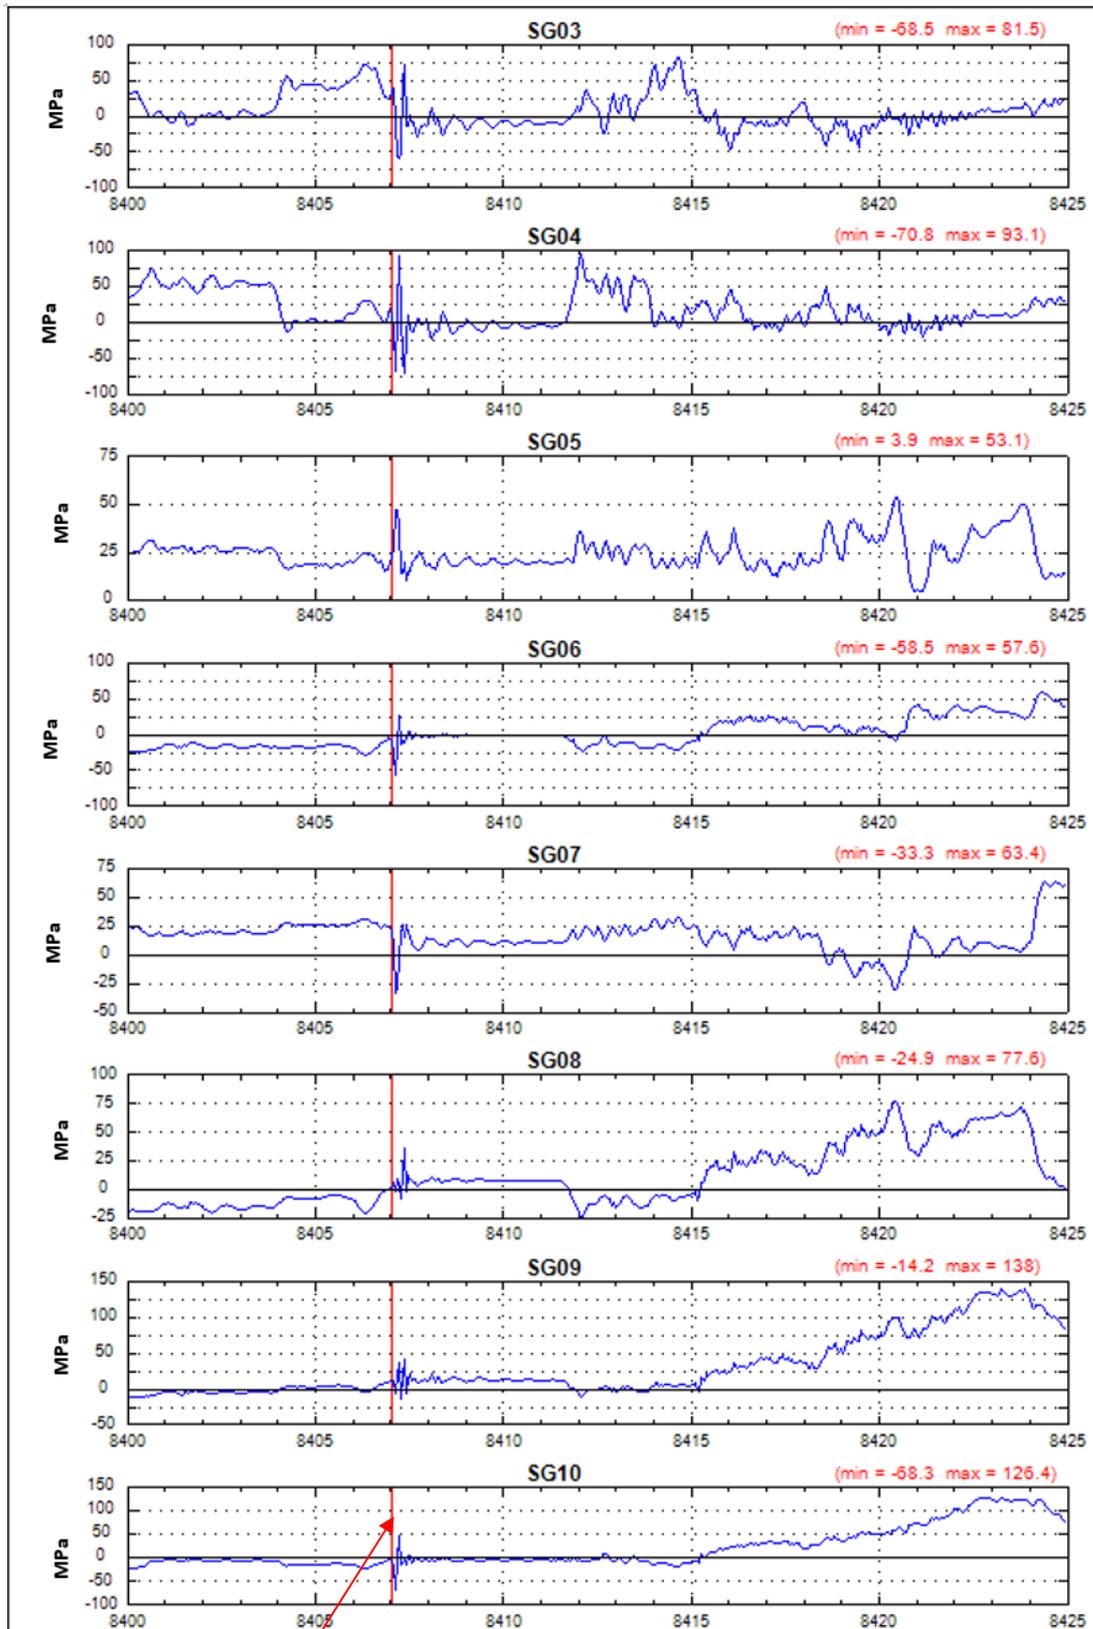
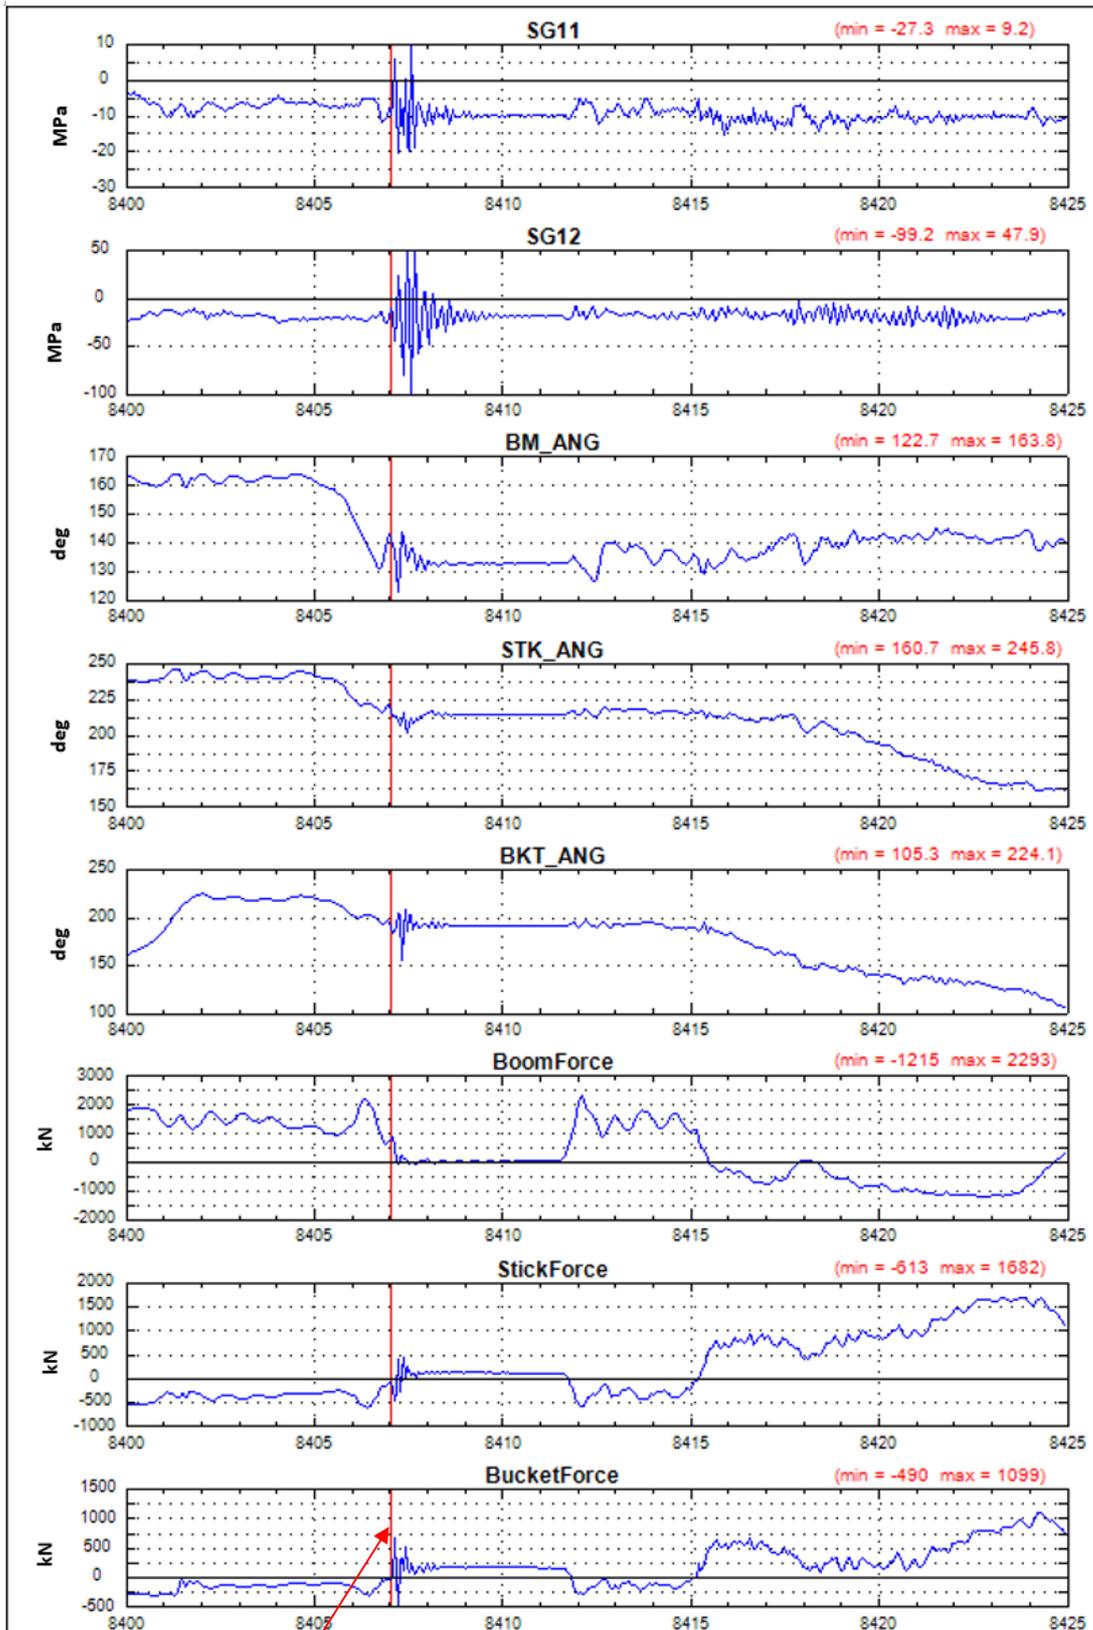
Figure 11-5: SMS Strain Gauge Data – Impact Testing 21st May 2019 9:20AM.

The sample of data from 21st May 2019 9:20AM is shown in Figure 11-5 and the corresponding measured data from the instrumented bolts, tri-axial accelerometer and displacement transducers are shown in Figure 11-6.

Sudden impact due to causing vibrations and stress reversals throughout structure

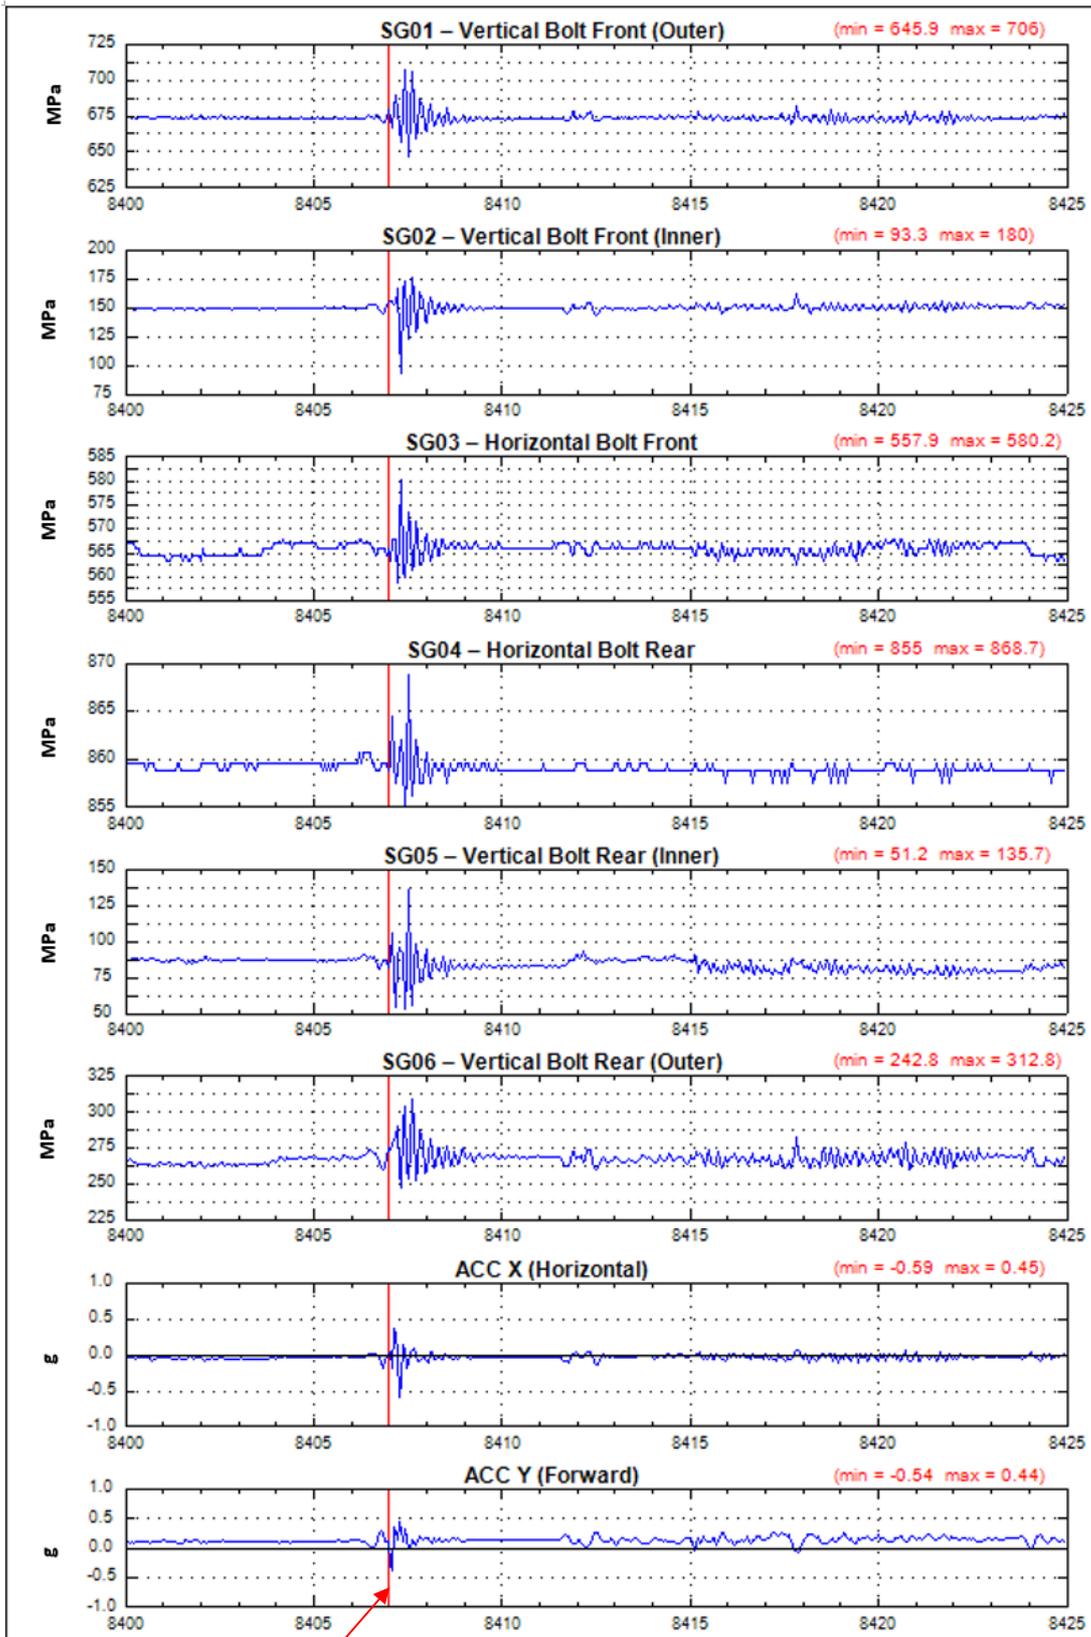
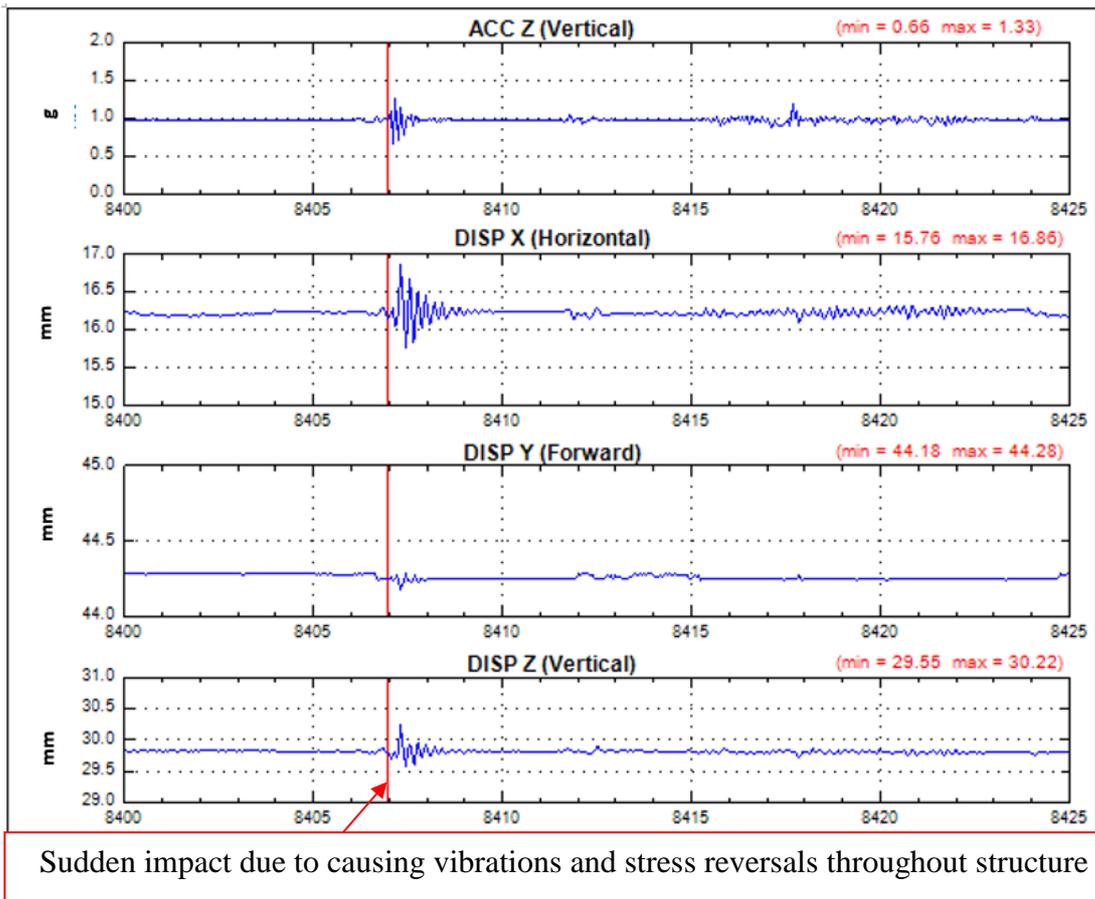
Figure 11-6 : Instrumented Bolts, Accelerometer and Displacement Transducer Data – Impact Testing 21st May 2019 9:20AM.

Sudden impact due to causing vibrations and stress reversals throughout structure

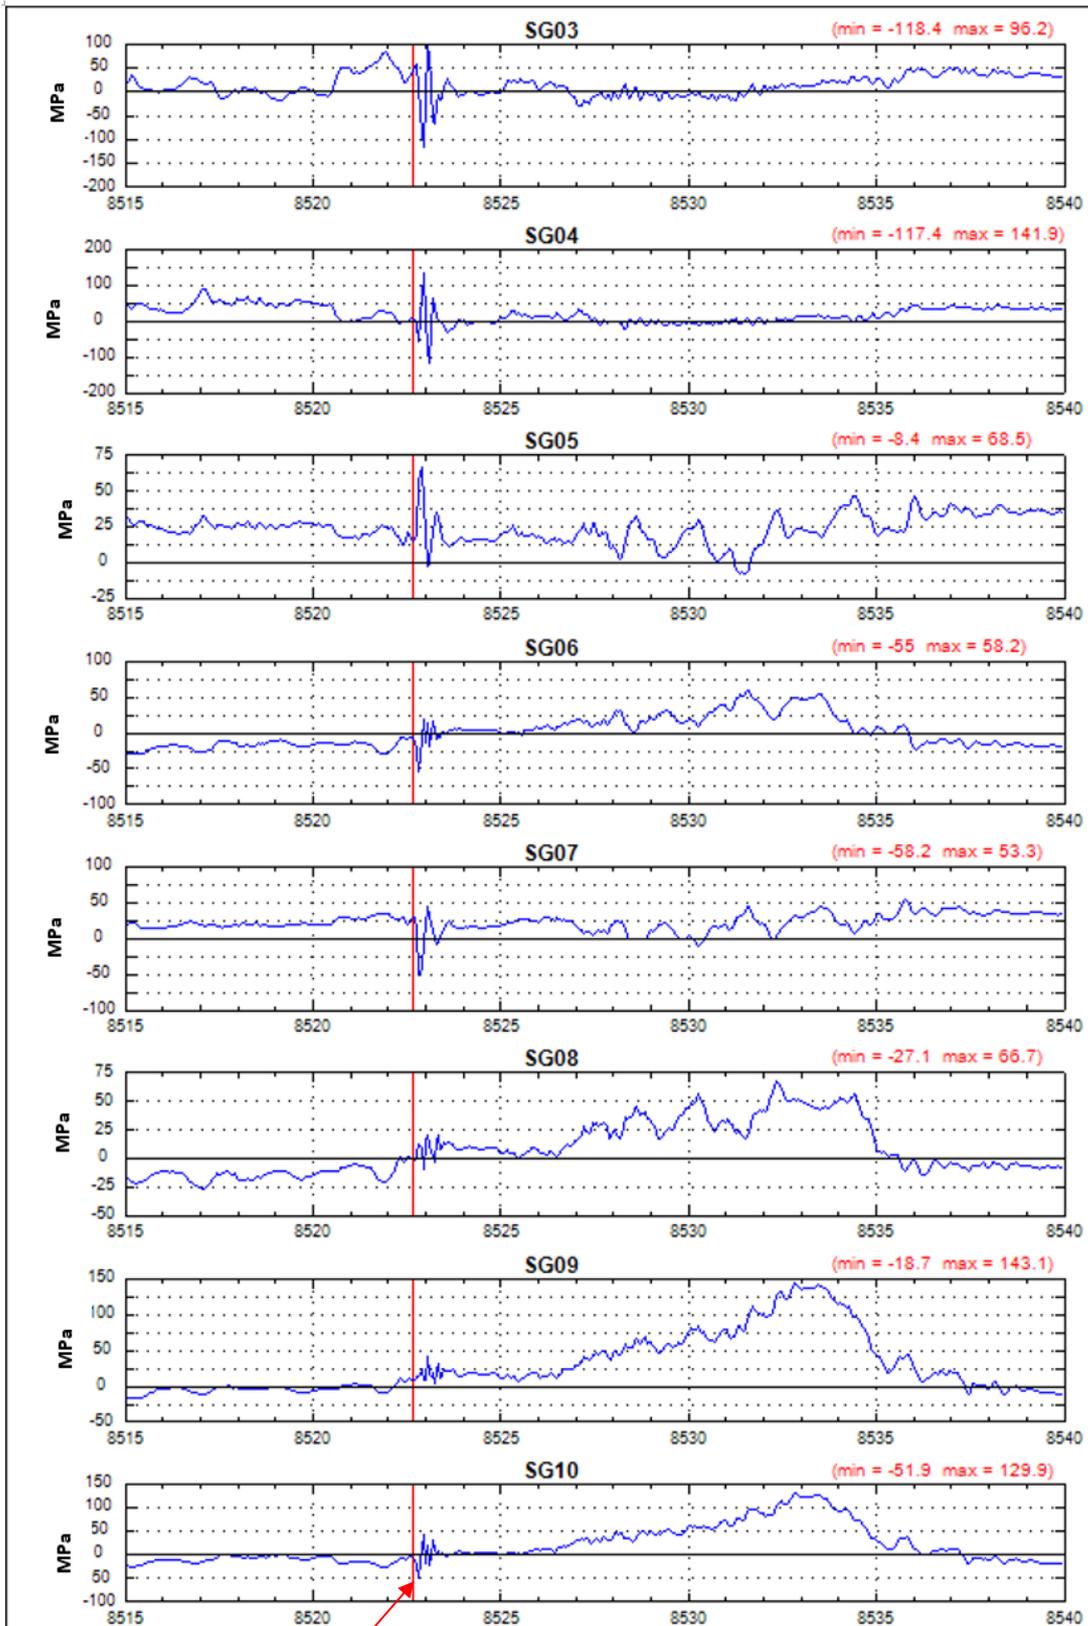
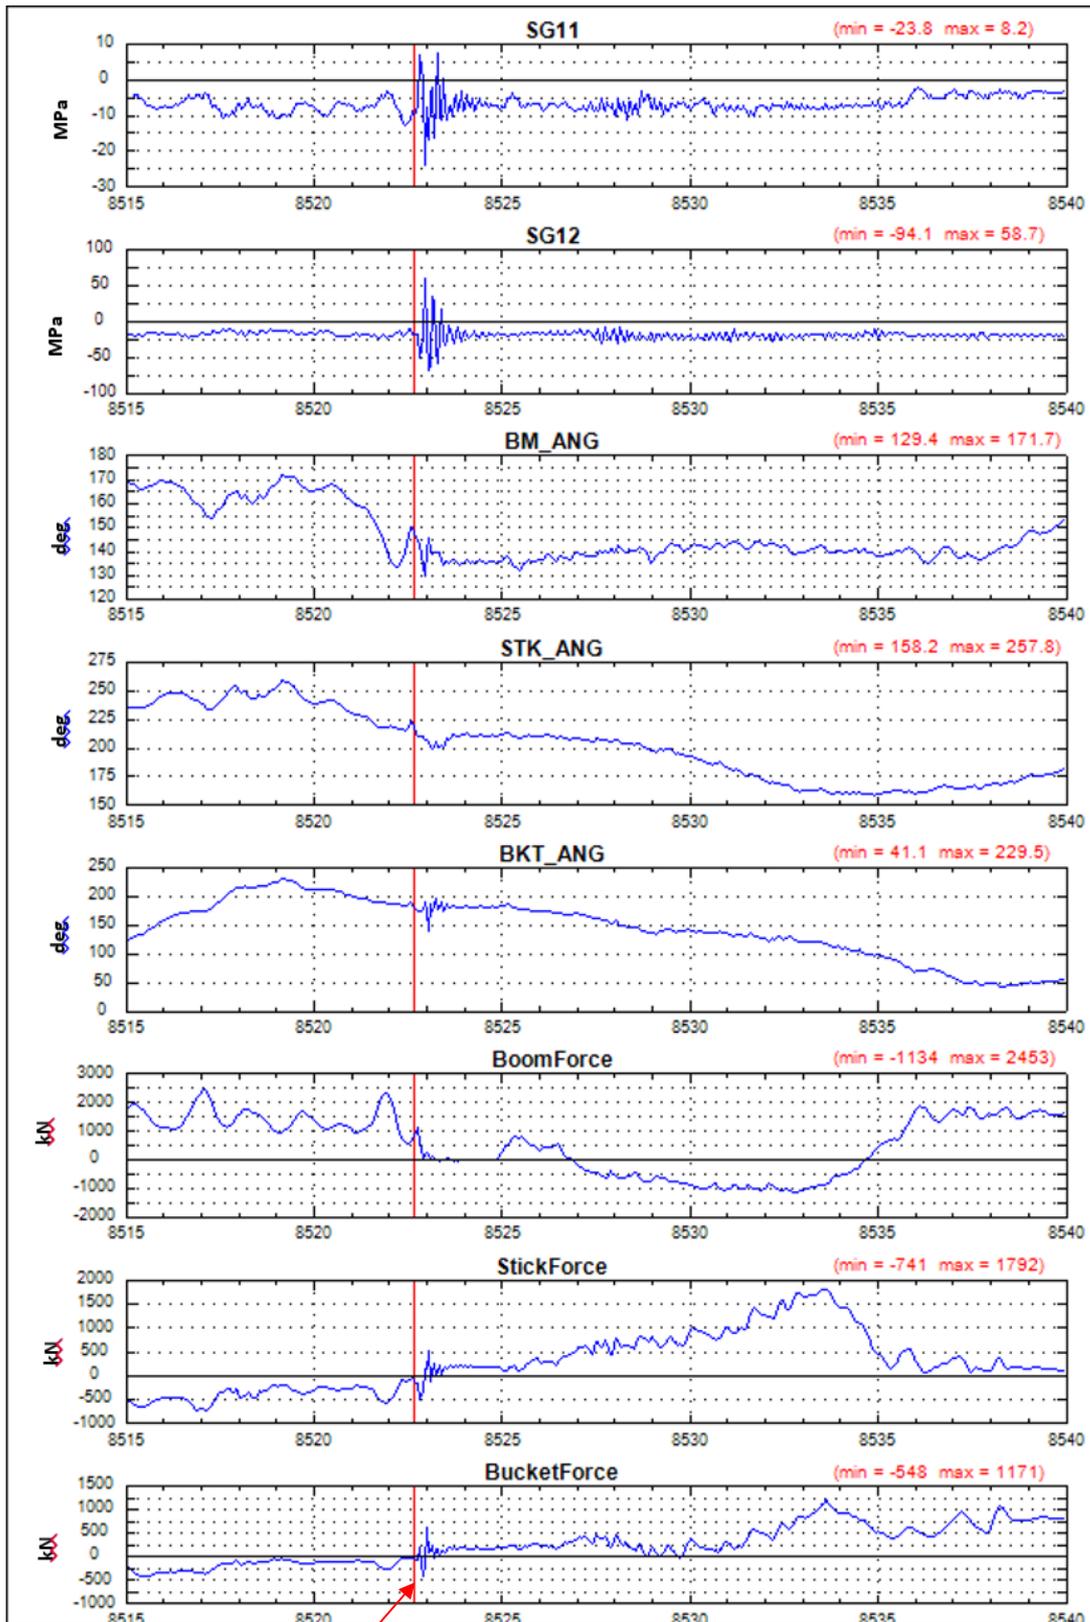
Figure 11-7: SMS Strain Gauge Data – Impact Testing 21st May 2019 9:22AM.

A sample of data from 21st May 2019 9:22AM is shown in Figure 11-7 and the corresponding measured data from the instrumented bolts, tri-axial accelerometer and displacement transducers are shown in Figure 11-8.

Large spikes showing bending due to downward boom force and side load application
