LIEBHERR R9250 RISER DETACHMENT FAILURE AT GLENCORE MANGOOLA MINE

Report No: MTI/DS/694

Maintenance Technology Institute Department of Mechanical and Aerospace Engineering Monash University (Clayton Campus) PO Box 31 Clayton, Victoria 3800, Australia Telephone: +61 3 9903 1985 Facsimile: + 61 3 9903 2076 http://www.eng.monash.edu.au/mti/	Document No:	MTI/DS/693
	Title:	Liebherr R9250 Riser Detachment Failure at Glencore Mangoola Mine
	Client:	Glencore Mangoola Mine

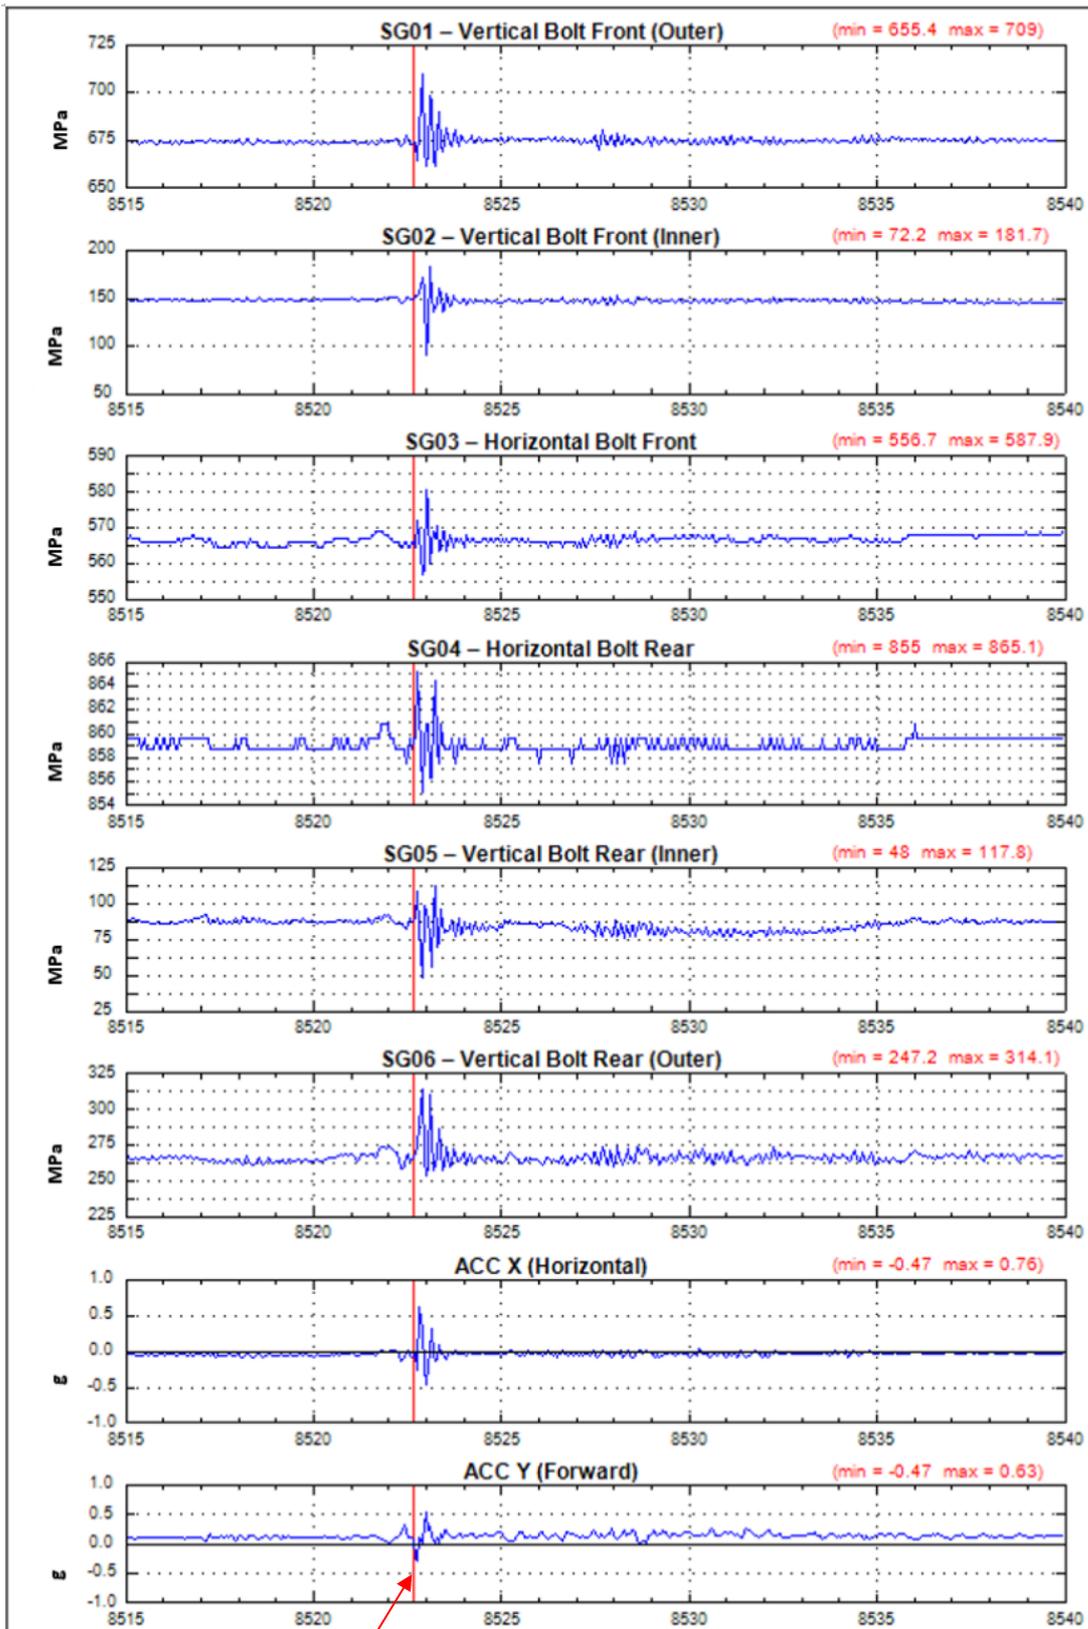
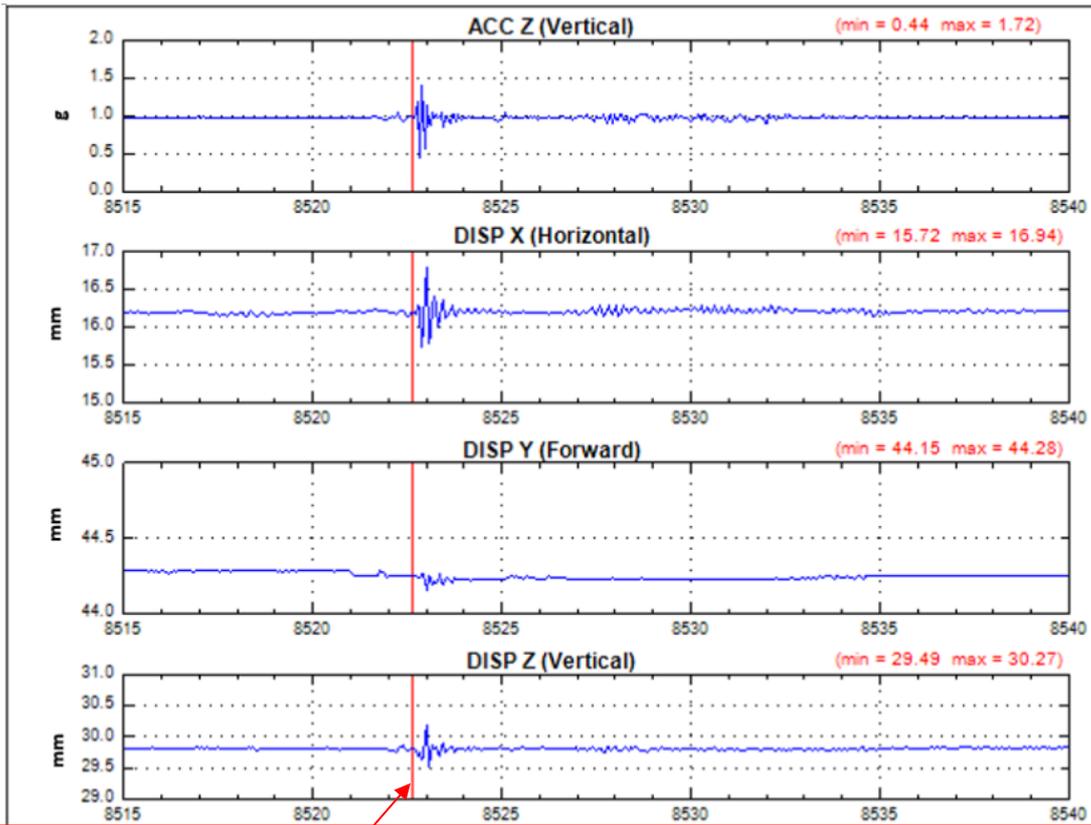
Figure 11-8: Instrumented Bolts, Accelerometer and Displacement Transducer Data – Impact Testing 21st May 2019 9:22AM.

A sample of data from 21st May 2019 9:22AM is shown in Figure 11-7 and the corresponding measured data from the instrumented bolts, tri-axial accelerometer and displacement transducers are shown in Figure 11-8.

Large spikes showing bending due to downward boom force and side load application
