CHAPTER 8

CASE STUDIES

8.1 INTRODUCTION

In this chapter case studies are presented on accidents that have occurred recently in New South Wales underground coal mines.

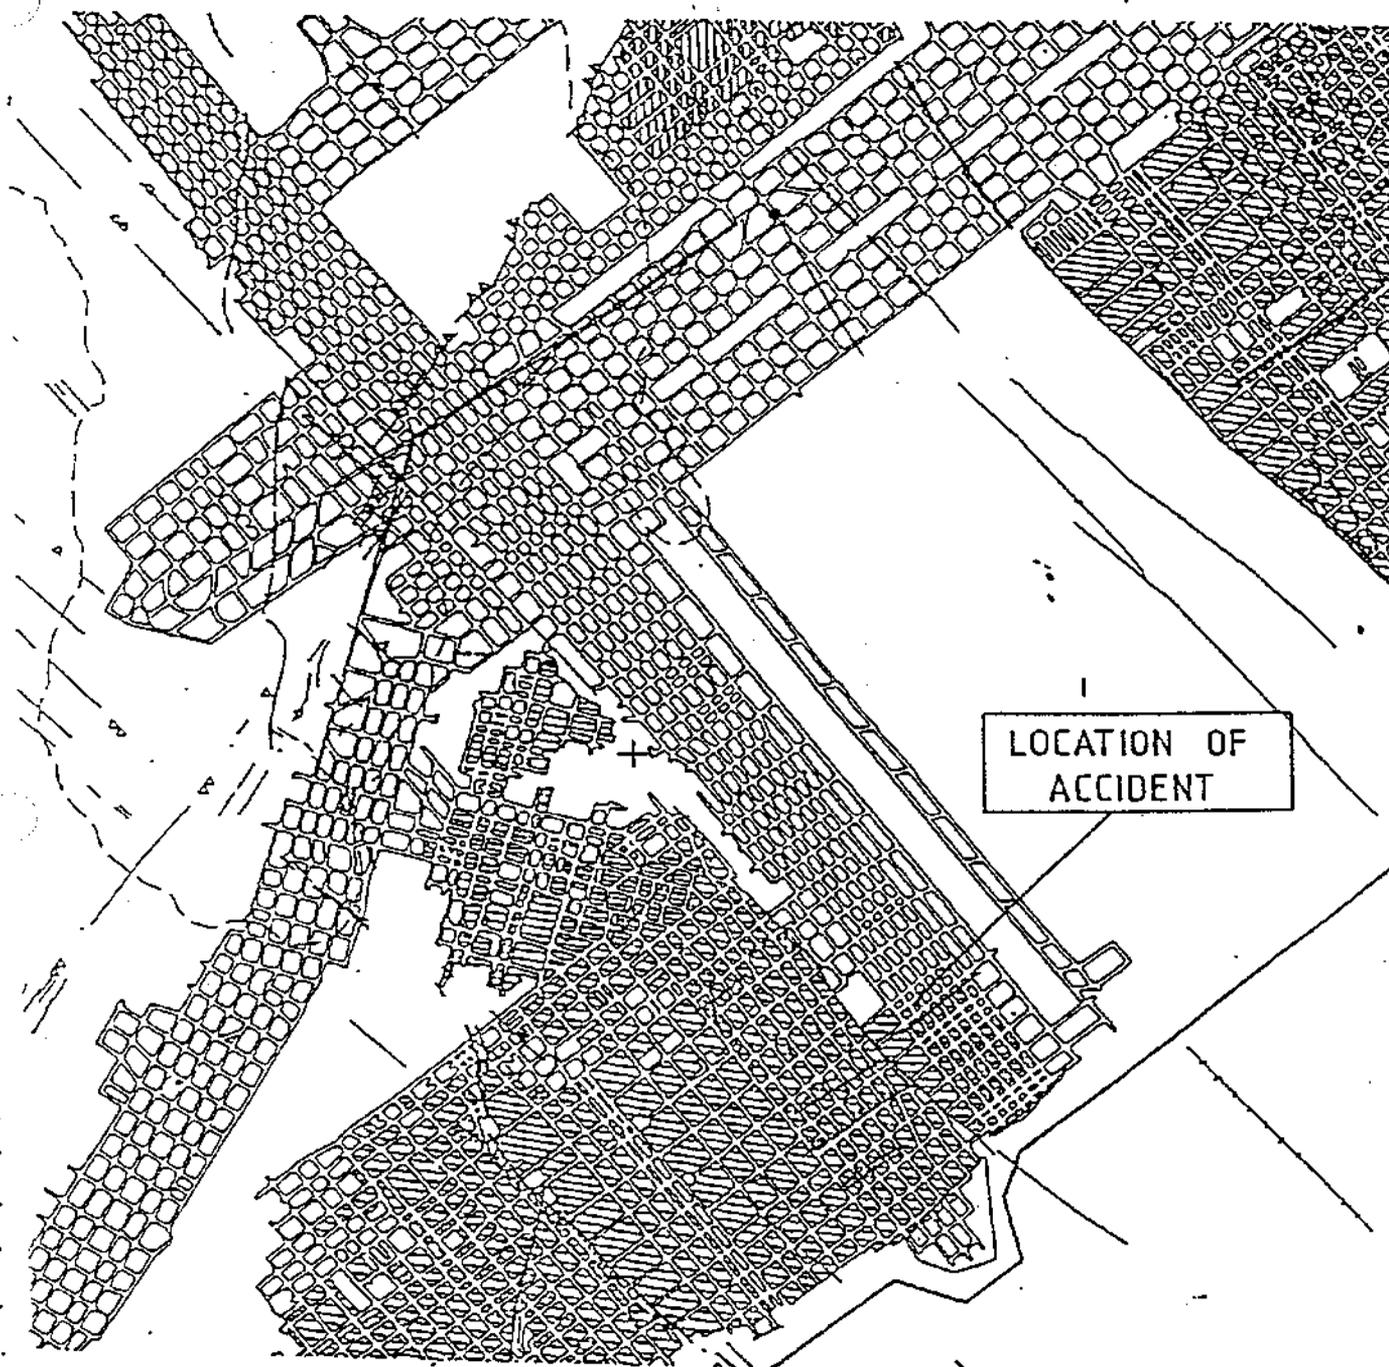
Plan 8.2

Reference to plan 8.2 shows that the panel was started adjacent to a geological weakness, (a large dyke), to help induce a quick cave. Also the plan of extraction allowed for the extension of an existing goaf, to further assist in creating an early cave and maintain goaf continuity.

On the old goaf side of the panel, considerable amounts of coal had been left adjacent to the dyke. This coal effectively prevented the two goaves from linking together. (It is also believed that more coal was actually left in the old goaf than shown on the plan).
