**NSW
Resources
Regulator**

Quarterly safety report

April to June 2021

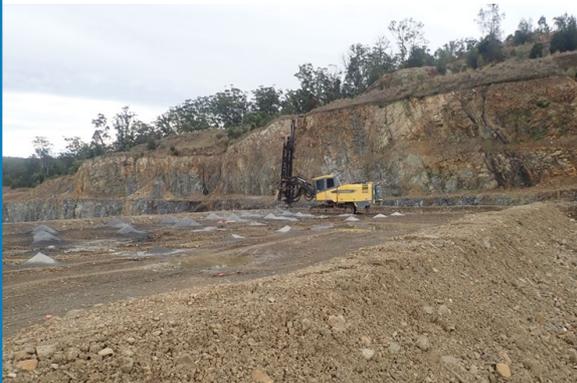
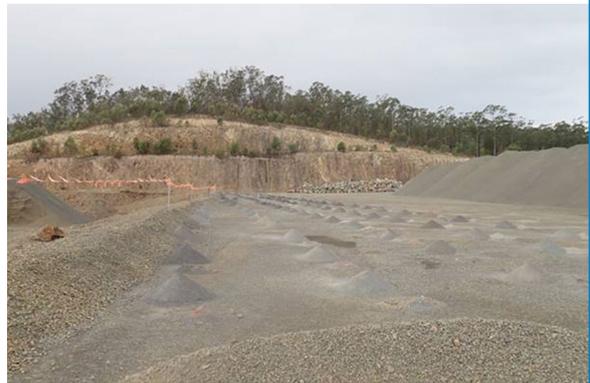
Many of the incidents reported under this hazard involve persons or vehicles falling over edges. A recent inspection at the HyTec Yarrabee Road Quarry, found the site had implemented good practice control measures when planning to conduct blasting including:

- the area was delineated by a surrounding bund to restrict access onto the bench (drilling area) to a single entry
- the edge of the highwall was protected by a bund
- the surface was well prepared and without hazards (uneven ground, pooling water)
- ‘witch’s hats’ were deployed to restrict vehicle access onto bench through single entry
- there was a designated parking spot for the driller’s light vehicle, outside of bunded area
- signage designating “blasting area ahead” posted on access roads leading to the works, as well as the shot firing area itself.

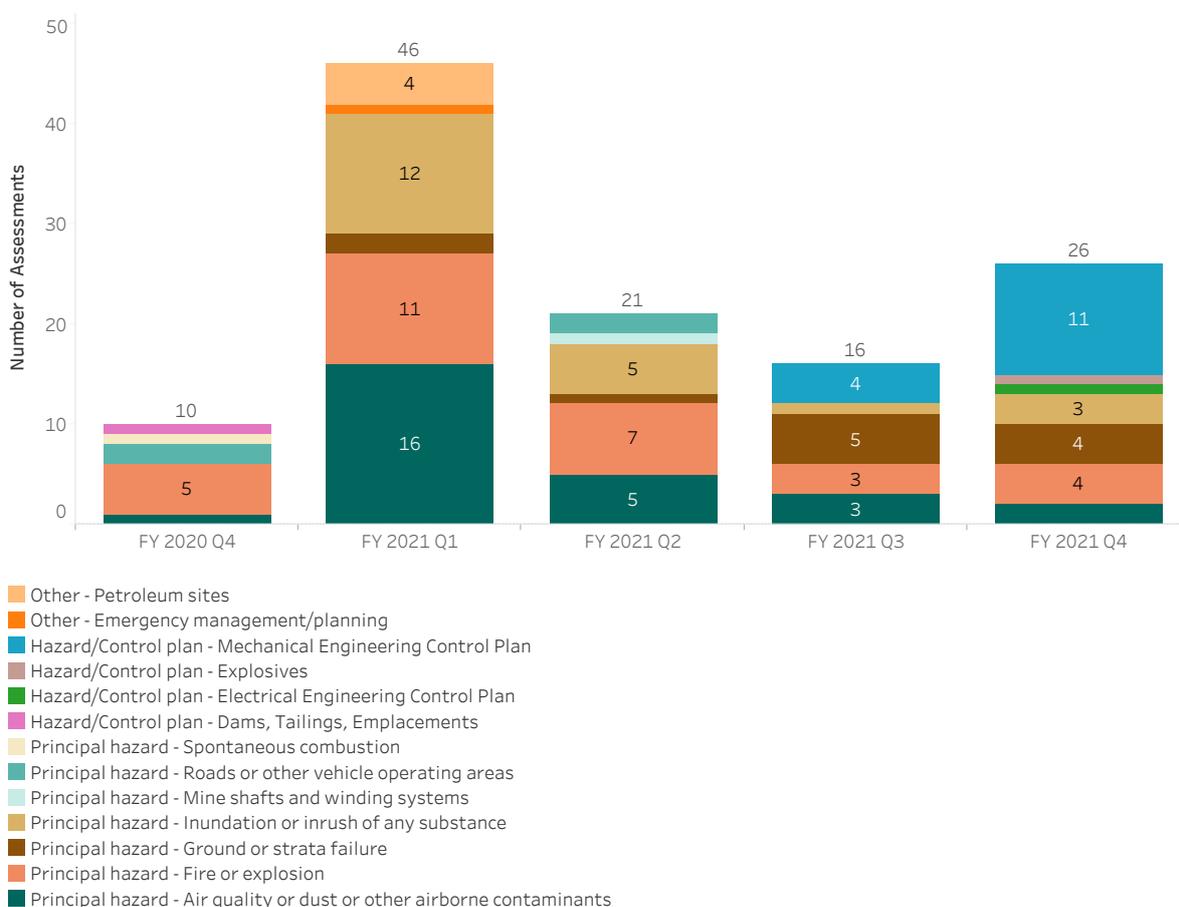
FIGURE 27. TARGETED ASSESSMENTS BY PRINCIPAL HAZARD, HAZARD/CONTROL PLAN AND OTHER APRIL 2020 TO JUNE 2021

This quarter, targeted assessments focused on entanglement hazards as managed within mechanical engineering control plans.

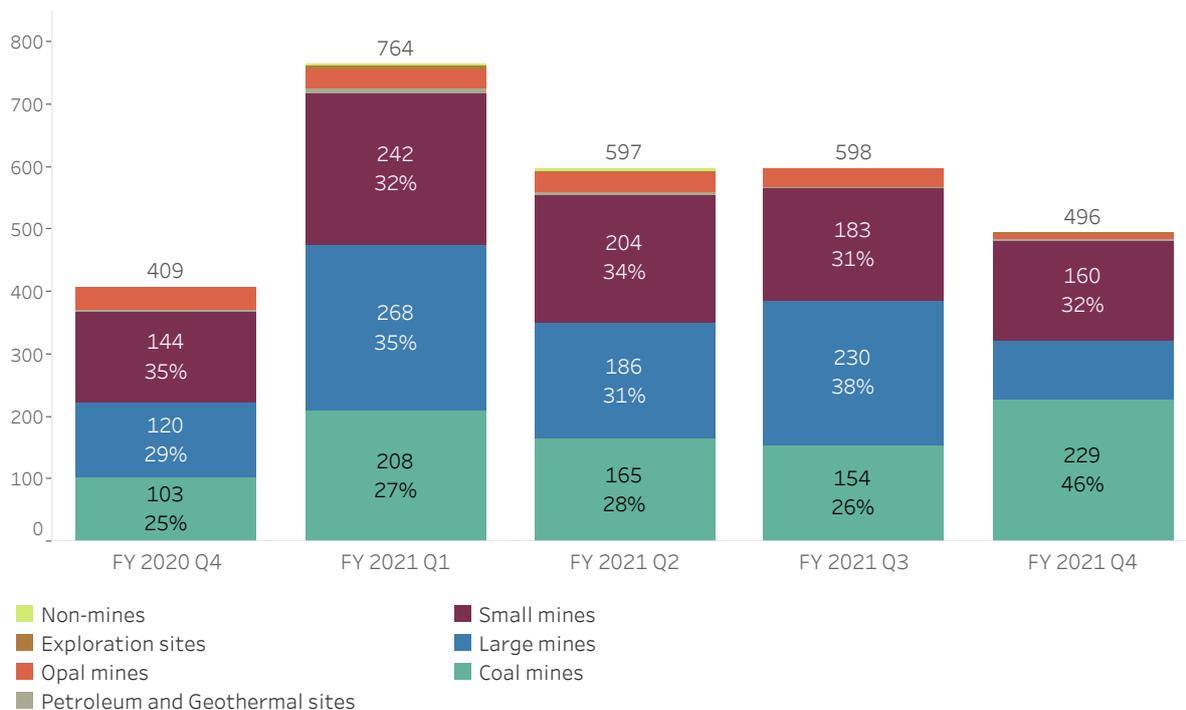
FIGURE 31. SAFETY NOTICES ISSUED BY SECTOR APRIL 2020 TO JUNE 2021

This quarter saw an increased number of safety notices issued in the coal sector which corresponded to the increased number of assessments undertaken in the sector.
