**NSW
Resources
Regulator**

FIRES ON MOBILE PLANT

April – June 2021

This report has been prepared by the NSW Resources Regulator for the NSW mining industry, original equipment manufacturers and suppliers. It contains quarterly data of notified incidents involving fires on mobile plant (FOMP) between 1 April 2021 and 30 June 2021.

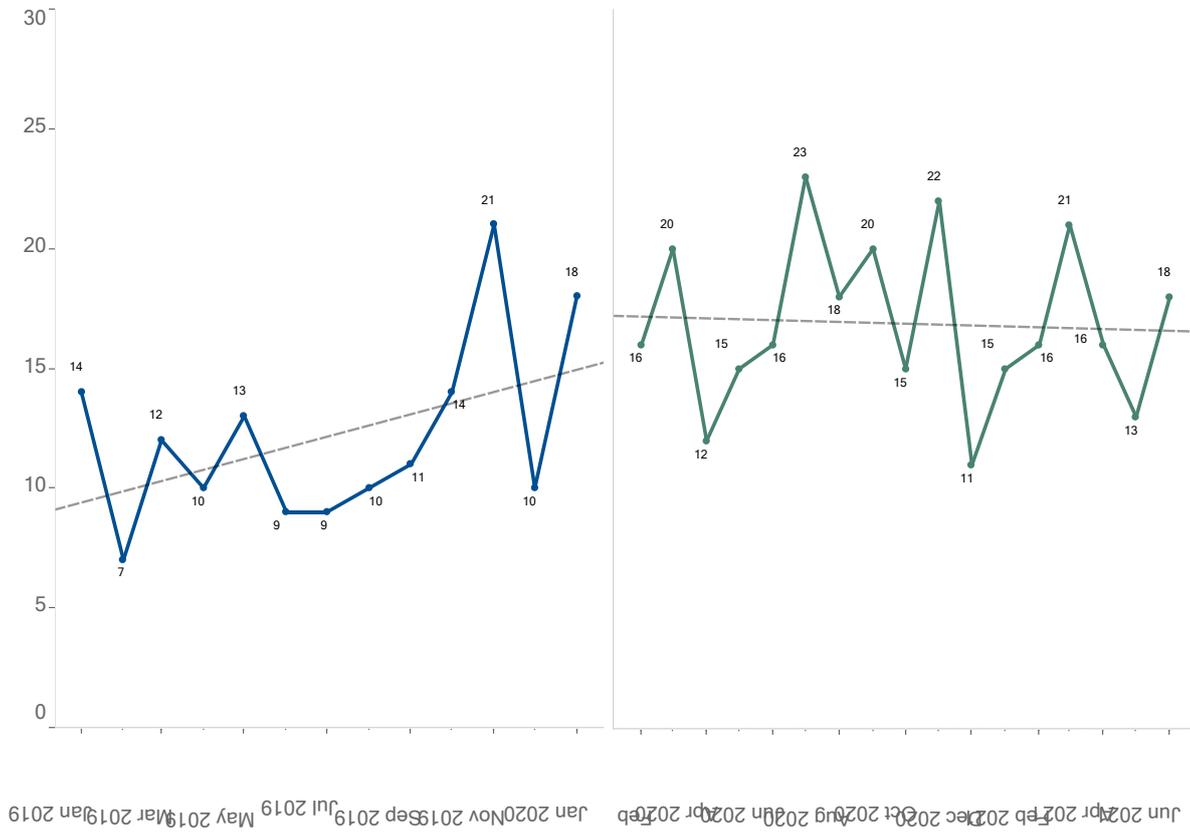
Figure 1: Notified incidents between 1 January 2019 and 30 June 2021

While notifications in June 2021 were up five from 13 in May, an overall slight decline in notifications can be seen since the legislation was amended in February 2020.

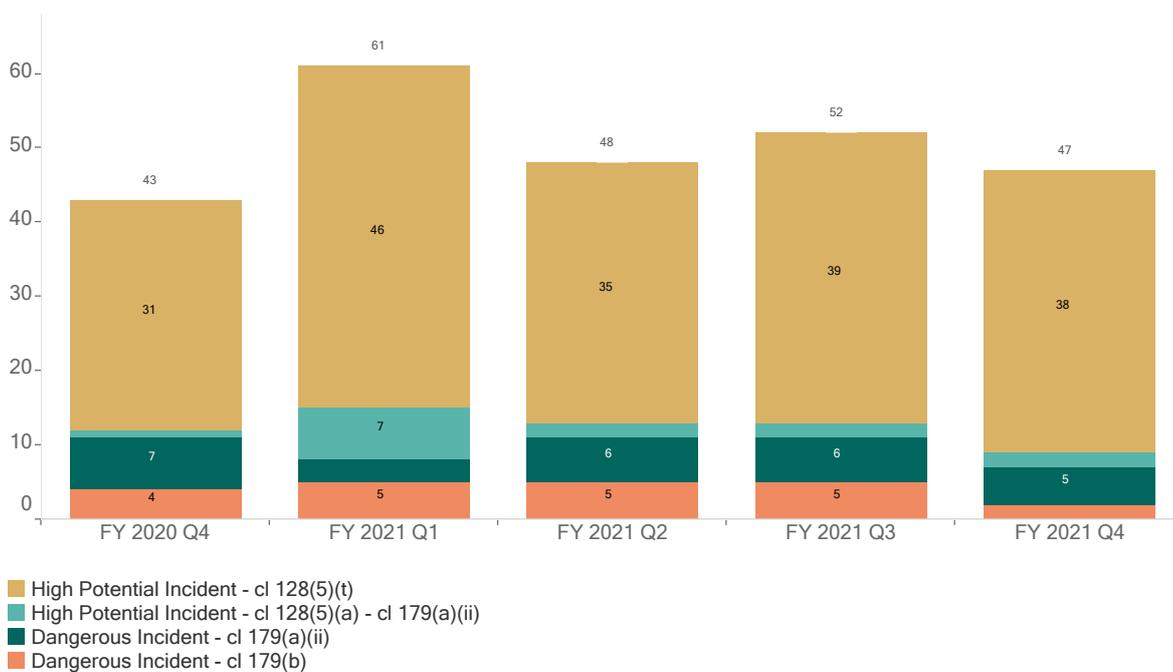
Figure 2: Notified incidents by legislative requirement to report between 1 April 2020 and 30 June 2021

The chart below highlights the number of notified incidents recorded by the legislative requirement to report.

Five incidents were recorded this quarter as a dangerous incident under cl 179(a)(ii) where there was ‘an uncontrolled implosion, explosion or fire’.

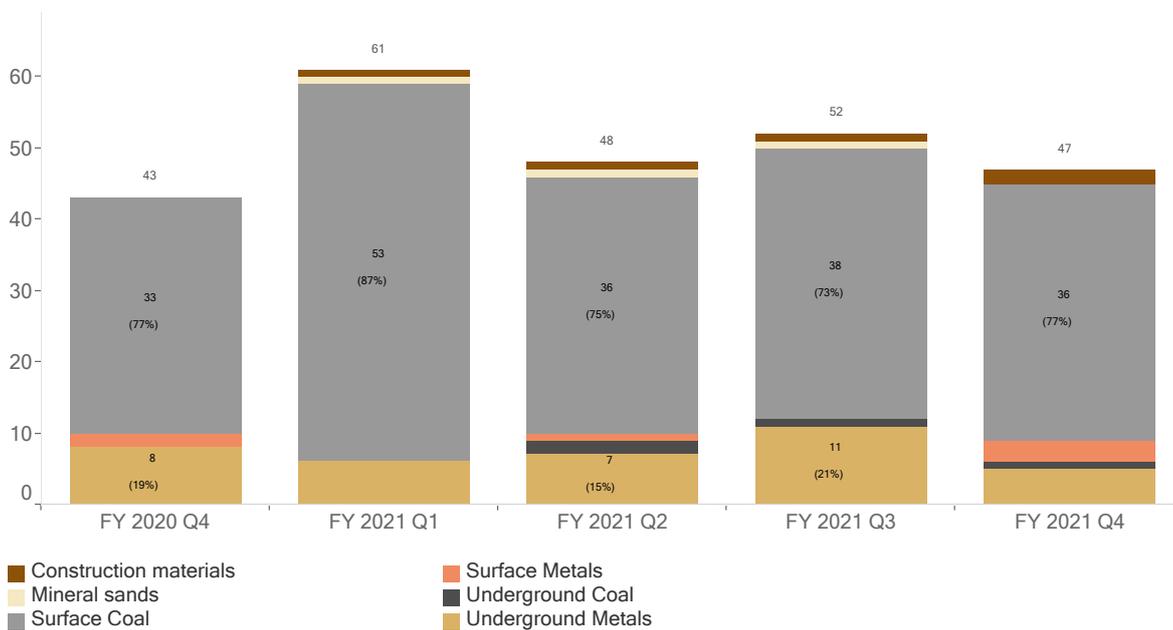
Figure 3: Notified incidents by mine and operation type between 1 April 2020 and 30 June 2021

The chart below shows the number of notified incidents by mine type and operation type.

There was an increase in notified incidents occurring at mines categorised as surface metals, from zero notifiable incidents in FY 2021 Q3 to three notifiable incidents this quarter.

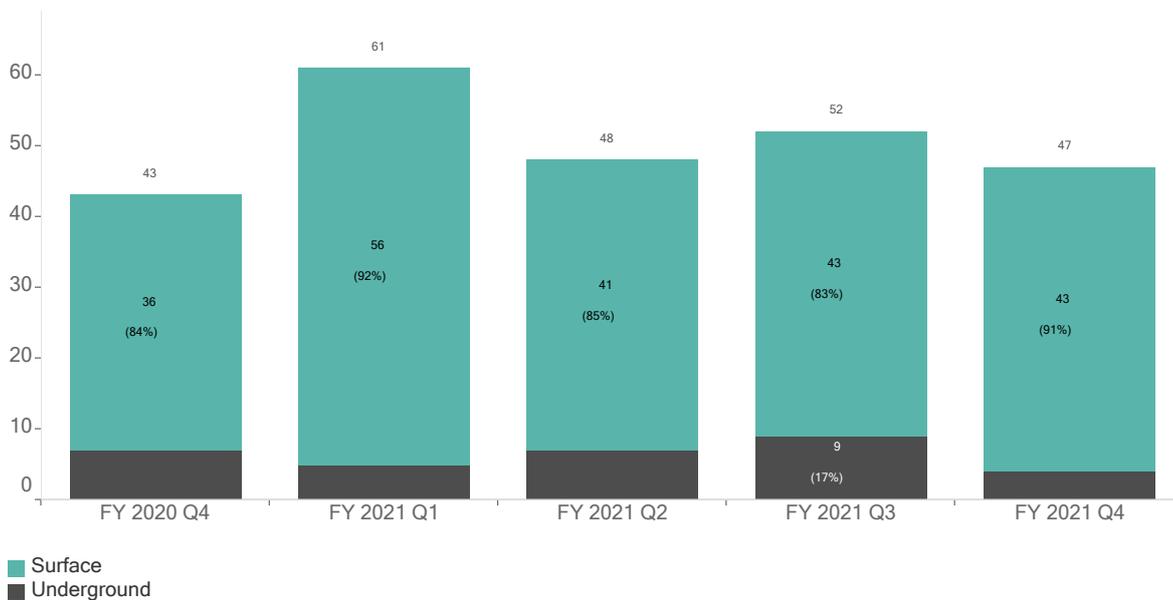
Figure 4: Notified incidents by primary location between 1 April 2020 and 30 June 2021

The figure below shows that the actual location of FOMP incidents, irrespective of the mine operation type, typically occurs on the surface rather than underground. For the past five quarters the proportion of mobile plant fires occurring at the surface has been 80% or higher.

There were four notified incidents this quarter that occurred underground, which is a reduction by five from nine incidents last quarter. This is the lowest number of mobile plant fires occurring underground for the past five quarters.

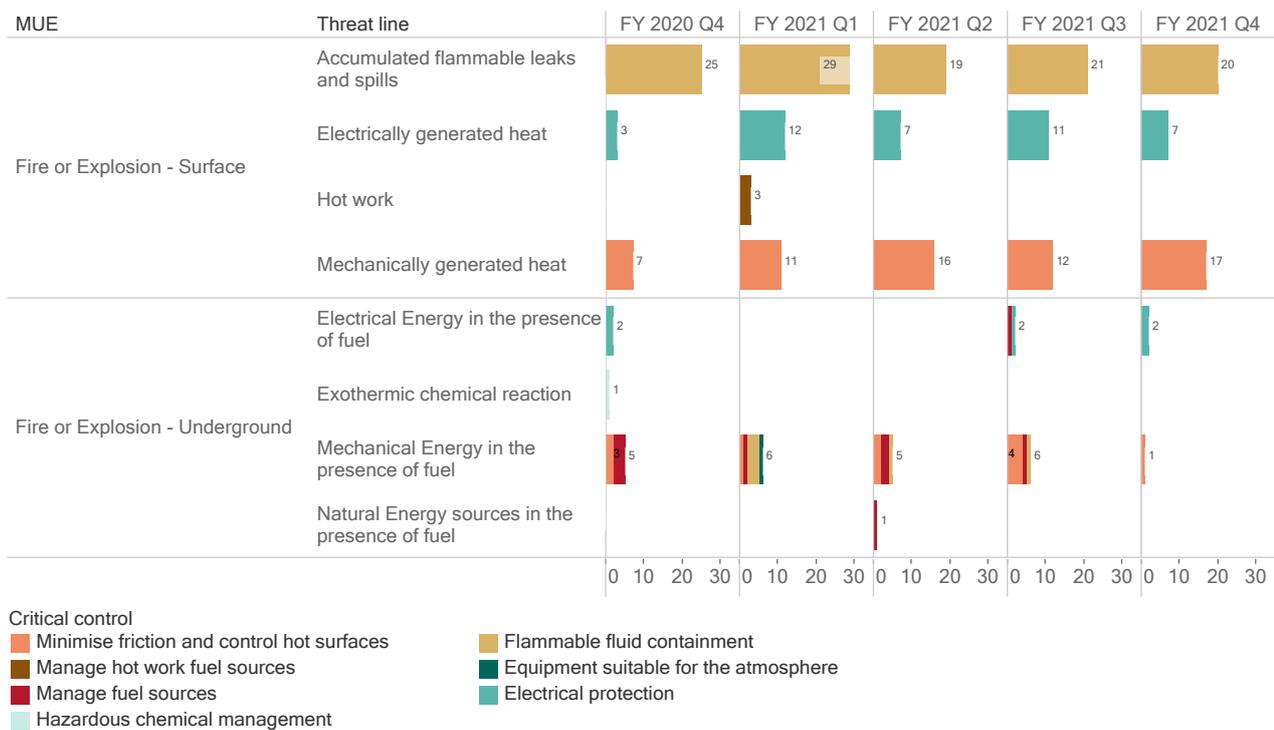
Figure 5: Notified incidents by MUE, threat and critical control between 1 April 2020 and 30 June 2021

The chart below shows notified incidents classified by MUE, threat and critical control.

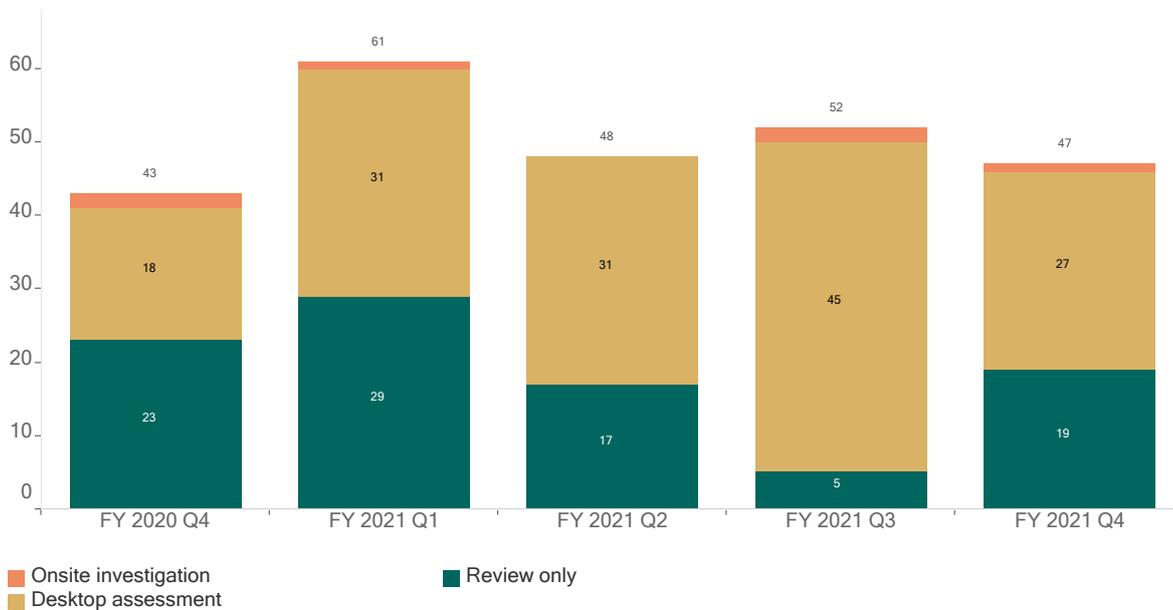
Figure 6: Notified incidents by response level between 1 April 2020 and 30 June 2021

The chart below shows that for this quarter there was one onsite investigation conducted in response to notified incidents involving fires on mobile plant. The number of desktop assessments conducted has reduced this quarter from 45 to 27, representing a 40% decrease. Reviews of FOMP incidents have increased from five reviews to 19 reviews.

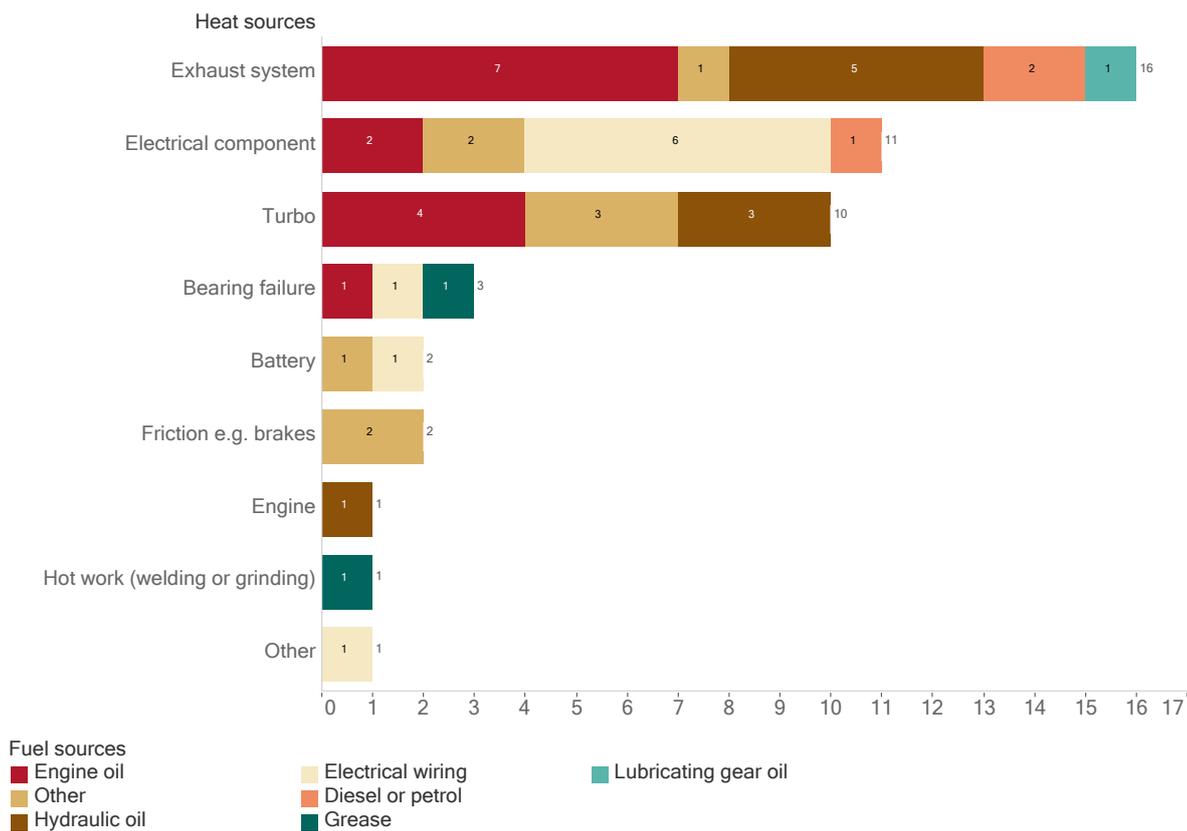
Figure 7: Ancillary reports - fuel sources combined with heat sources, between 1 April 2021 and 30 June 2021

Data for heat sources and fuel sources for FOMP notifiable incidents this quarter indicate that the exhaust system heat source category and engine oil fuel source category combined for seven out of 47 incidents (15%). The second most common combination this quarter was electrical component and electrical wiring, accounting for six out of 47 incidents (13%).

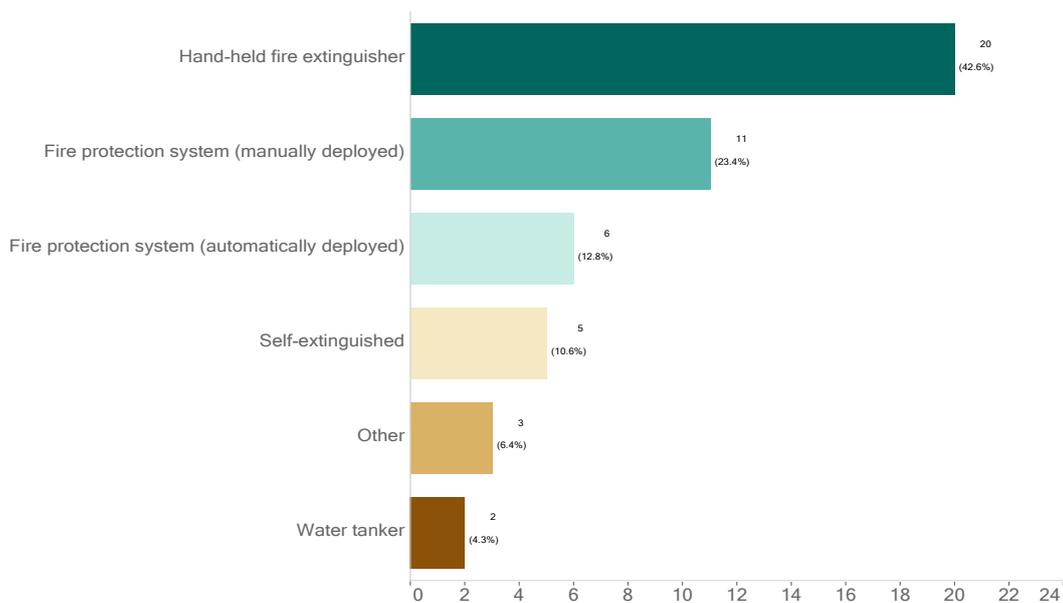
Figure 8: Ancillary reports - extinguished by, between 1 April 2021 and 30 June 2021

The charts below show that a hand-held fire extinguisher remains one of the highest recorded methods of extinguishment. The second highest method of extinguishment this quarter was recorded as a manually deployed fire protection system, recorded in 11 notified incidents of fire on mobile plant.

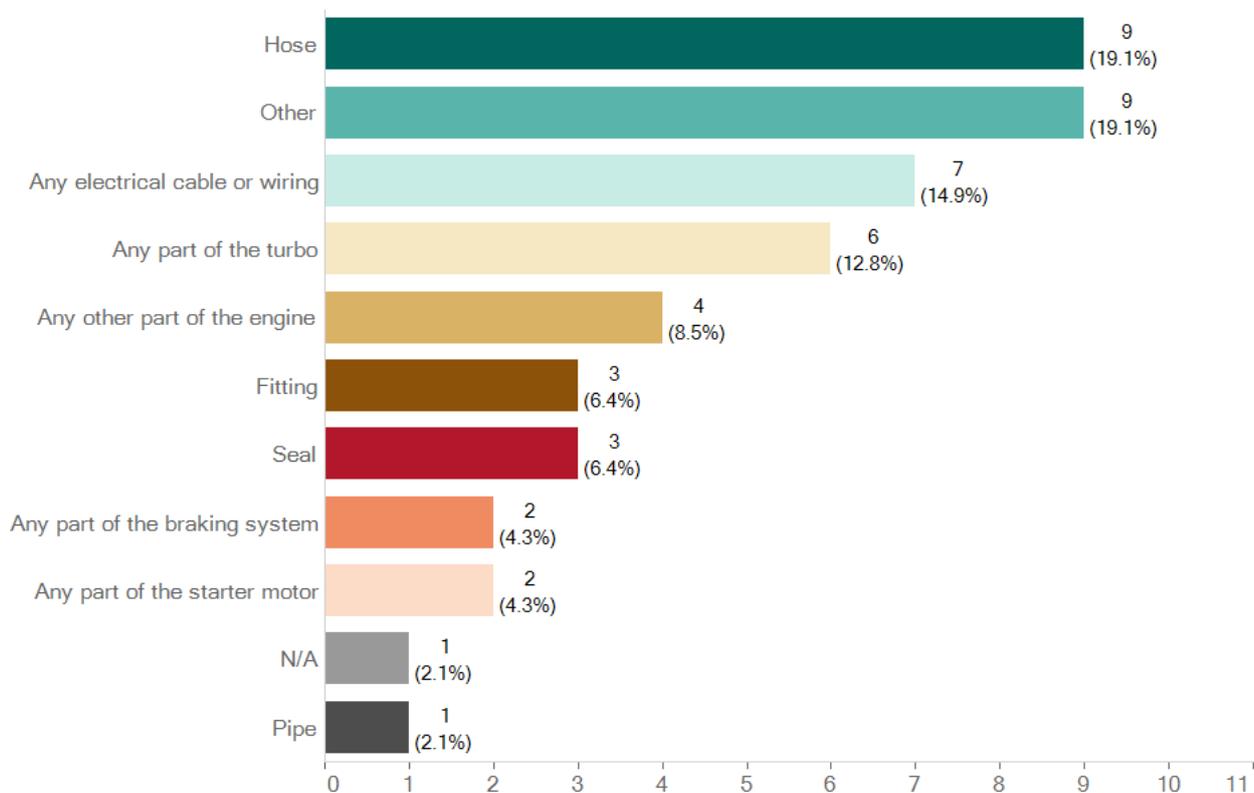
Figure 9: Ancillary reports - failed components, between 1 April 2021 and 30 June 2021

There has been a reduction this quarter in notified incidents occurring where the hose was listed as the failed component (from 14 to nine) however the hose was the most common single failed component.

The category of ‘other’ as a failed component has increased from five incidents last quarter to nine incidents this quarter. The Regulator is conducting a review of incidents in which the failed component is listed as ‘other’ in an effort to reduce FOMP incident notifications with this category in future.

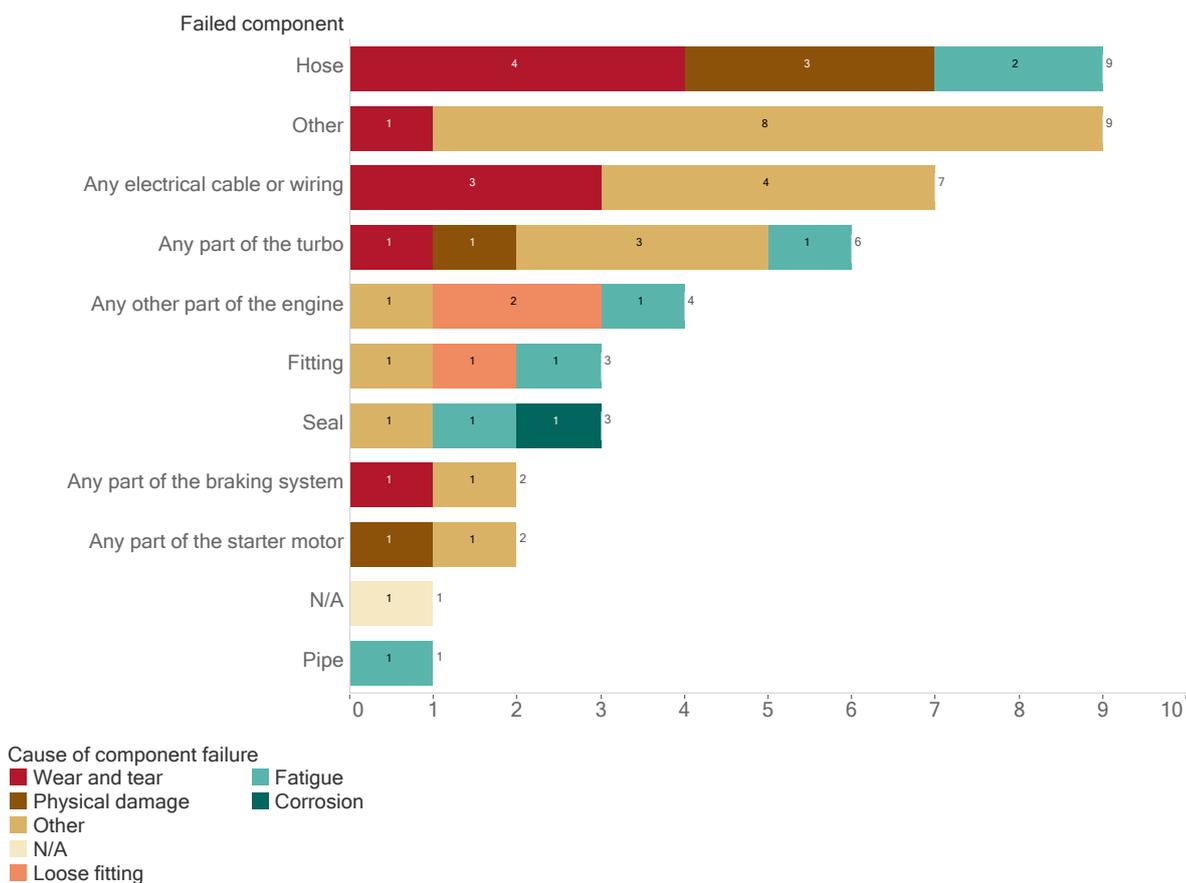
Figure 10: Ancillary reports - failed component and cause of component failure, between 1 April 2021 and 30 June 2021

The most common combination this quarter was ‘other’ and ‘other’, with eight notified incidents out of 47 noting this combination. These categories may be recorded as ‘other’ for several reasons including human errors or uncategorised component failures. The Regulator is conducting a review of incidents in which failed components and cause of component failure were listed as ‘other’ in an effort to reduce the instances of this grouping.

Hoses being the failed component combined with wear and tear as the cause of component failure combined for four out of 47 incidents (9%).
